Expertise

Protocol number: 41227807
Order No. / Reference: 25122423
Inspection date: 26 Aug 2025

Manufacturer: Volkswagen	Model: Tiguan 2.0 TDI SCR 4MOTION DSG Life
VIN: WVGZZZ5NZMW009216

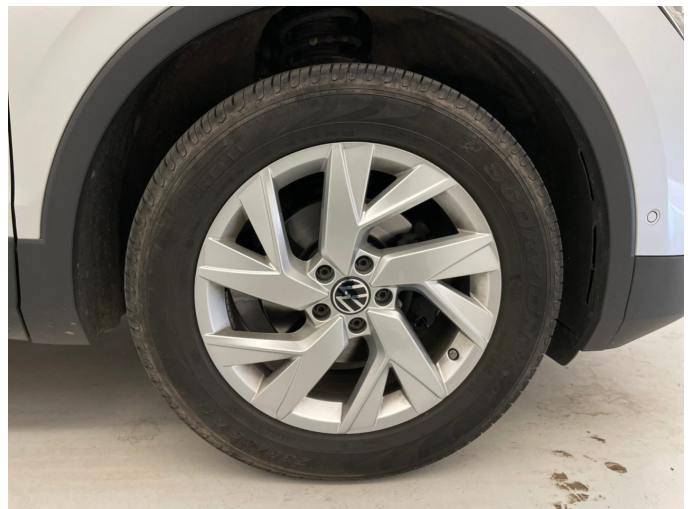
Figure 12: Mounted tyres

#	Tyre size	Type of tyre	Manufacturer	Tread depth
1)	235/55 R18 100V	Summer tyres (with run-flat tyres) on Light alloy	Pirelli	4mm / 4mm
2)	235/55 R18 100V	Summer tyres (with run-flat tyres) on Light alloy	Hankook	5mm / 5mm

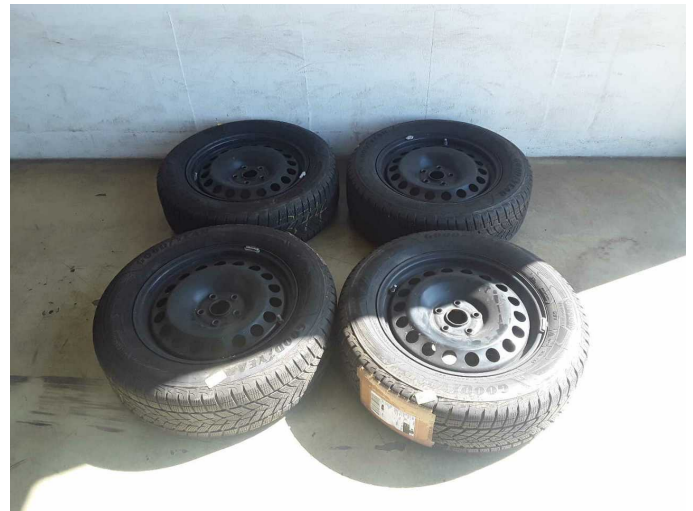
Figure 16: Additional tyres

#	Tyre size	Type of tyre	Manufacturer	Tread depth
1)	215/65 R17 99V	Winter tyres on Steel	Goodyear	5mm / 5mm
2)	215/65 R17 99V	Winter tyres on Steel	Goodyear	6mm / 6mm

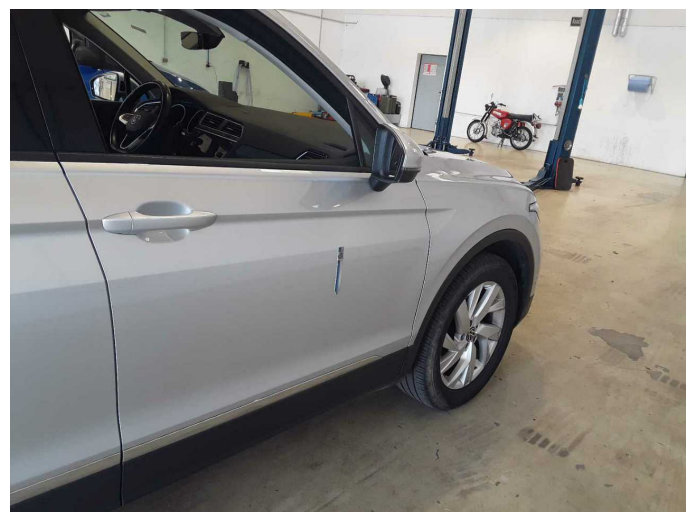
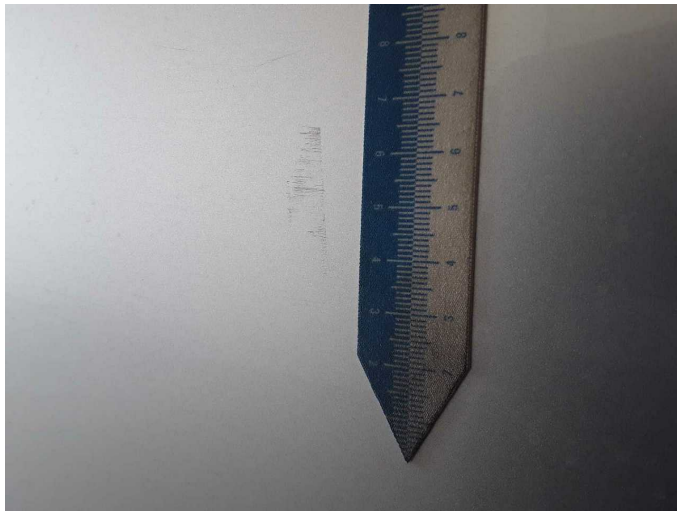
Damage 1: Door - front right side: Door - Scratch(es) - Smart repair

No.	Component group	Description
1	Door - front right side	Door - Scratch(es) - Smart repair
2	Bonnet	Bonnet - Stone chips - Paint
3	Vehicle glazing	Windscreen - Damaged - Replace

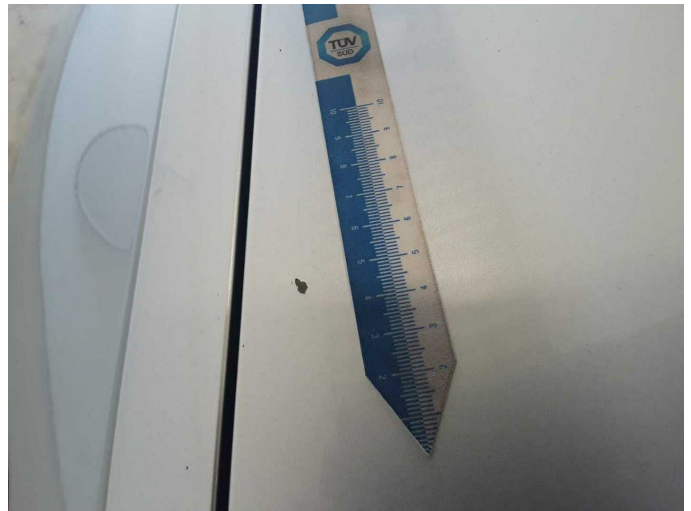
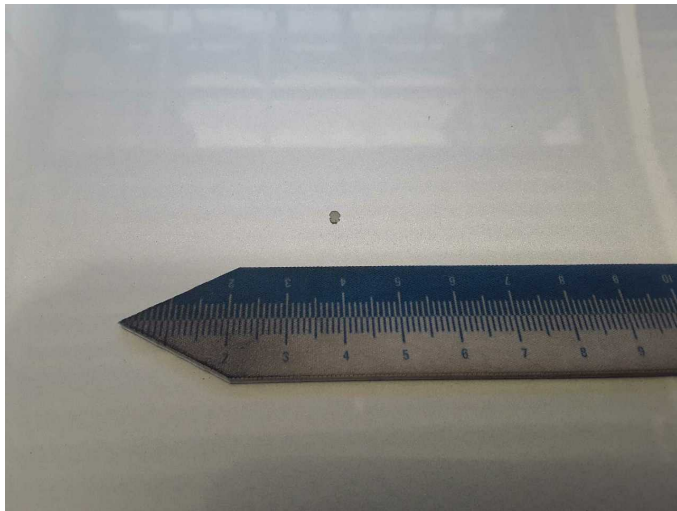
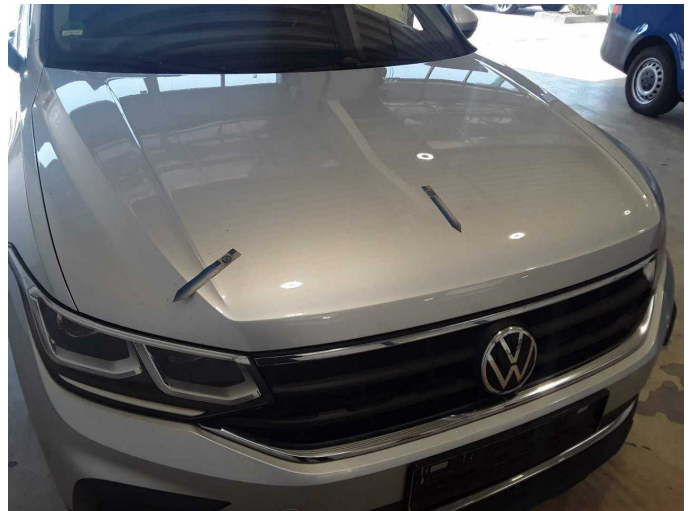
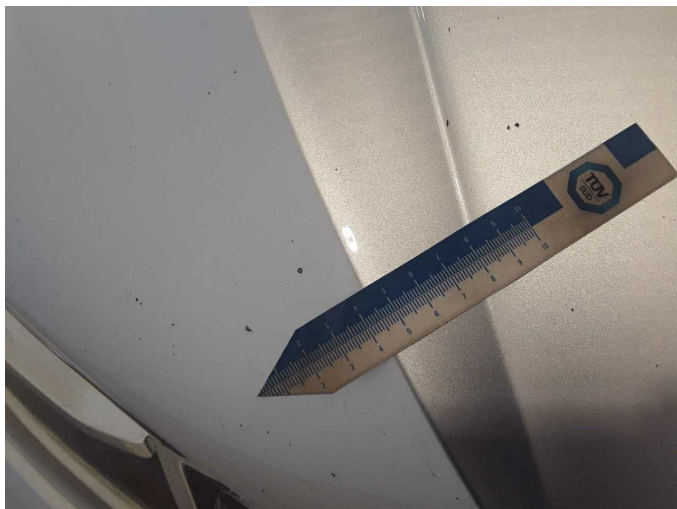
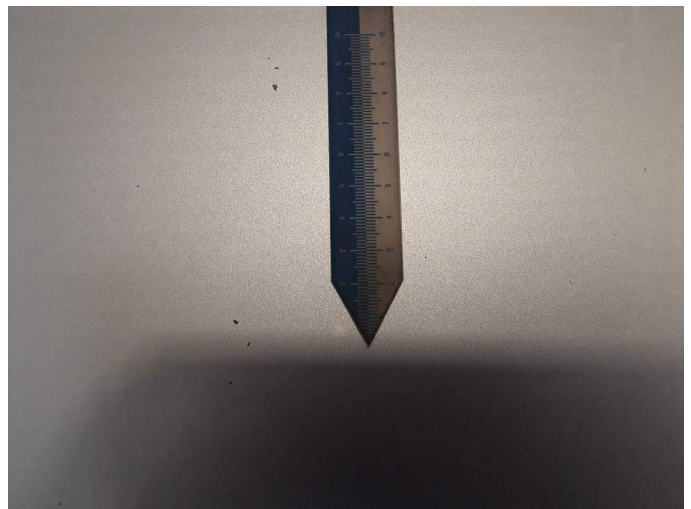
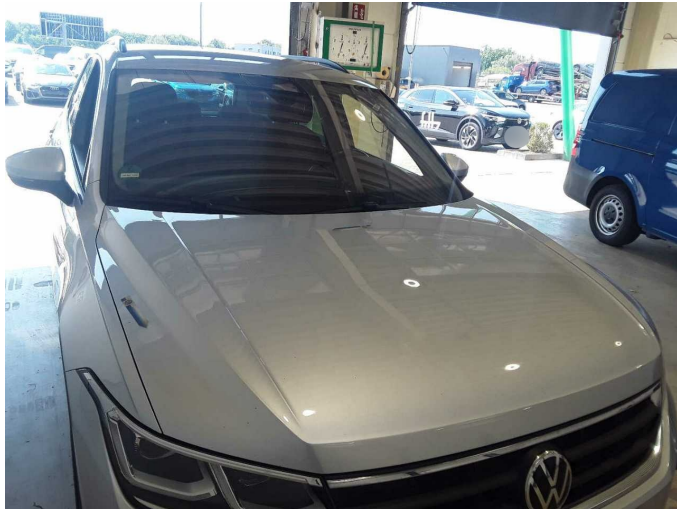
Damage 2: Bonnet: Bonnet - Stone chips - Paint

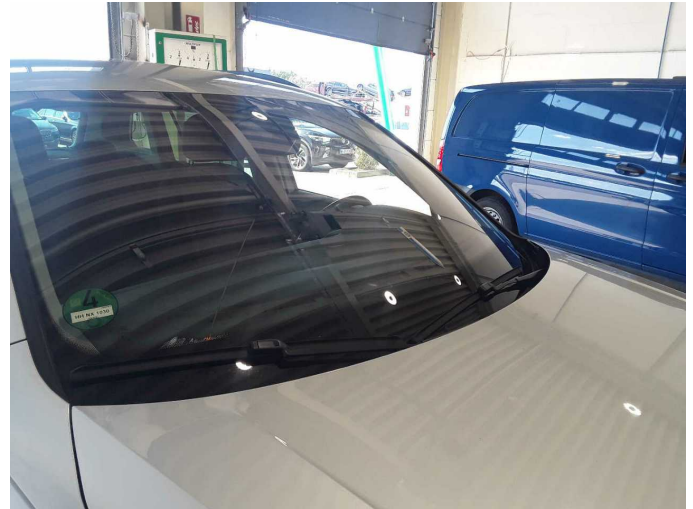
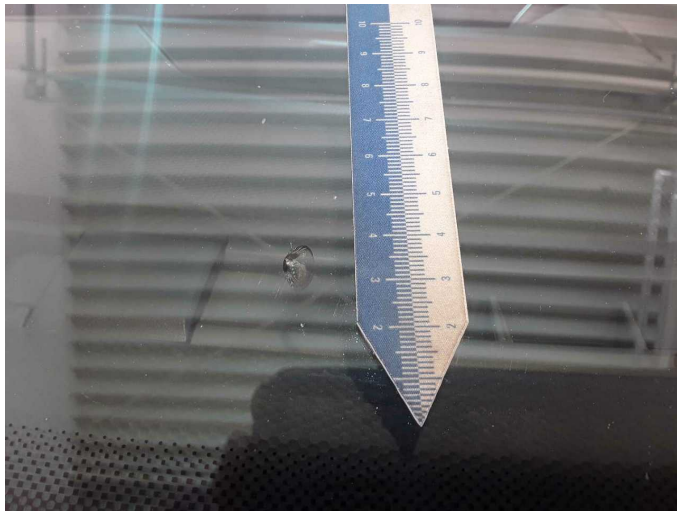
Damage 3: Vehicle glazing: Windscreen - Damaged - Replace

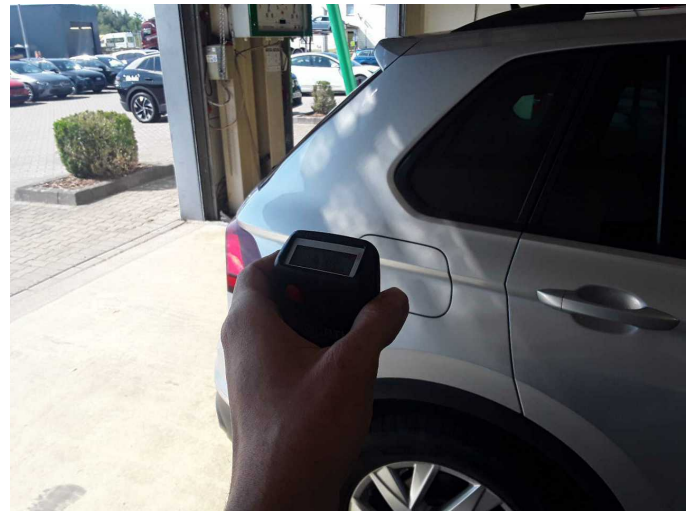
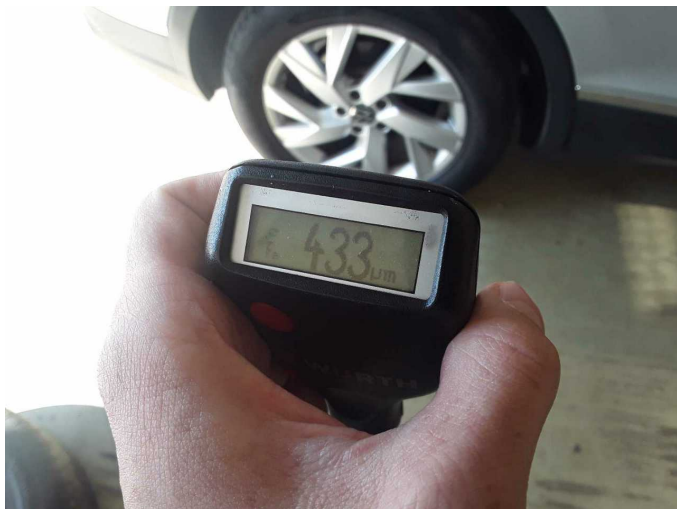
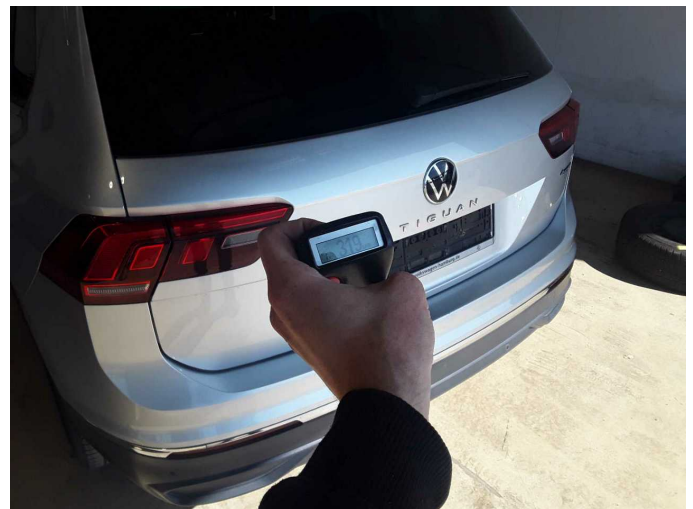
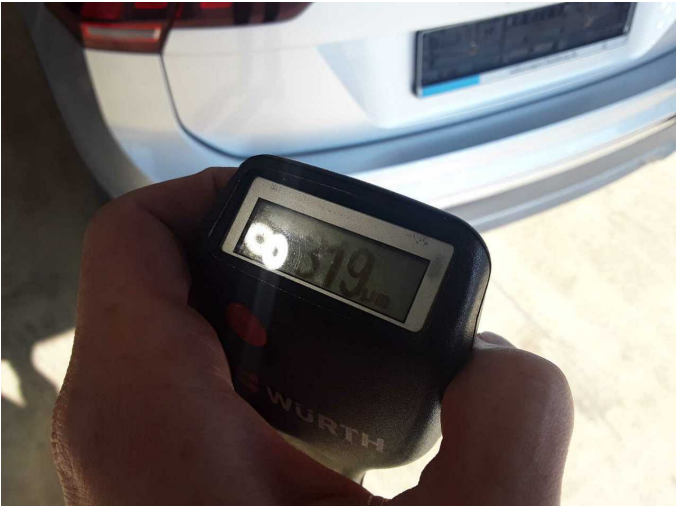
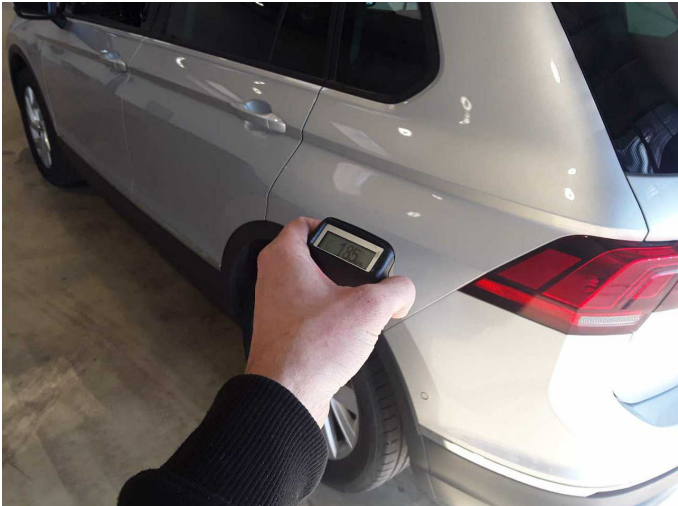
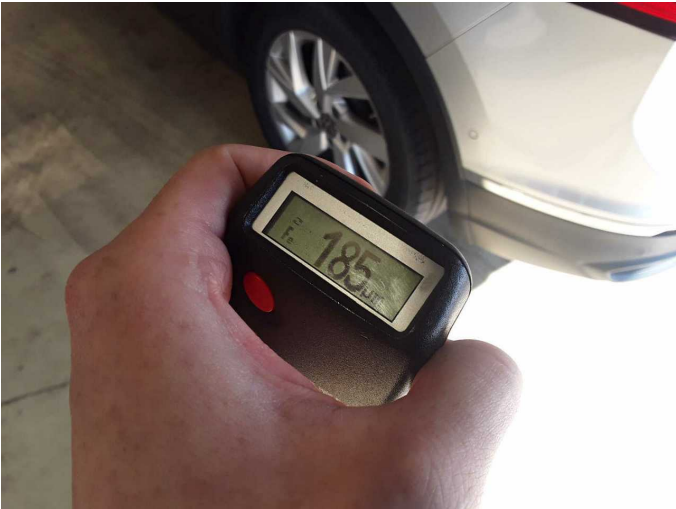
No.	Repainting
1	Boot lid / rear door, Side panel - rear left side, Side panel - rear right side, Professionally carried out, Invoice of repair done Non-existent

Boot lid / rear door	319 µm	Side panel - rear left side	185 µm
Side panel - rear right side	433 µm

Repainting 1: Boot lid / rear door, Side panel - rear left side, Side panel - rear right side
