Expertise

Protocol number: 41520322
Order No. / Reference: 25186955
Inspection date: 15 Sept 2025

Manufacturer: Volkswagen	Model: Tiguan 2.0 TDI SCR 4MOTION DSG Elegance
VIN: WVGZZZ5NZNW058612

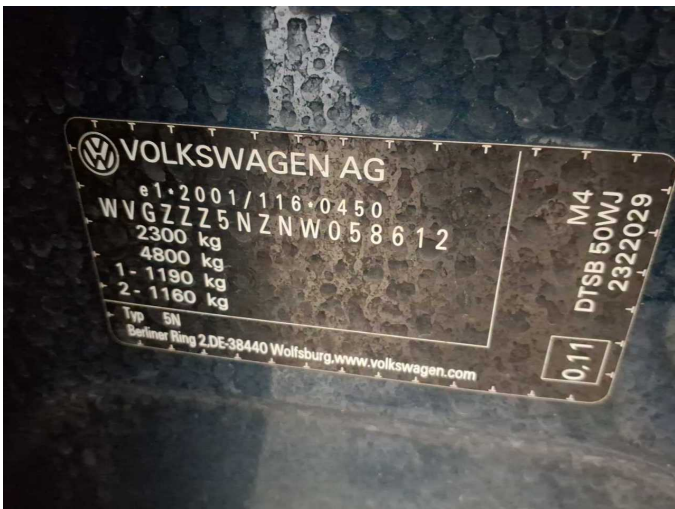
Figure 11: VIN

Documents submitted	At the time of the inspection, the registration certificate Part 2 (letter) was available, but the registration certificate Part 1 (certificate) was not. (Copy)
VIN comparison	The vehicle identification number (VIN) was read from the vehicle and its conformity with the submitted documents was verified during the inspection by the undersigned.
Inspection	The inspection conditions were sufficient for the assessment of the vehicle. Lifting equipment and a pit were available for examining the vehicle.
Test drive	No test drive/maneuvering was carried out during the inspection of the vehicle.
Engine function test	An engine test run was performed.

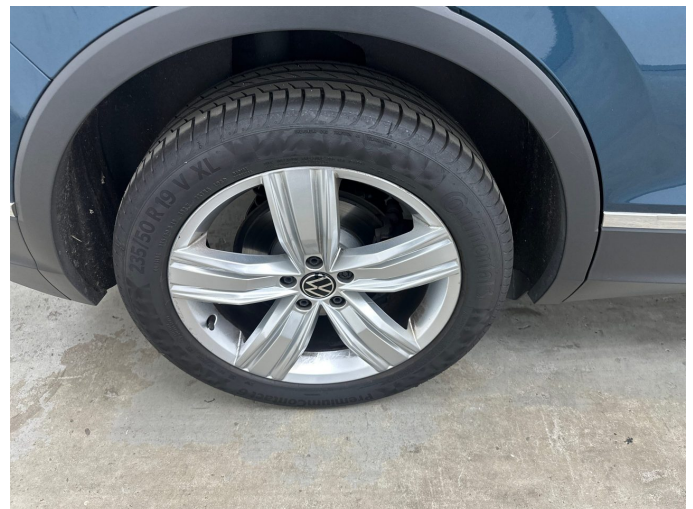
Figure 12: Mounted tyres

Tyres				
Mounted tyres				
#	Tyre size	Type of tyre	Manufacturer	Tread depth
1)	235/50 R19 103V	Summer tyres on Light alloy	Continental	7mm / 7mm
2)	235/50 R19 103V	Summer tyres on Light alloy	Continental	7mm / 7mm
Legend: Tread depth information for tires on the left is in the first place, for tires on the right is in the second place on the axle in the direction of travel

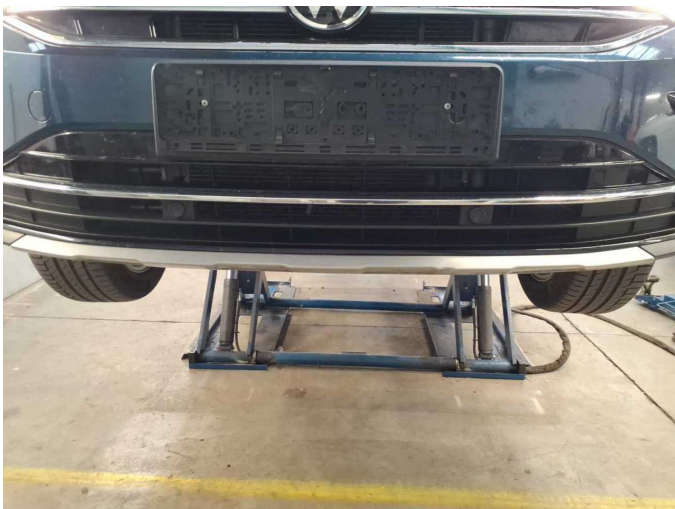
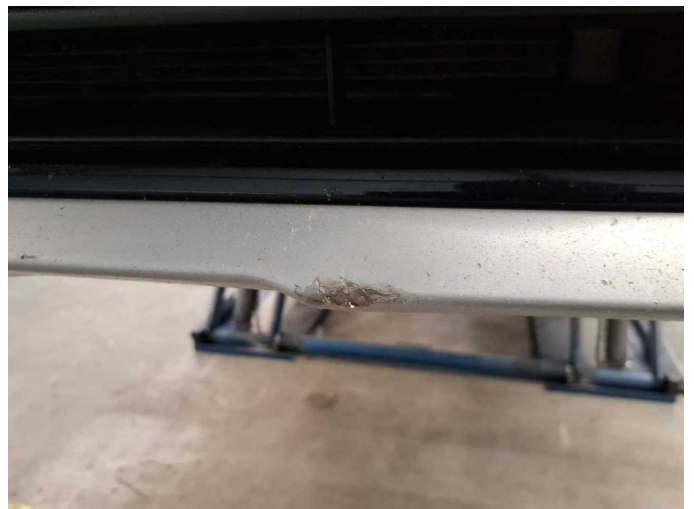
Damage 1: Front bumper: Spoiler - Scratched - Replace

No.	Component group	Description
1	Front bumper	Spoiler - Scratched - Replace
2	Front bumper	Front bumper - Scratched - Paint
3	Door - front right side	Door - Scratch(es) - Paint

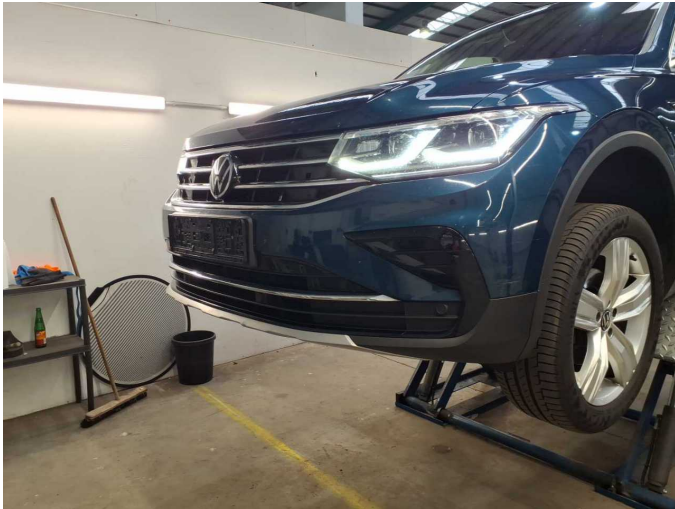
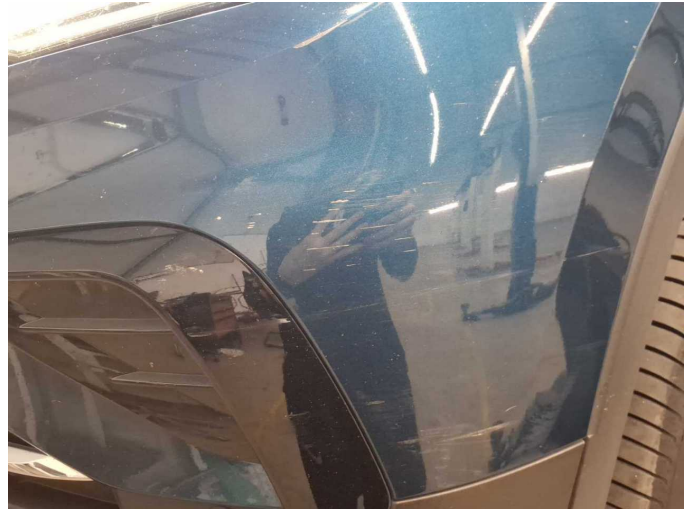
Damage 2: Front bumper: Front bumper - Scratched - Paint

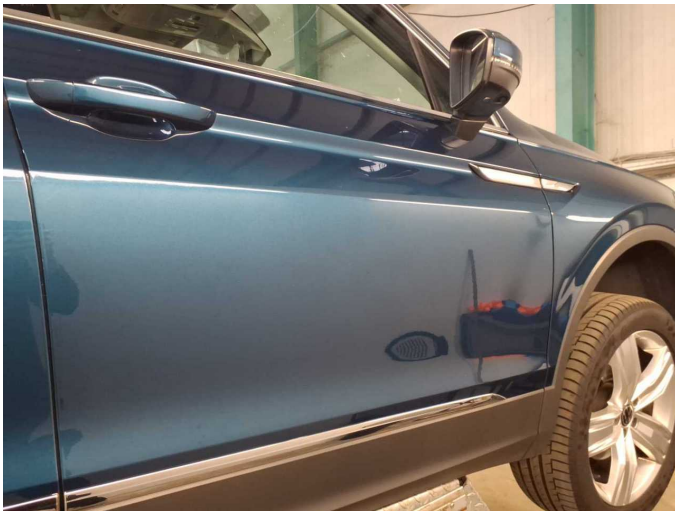
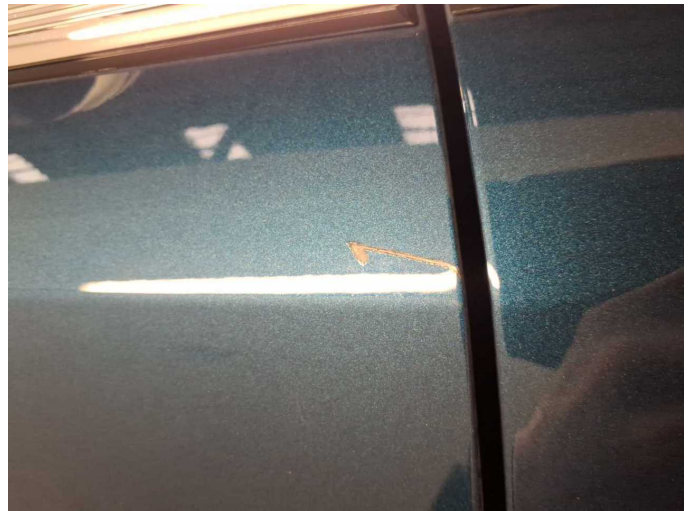
Damage 3: Door - front right side: Door - Scratch(es) - Paint
