Expertise

Protocol number: 41474824  
Order No. / Reference: 25188126  
Inspection date: 9 Sept 2025

Manufacturer: Volkswagen

Model: TIGUAN 1.4 eHybrid OPF DSG R-Line

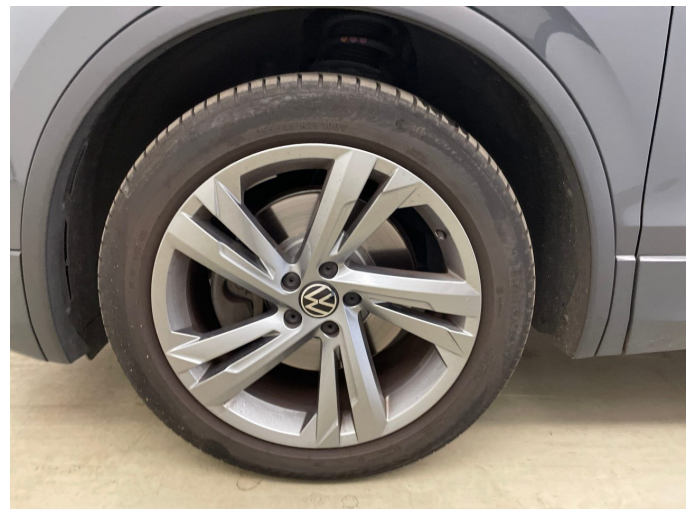
#	Tyre size	Type of tyre	Manufacturer	Tread depth
1)	255/45 R19 100V	Summer tyres on Light alloy	Pirelli	5mm / 5mm
2)	255/45 R19 100V	Summer tyres on Light alloy	Pirelli	6mm / 6mm

Figure 12: Mounted tyres

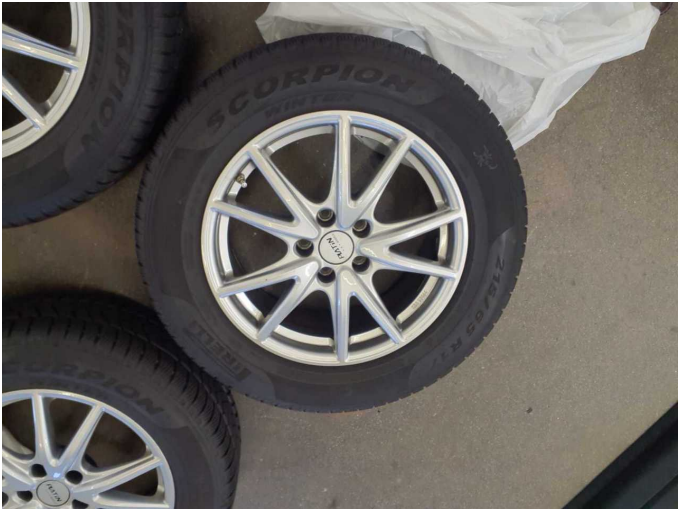
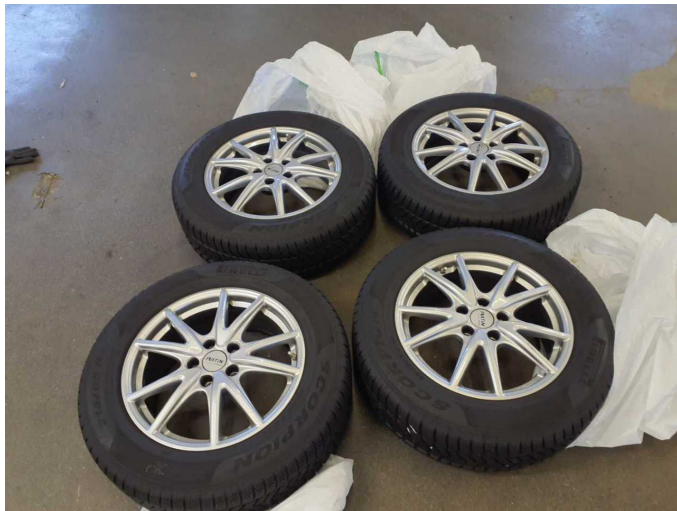
#	Tyre size	Type of tyre	Manufacturer	Tread depth
1)	215/65 R17 99H	Winter tyres on Light alloy	Pirelli	6mm / 6mm
2)	215/65 R17 99H	Winter tyres on Light alloy	Pirelli	6mm / 6mm

Figure 18: Additional tyres

Figure 19: Additional tyres

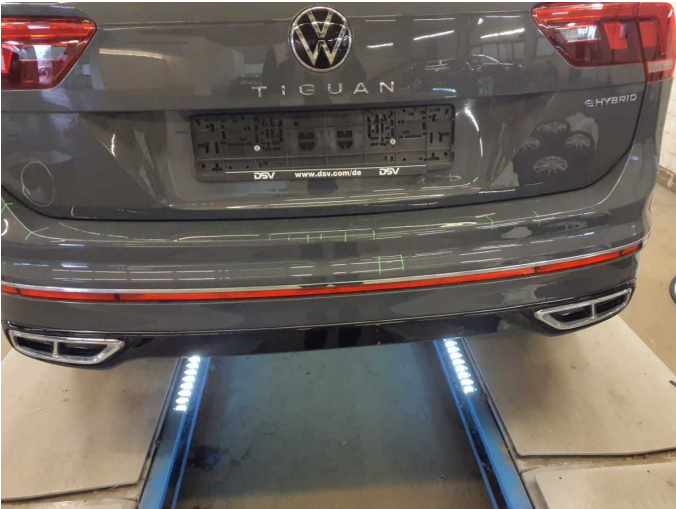
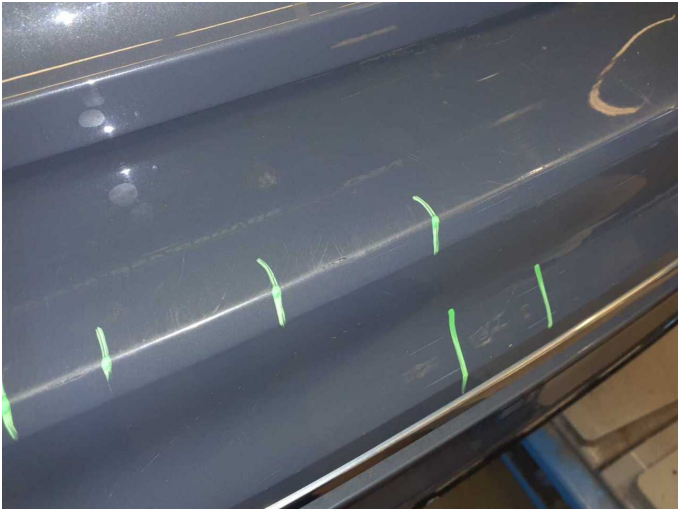
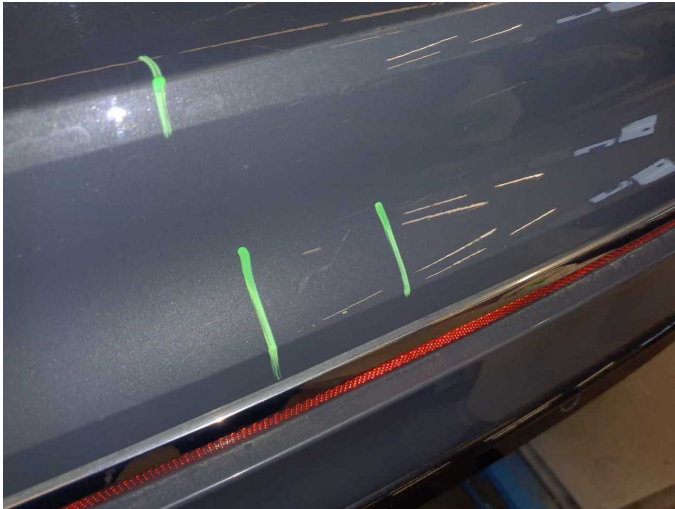
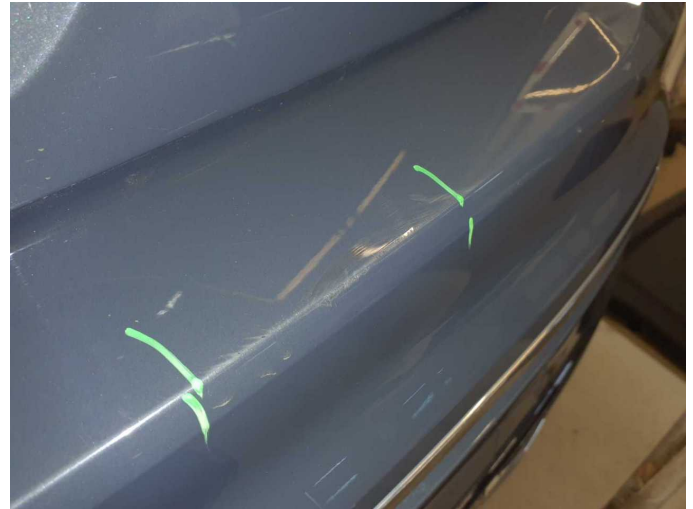
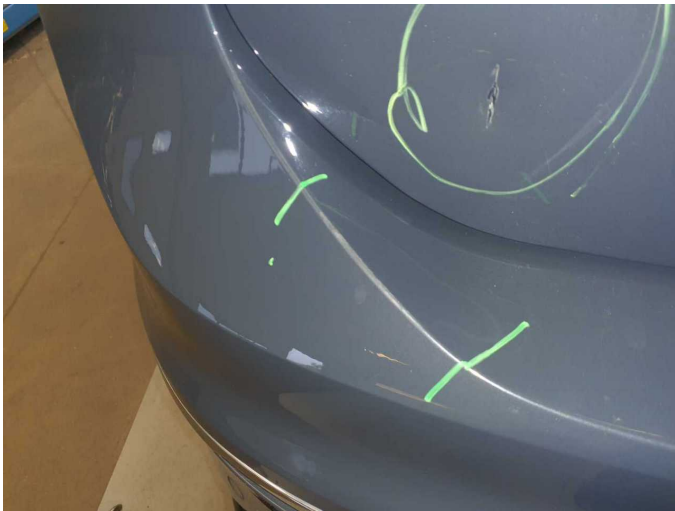
Damage 1: Rear bumper: Rear bumper - Scratch(es) - Paint

**Damage 1:** Rear bumper: Rear bumper - Scratch(es) - Paint

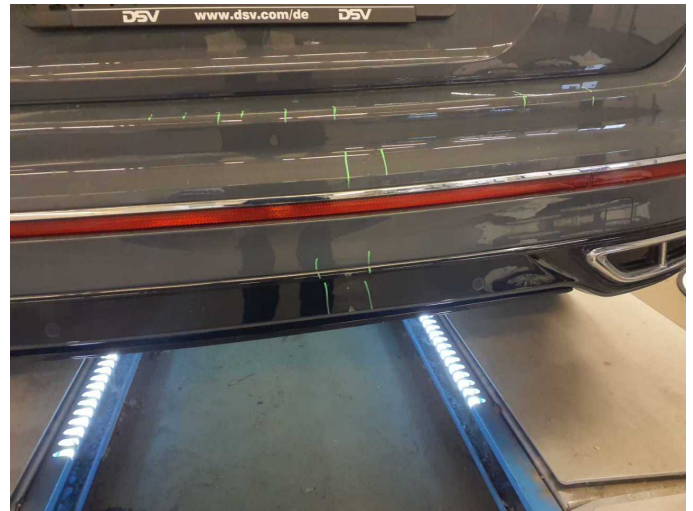
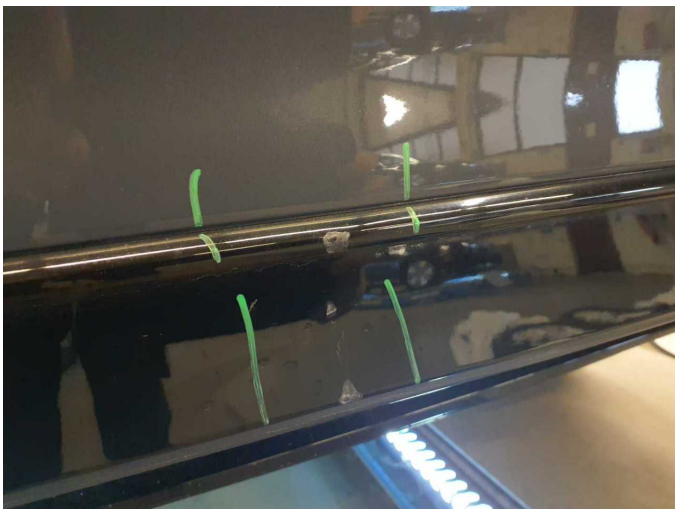
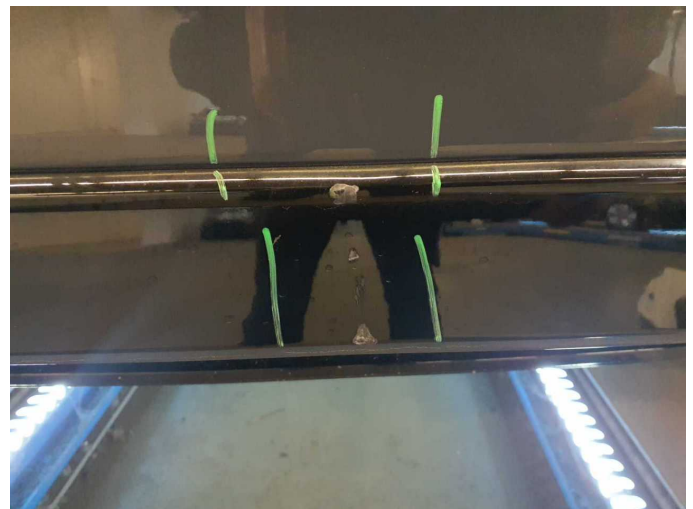
**Damage 2:** Rear bumper: Spoiler - Damaged - Replace

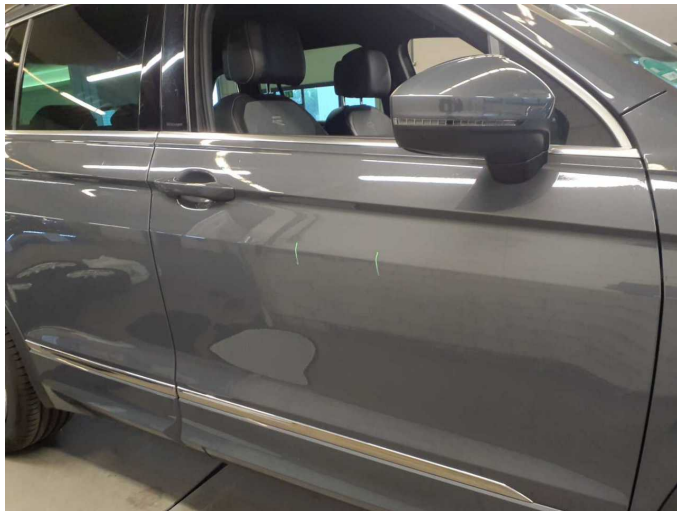
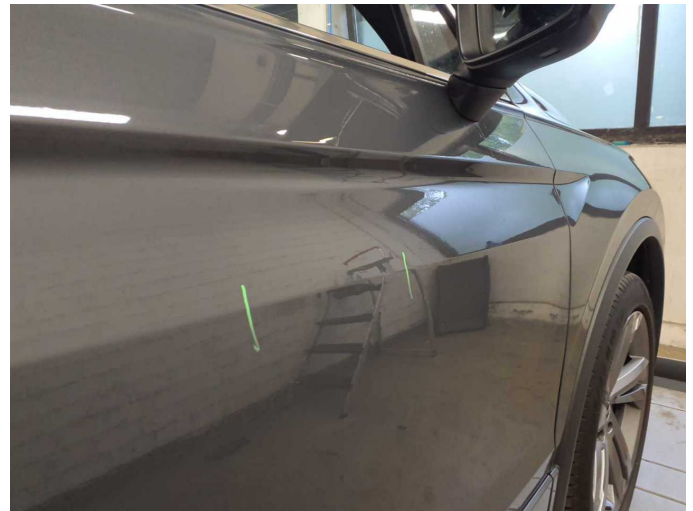
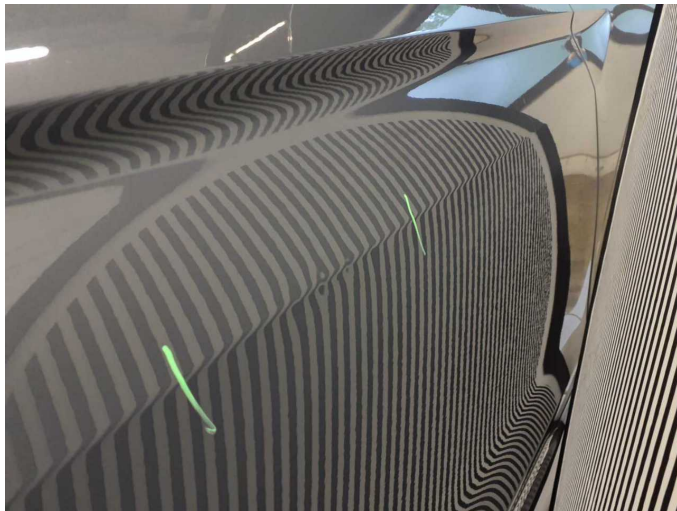
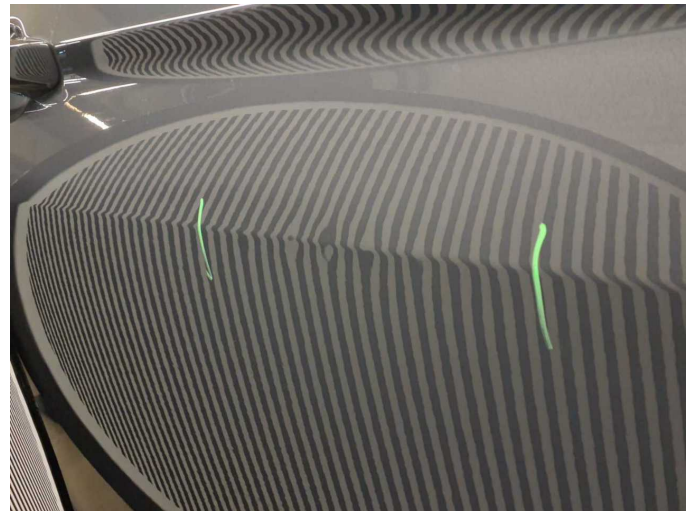
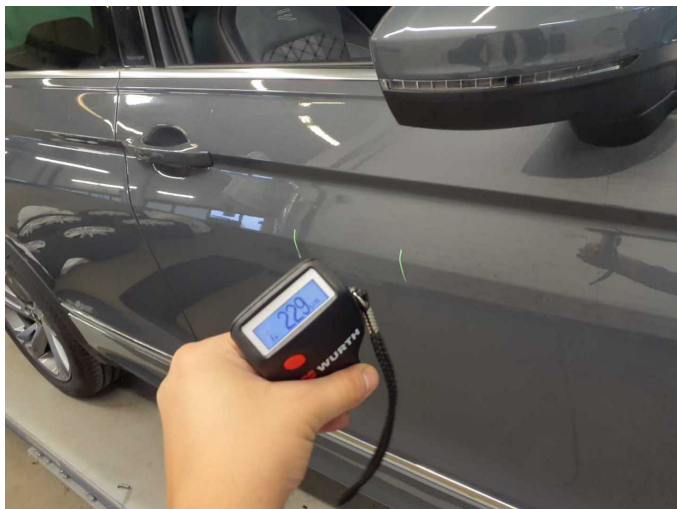
**Damage 3:** Door - front right side: Door - Unprofessionally repaired - Repair and paint

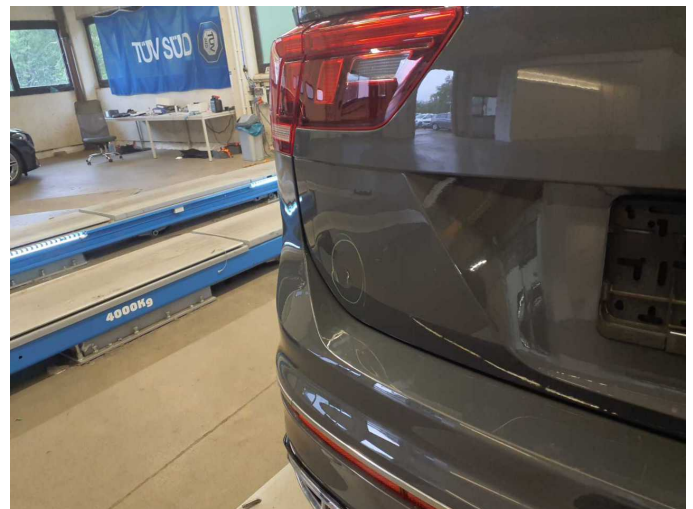
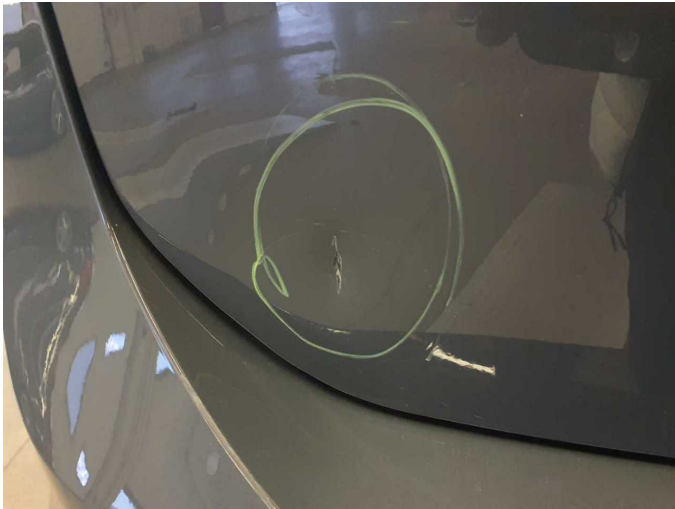
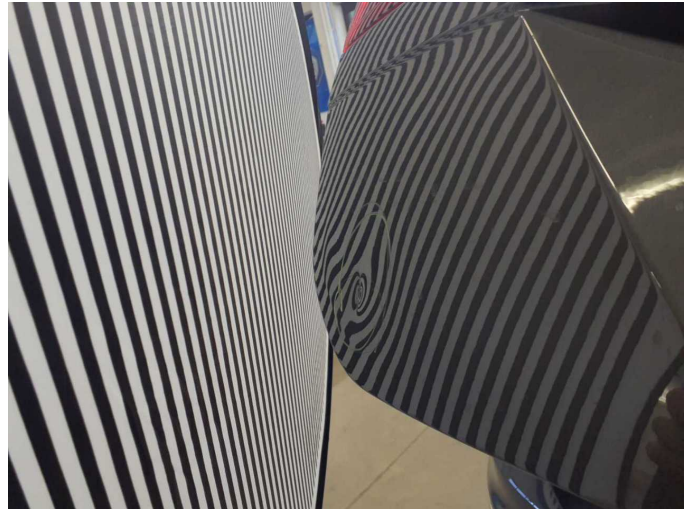
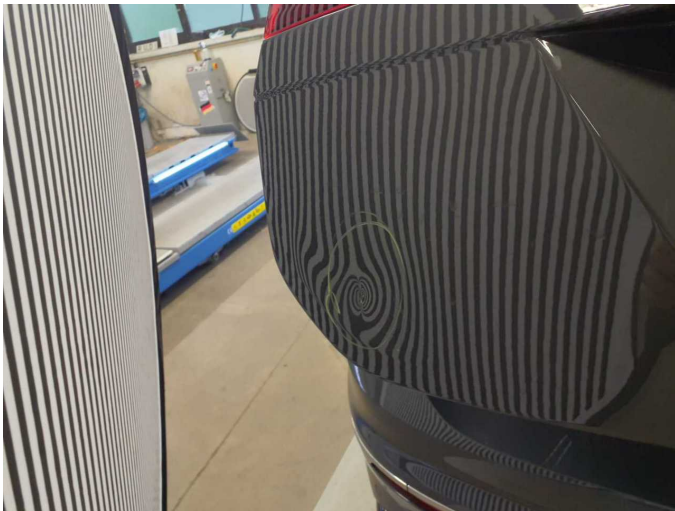
**Damage 4:** Boot lid / rear door: Boot lid - Deformed - Repair and paint

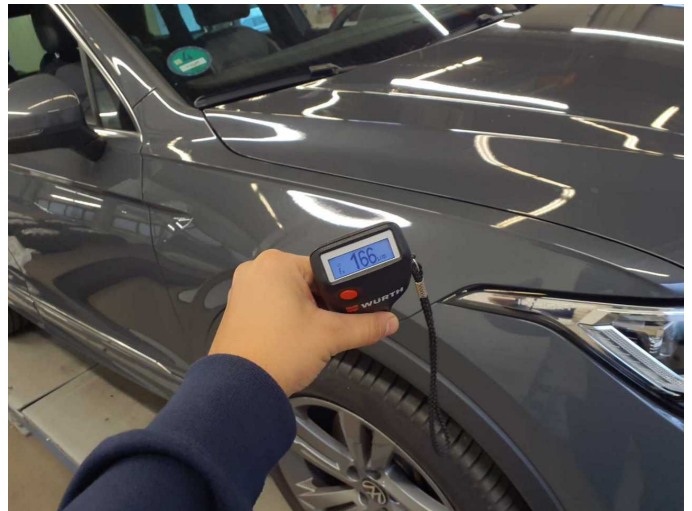
No.	Repainting
1	Mudguard - right side, Professionally carried out, Invoice of repair done Non-existent

**Repainting 1:** Mudguard - right side

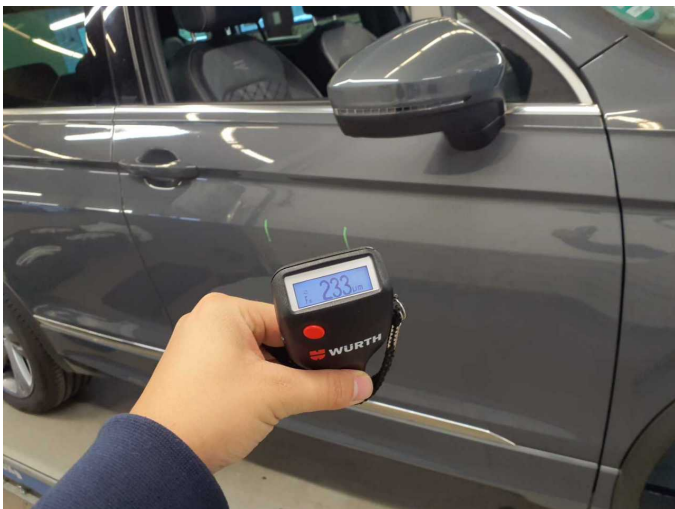
2 Door - front right side, Unprofessionally carried out, Invoice of repair done Non-existent

**Repainting 2:** Door - front right side
