Expertise

Protocol number: 41484905
Order No. / Reference: 25212865
Inspection date: 10 Sept 2025

Manufacturer: Volkswagen	Model: Tiguan 2.0 TDI SCR DSG Life
VIN: WVGZZZ5NZNW526387

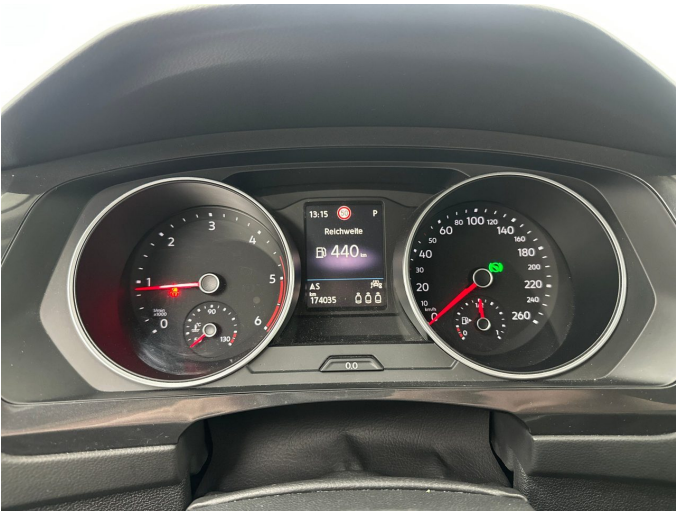
Figure 7: Instrument cluster

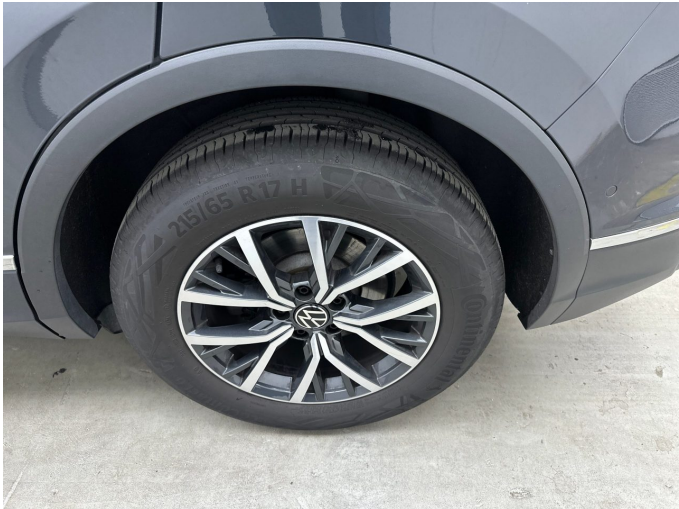
Figure 12: Mounted tyres

#	Tyre size	Type of tyre	Manufacturer	Tread depth
1)	215/65 R17 99H	Summer tyres on Light alloy	Continental	6mm / 6mm
2)	215/65 R17 99H	Summer tyres on Light alloy	Continental	6mm / 6mm

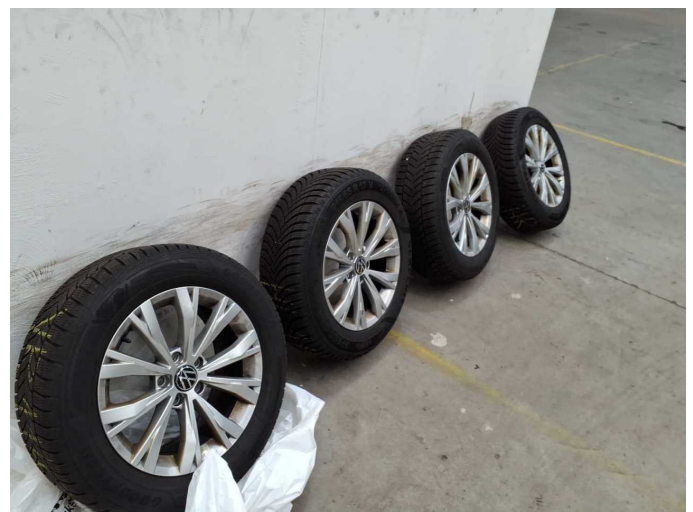
Figure 16: Additional tyres

#	Tyre size	Type of tyre	Manufacturer	Tread depth
1)	215/65 R17 99V	Winter tyres on Light alloy	Goodyear	6mm / 6mm
2)	215/65 R17 99V	Winter tyres on Light alloy	Semperit	7mm / 7mm

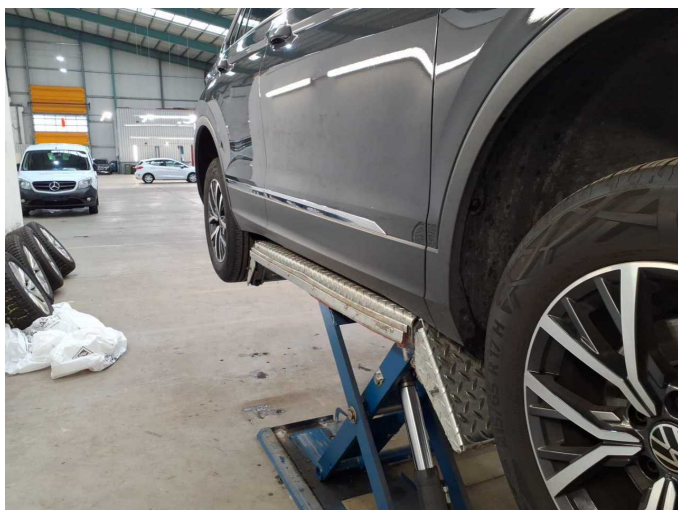
A rear view of a dark grey Volkswagen Tiguan parked in a workshop. The car is positioned on a blue hydraulic lift. The rear features include the VW logo, 'TIGUAN' text, and a license plate that reads 'TIGUAN'. A '4x4' badge is visible on the right side of the rear. The car is surrounded by workshop equipment, including a blue lift and various tools.

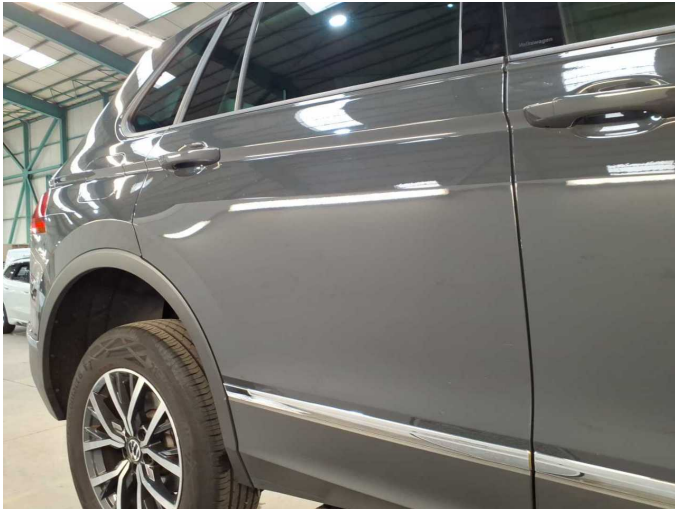
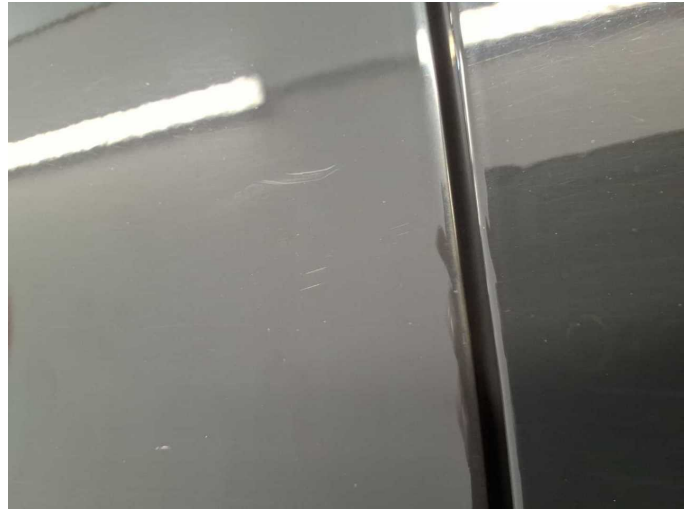
Damage 4: Door - rear right side: Door - Scratch(es) - Paint

No.	Component group	Description
1	Boot lid / rear door	Boot lid - Glued / labelled - De-glue / neutralise
2	Door - front right side	Door edge - Scratch(es) - Smart repair
3	Interior	Rear shelf - Broken / torn - Replace
4	Door - rear right side	Door - Scratch(es) - Paint

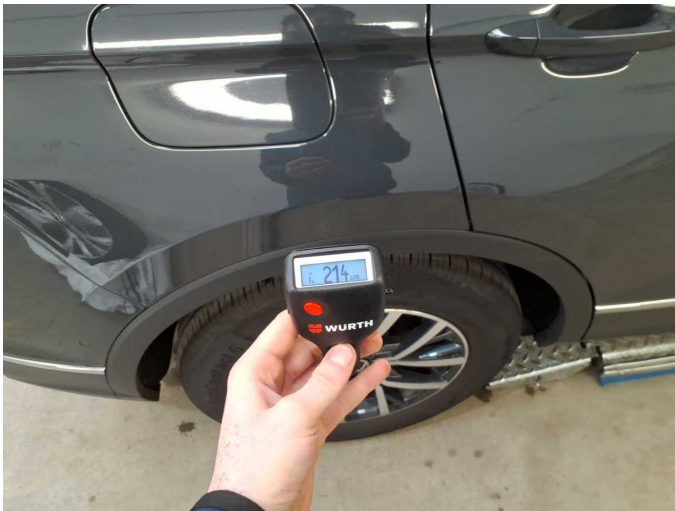
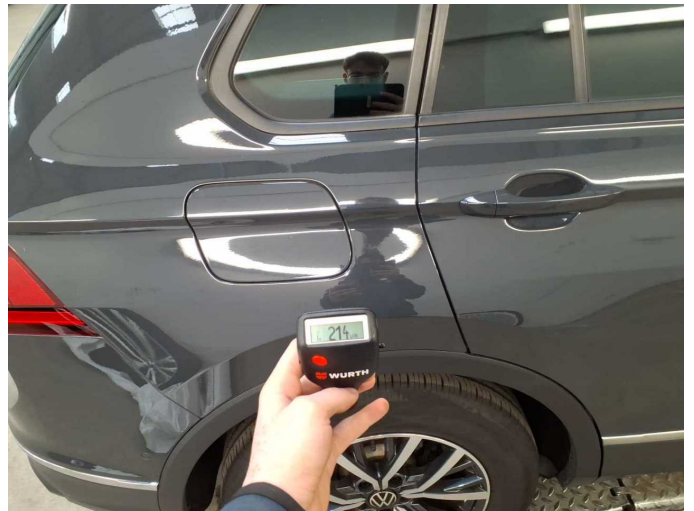
Repainting 1: Side panel - rear right side

No.	Repainting
1	Side panel - rear right side

Side panel - rear right side	214 µm
------------------------------	--------
