# VOLKSWAGEN Passat

## Passat Variant 2.0 TDI DPF

VIN NO WVWZZZ3CZ9E030284  
Registration Number CZ9E030284

### Inspection Report Summary

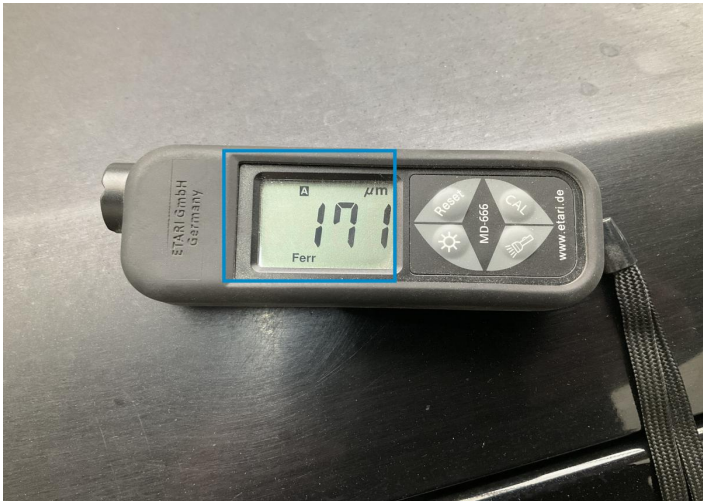
| Component | | Damage | Comments |
|---|---|---|---|
| 1 | Fender / Front Left | Paint / Poor Previous Repair | |

1. Fender / Front Left  
Paint / Poor Previous Repair -

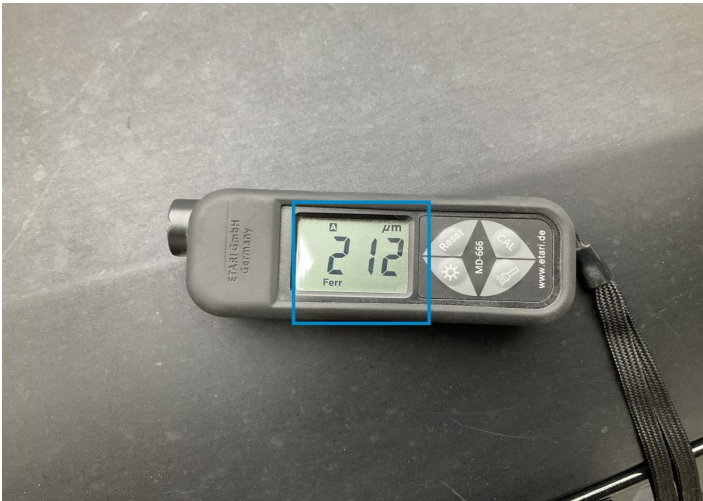
| Component | | Damage | Comments |
|---|---|---|---|
| 2 | Hood | Paint / Poor Previous Repair | |

2. Hood  
Paint / Poor Previous Repair -

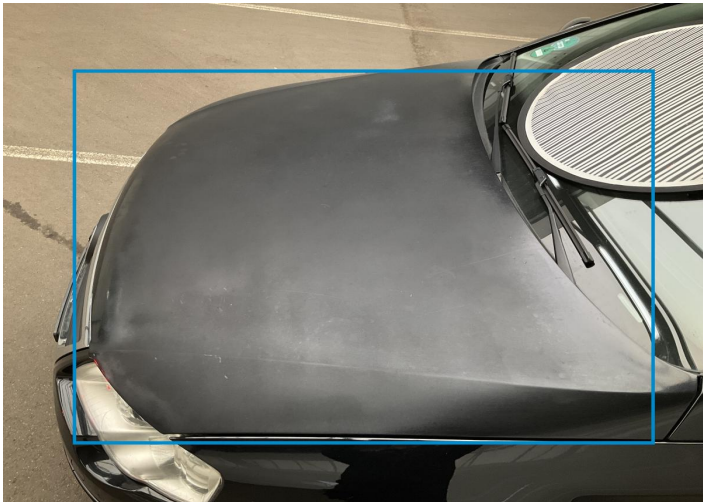
| Component | | Damage | Comments |
|---|---|---|---|
| 3 | Hood | Paint / Poor Previous Repair | |

3. Hood  
Paint / Poor Previous Repair -

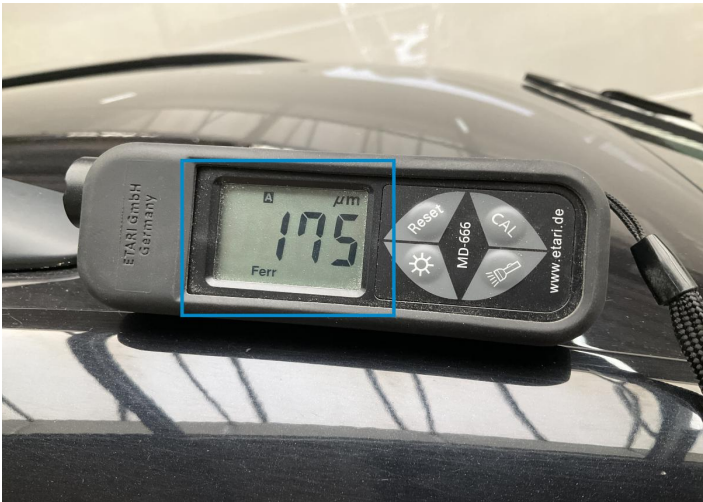
| Component | | Damage | Comments |
|---|---|---|---|
| 4 | Door / Front Right | Paint / Poor Previous Repair | |

4. Door / Front Right  
Paint / Poor Previous Repair -

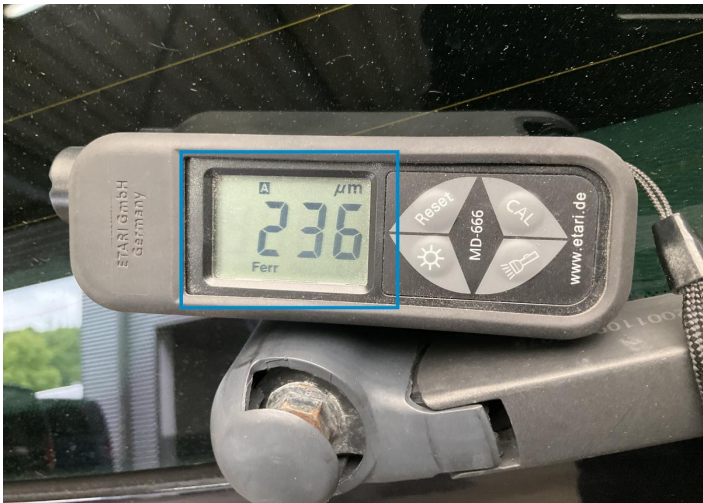
| Component | | Damage | Comments |
|---|---|---|---|
| 5 | Tailgate | Paint / Poor Previous Repair | |

5. Tailgate  
Paint / Poor Previous Repair -

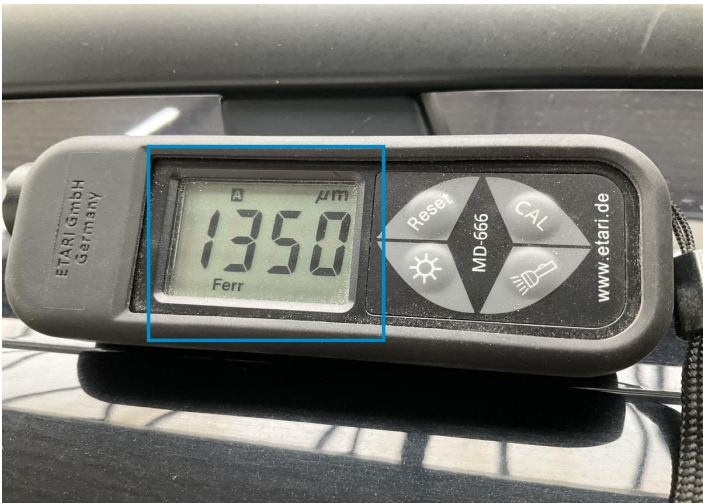
| Component | | Damage | Comments |
|---|---|---|---|
| 6 | Side Panel / Back Left | Paint / Poor Previous Repair | |

6. Side Panel / Back Left  
Paint / Poor Previous Repair -

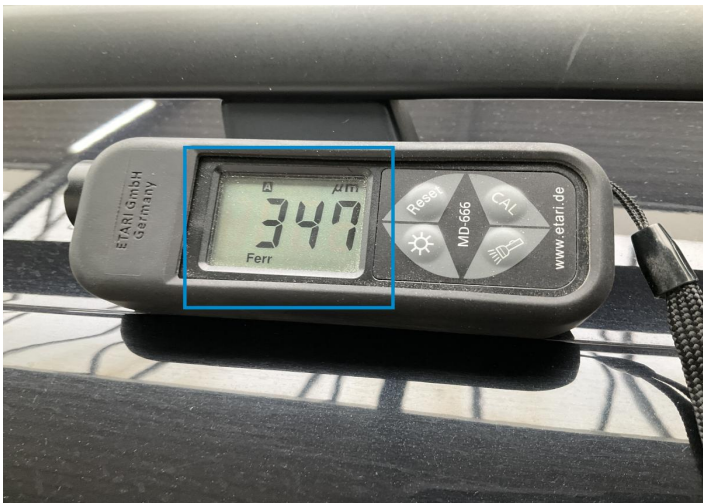
| Component | | Damage | Comments |
|---|---|---|---|
| 7 | Door / Back Left | Paint / Poor Previous Repair | |

7. Door / Back Left  
Paint / Poor Previous Repair -

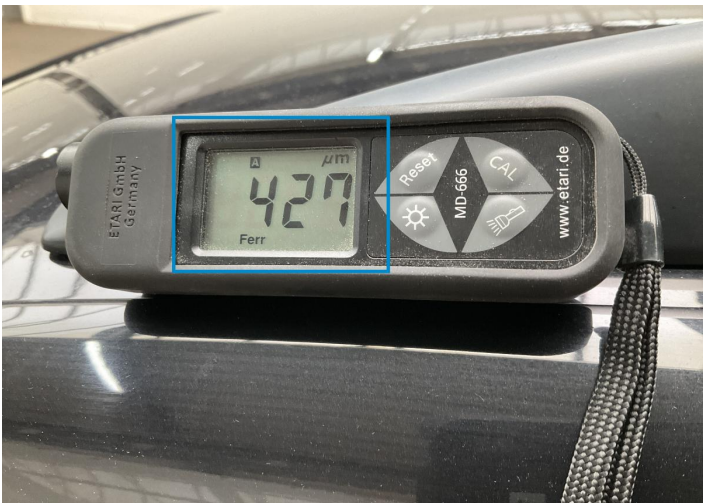
| Component | | Damage | Comments |
|---|---|---|---|
| 8 | Door / Front Left | Paint / Poor Previous Repair | |

8. Door / Front Left  
Paint / Poor Previous Repair -

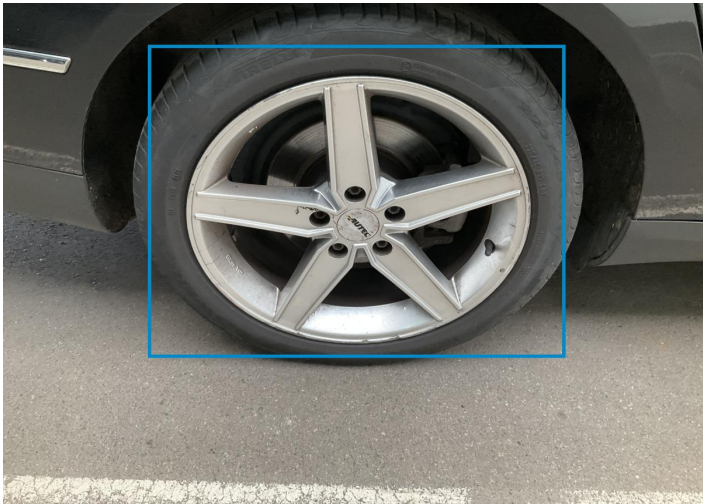
| Component | | Damage | Comments |
|---|---|---|---|
| 9 | Rim / Back Right | Out of Bodywork / Scratch | |

9. Rim / Back Right  
Out of Bodywork / Scratch -

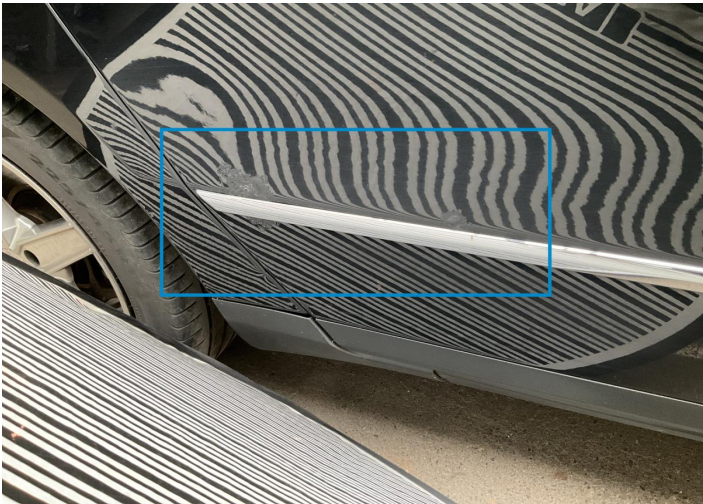
| Component | | Damage | Comments |
|---|---|---|---|
| 10 | Door / Back Right | Paint / Corrosion | |

10. Door / Back Right  
Paint / Corrosion -

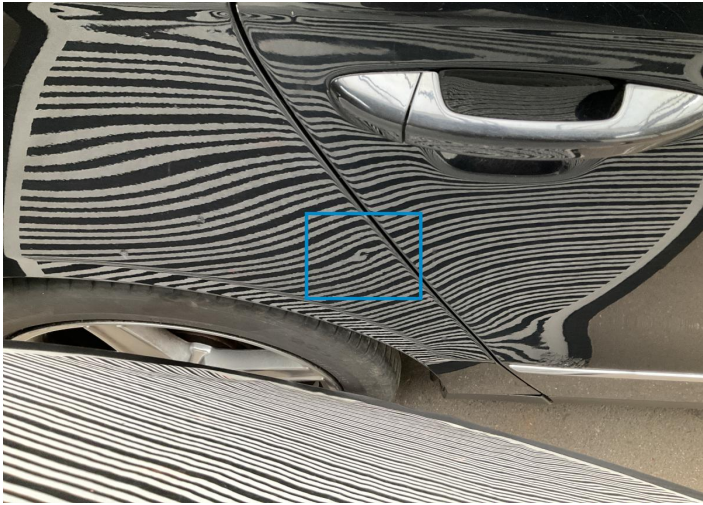
| Component | | Damage | Comments |
|---|---|---|---|
| 11 | Side Panel / Back Right | Bodywork / Dent / Dent | |

11. Side Panel / Back Right  
Bodywork / Dent / Dent -

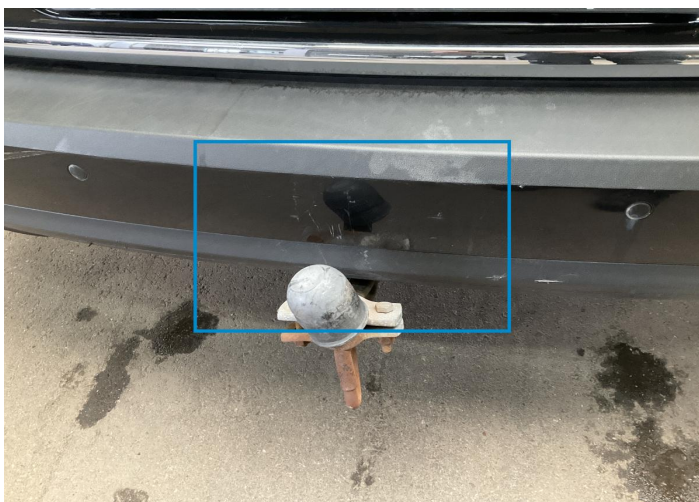
| Component | | Damage | Comments |
|---|---|---|---|
| 13 | Bumper / Back | Paint / Scratch / Scuff | |

13. Bumper / Back  
Paint / Scratch / Scuff -

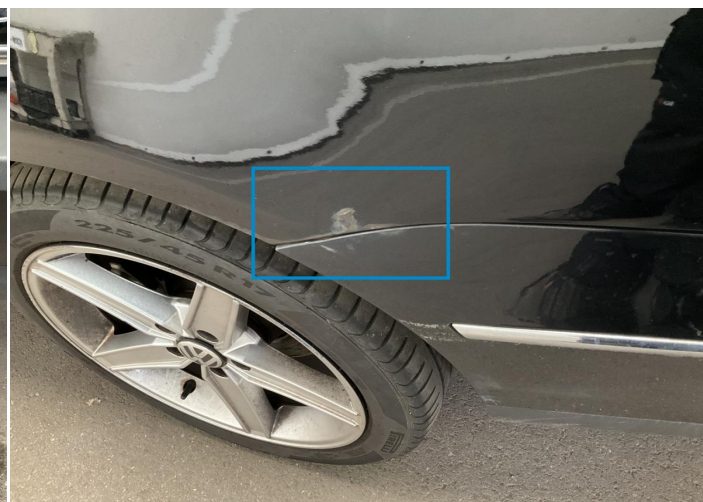
| 14 | Side Panel / Back Left | Paint / Corrosion |

14. Side Panel / Back Left  
Paint / Corrosion -

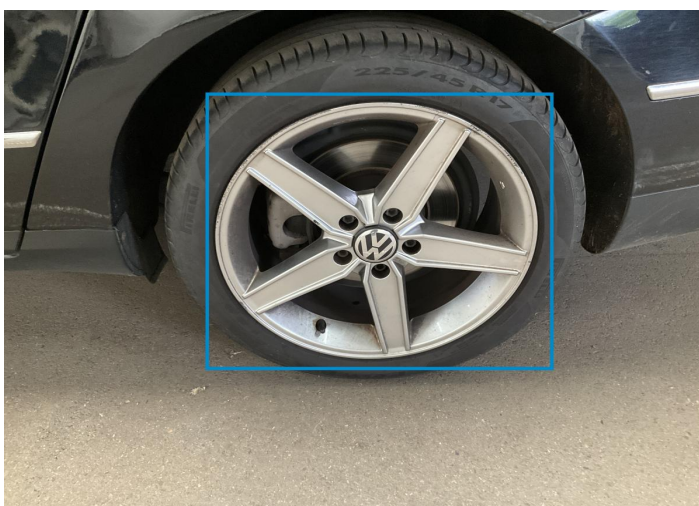
| 15 | Rim / Back Left | Out of Bodywork / Scratch |

15. Rim / Back Left  
Out of Bodywork / Scratch -

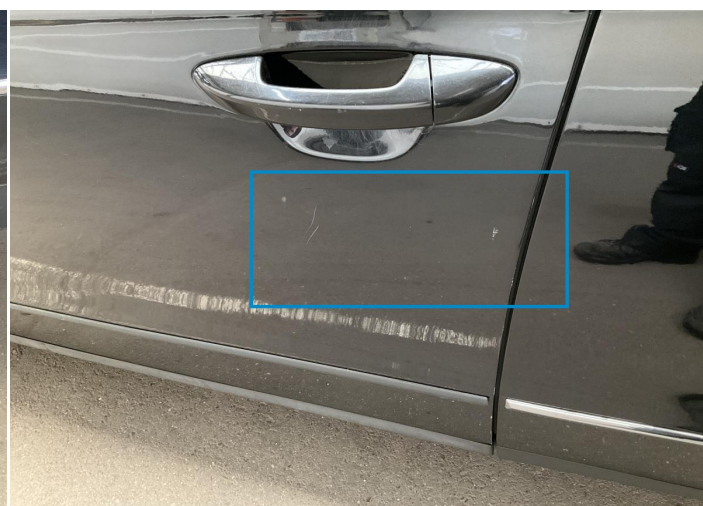
| 16 | Door / Front Left | Paint / Scratch / Scuff |

16. Door / Front Left  
Paint / Scratch / Scuff -

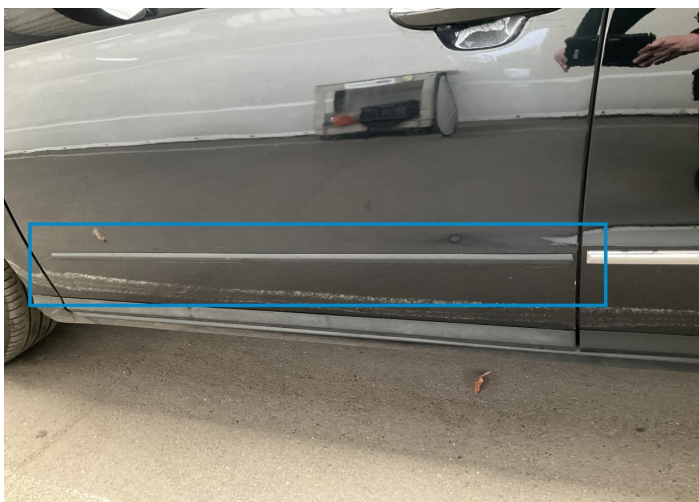
| 17 | Door Side Molding / Front Left | Bodywork / Poor Previous Repair |

17. Door Side Molding / Front Left  
Bodywork / Poor Previous Repair -

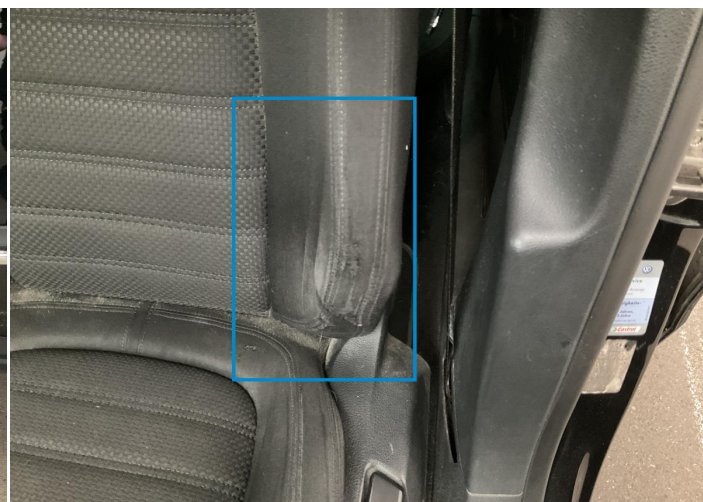
| 18 | Seat / Front Left | Interior / Holed |

18. Seat / Front Left  
Interior / Holed -

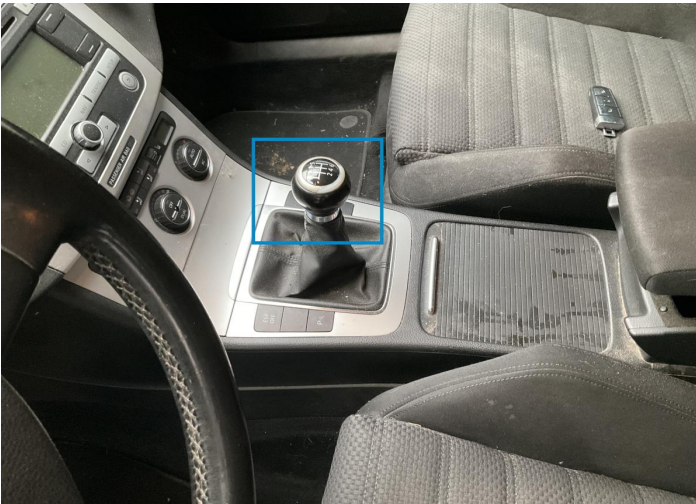
| 19 | Gear Knob | Interior / Scratched |

19. Gear Knob  
Interior / Scratched -

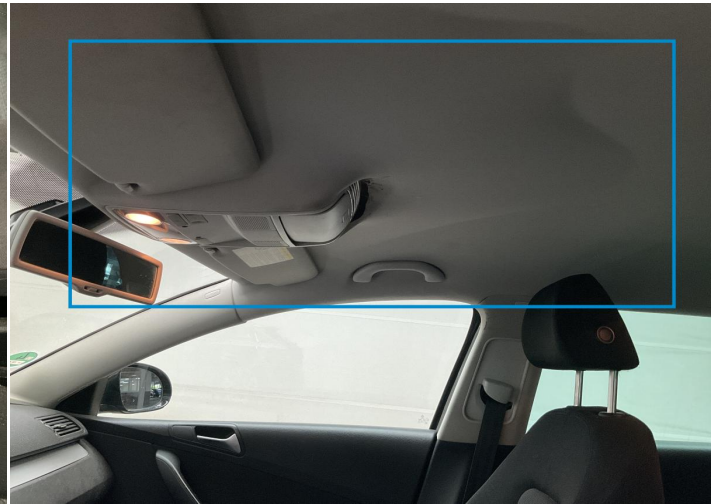
| 20 | Roof Upholstery | Interior / Distorted |

20. Roof Upholstery  
Interior / Distorted -

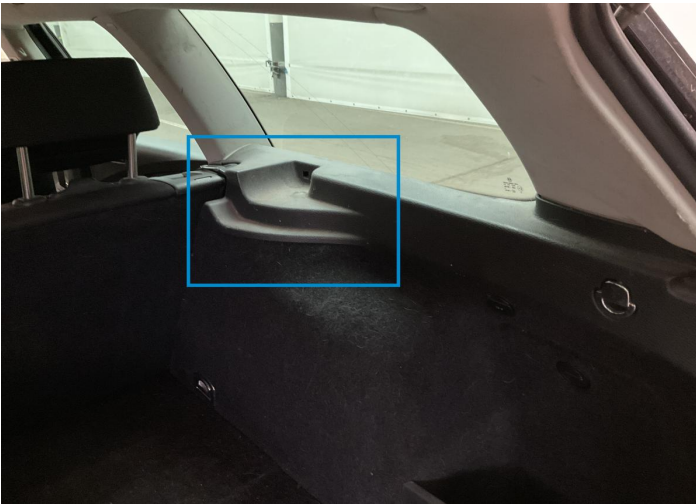
| 21 | Luggage Space Cover / Back | Interior / Missing |

21. Luggage Space Cover / Back  
Interior / Missing -

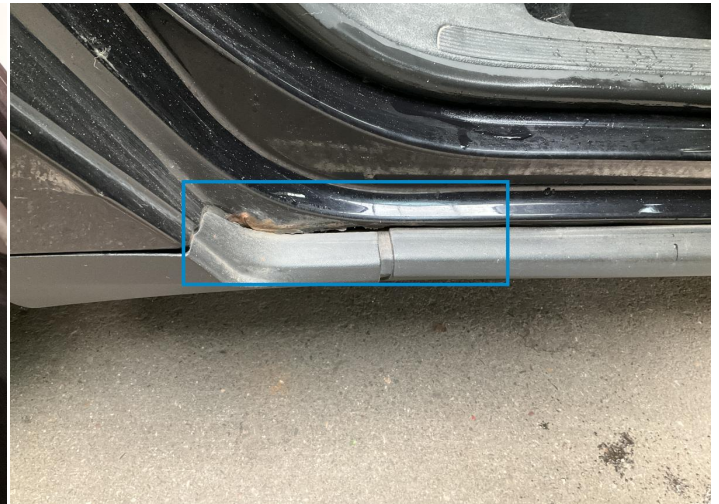
| 22 | Rocker Panel / Center Right | Paint / Corrosion |

22. Rocker Panel / Center Right  
Paint / Corrosion -
