Expertise

Protocol number: 40974048  
Order No. / Reference: 25001738  
Inspection date: 7 Aug 2025

Manufacturer: Volkswagen

Model: Passat Variant 2.0 TDI SCR Business

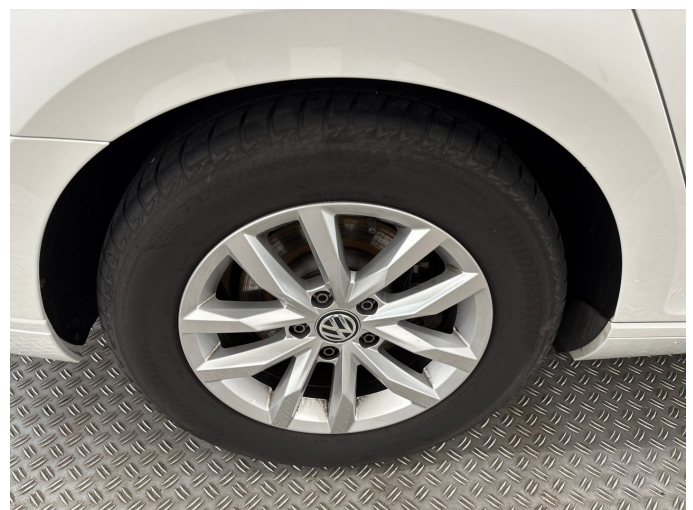
| # | Tyre size | Type of tyre | Manufacturer | Tread depth |
|---|---|---|---|---|
| 1) | 215/60 R16 99V | Summer tyres on Light alloy | Pirelli | 6mm / 6mm |
| 2) | 215/60 R16 99V | Summer tyres on Light alloy | Pirelli | 5mm / 5mm |

Figure 12: Mounted tyres

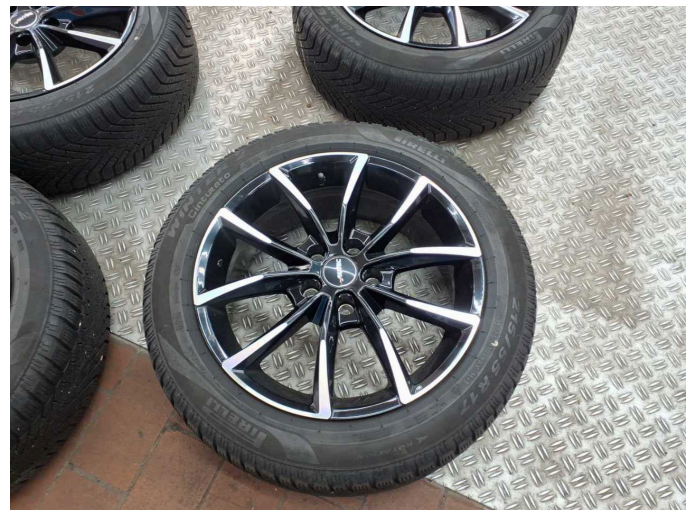
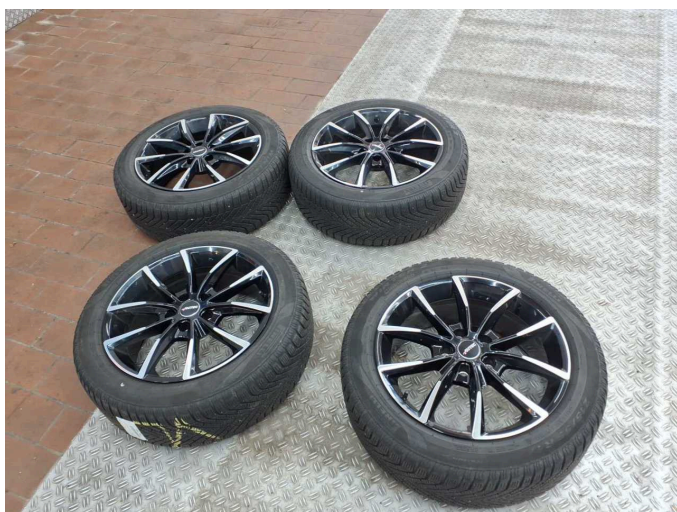
| # | Tyre size | Type of tyre | Manufacturer | Tread depth |
|---|---|---|---|---|
| 1) | 215/55 R17 98V | Winter tyres on Light alloy | Pirelli | 6mm / 6mm |
| 2) | 215/55 R17 98V | Winter tyres on Light alloy | Pirelli | 5mm / 5mm |

Figure 16: Additional tyres

Figure 17: Additional tyres

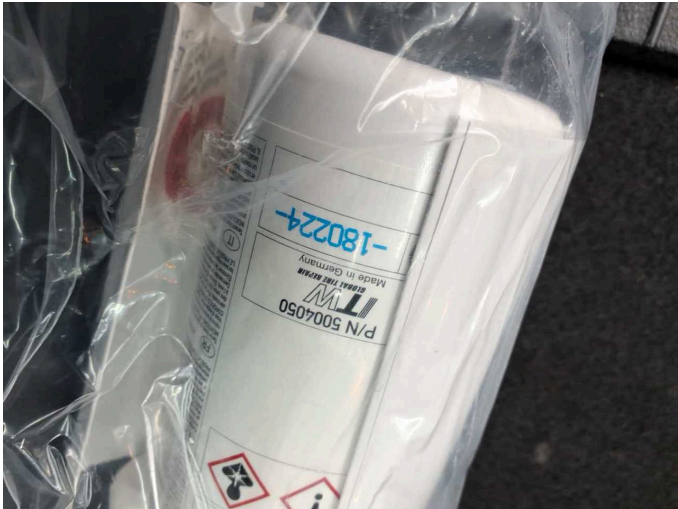
Damage 1: Equipment: Tirefit filler - Expired - Replace

| No. | Component group | Description |
|---|---|--|
| 1 | Equipment | Tirefit filler - Expired - Replace |

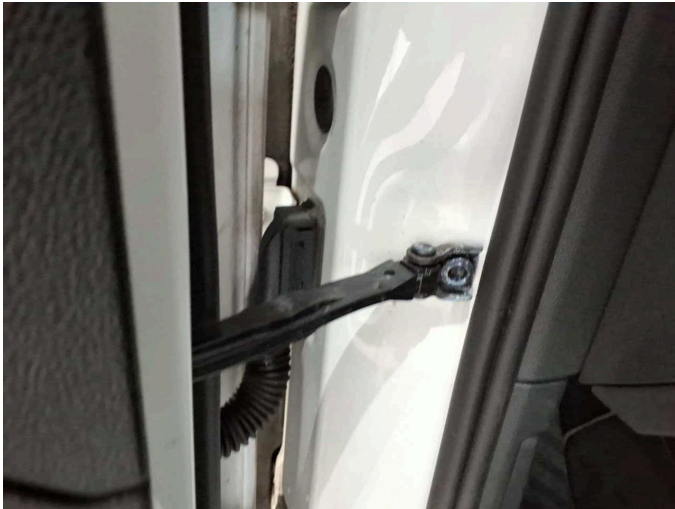
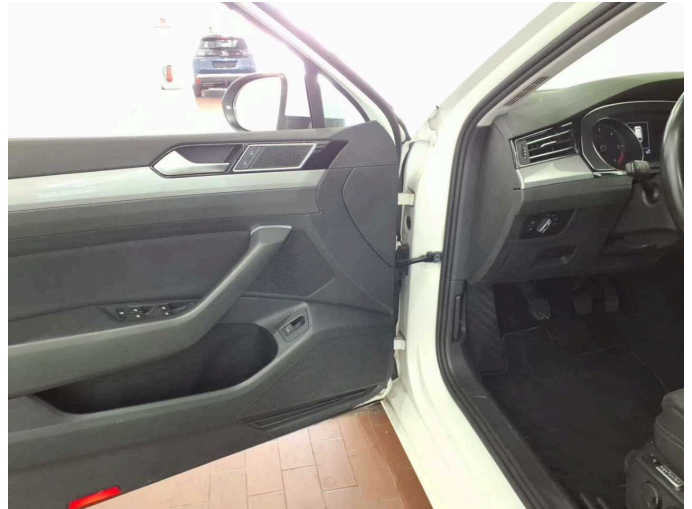
**Damage 2:** Door - front left side: Door (Türfangband) - Noise - Perform diagnosis

| No. | Component group | Description |
|---|---|--|
| 2 | Door - front left side | Door (Türfangband) - Noise - Perform diagnosis |

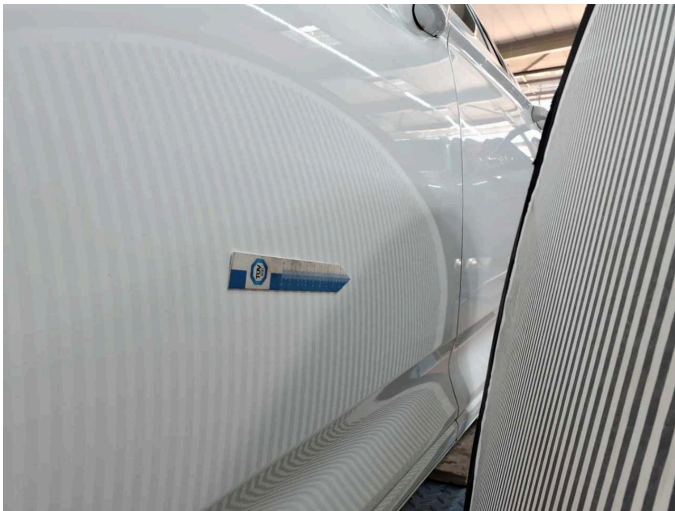
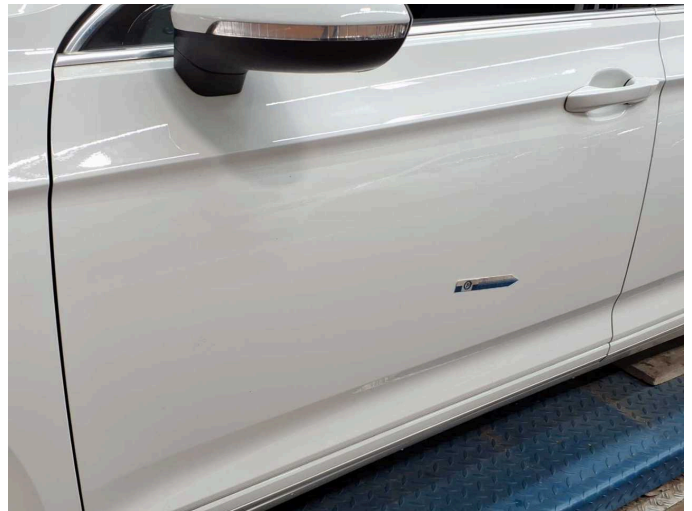
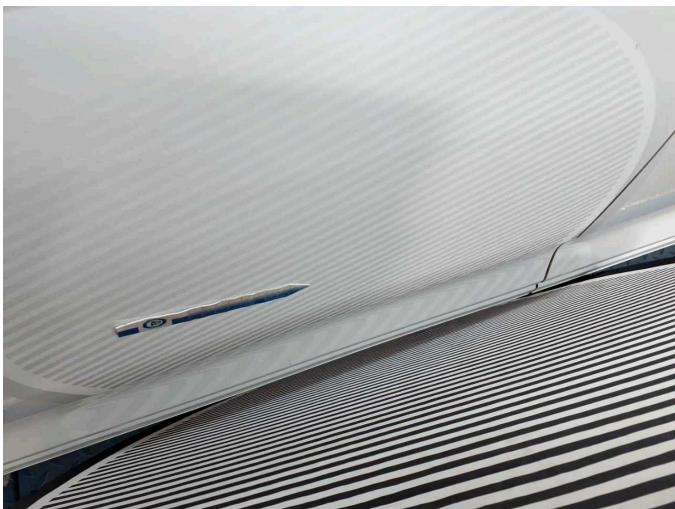
**Damage 3:** Door - front left side: Door - dent(s) - Smart repair

| No. | Component group | Description |
|---|---|--|
| 3 | Door - front left side | Door - dent(s) - Smart repair |
