Expertise

Protocol number: 40671128  
Order No. / Reference: 24954281  
Inspection date: 18 Jul 2025

Manufacturer: Volkswagen

Model: Passat Variant 2.0 TDI SCR Business

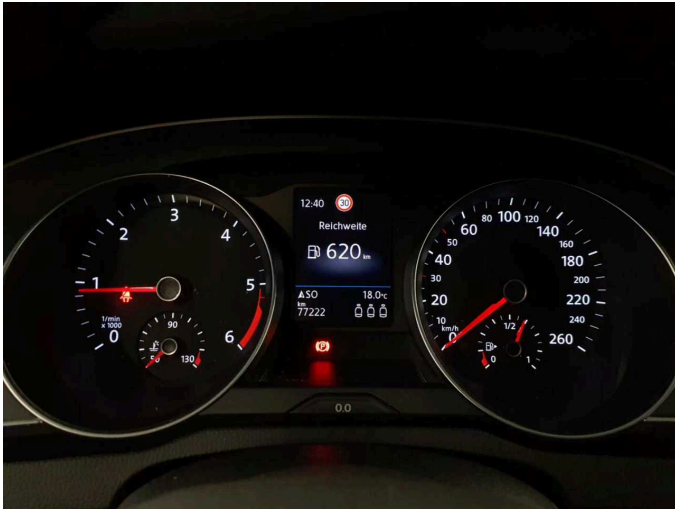
Figure 7: Instrument cluster

| Vehicle details | |
|---|---|
| Mileage (Read) | 77,222 km |

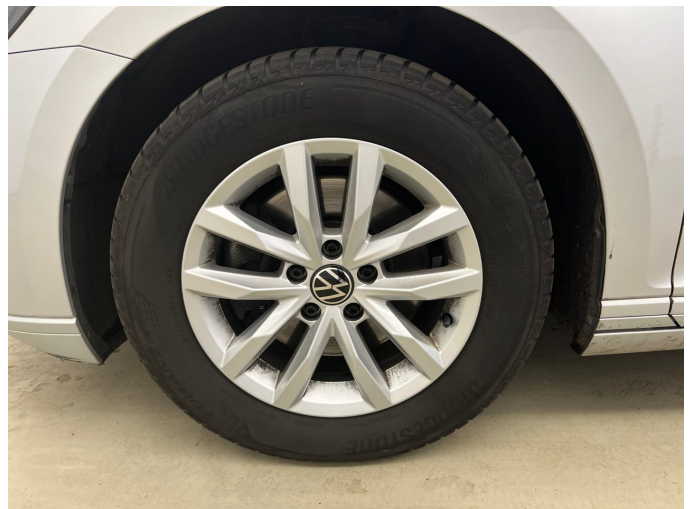
Figure 12: Mounted tyres

| # | Tyre size | Type of tyre | Manufacturer | Tread depth |
|---|---|---|---|---|
| 1) | 215/60 R16 95V | Summer tyres on Light alloy | Bridgestone | 4mm / 4mm |
| 2) | 215/60 R16 95V | Summer tyres on Light alloy | Bridgestone | 4mm / 4mm |

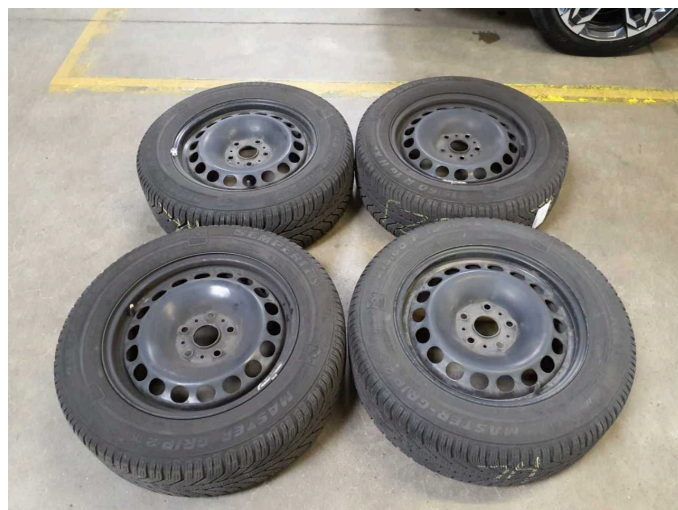
Figure 15: Additional tyres

| # | Tyre size | Type of tyre | Manufacturer | Tread depth |
|---|---|---|---|---|
| 1) | 215/60 R16 99H | Winter tyres on Steel | Semperit | 4mm / 4mm |
| 2) | 215/60 R16 99H | Winter tyres on Steel | Semperit | 5mm / 5mm |

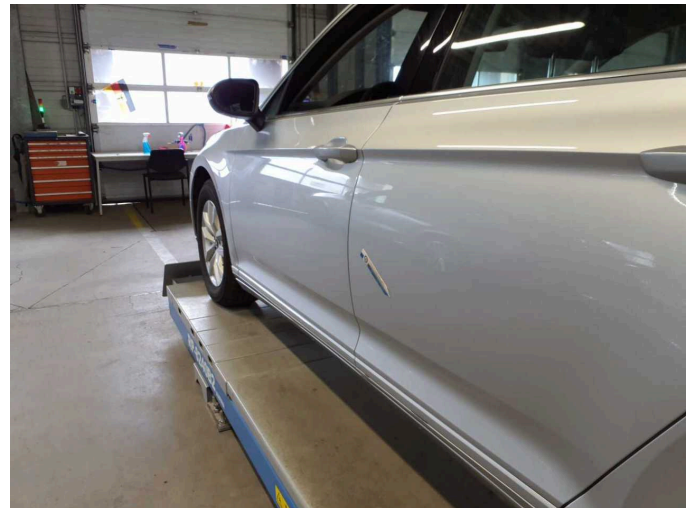
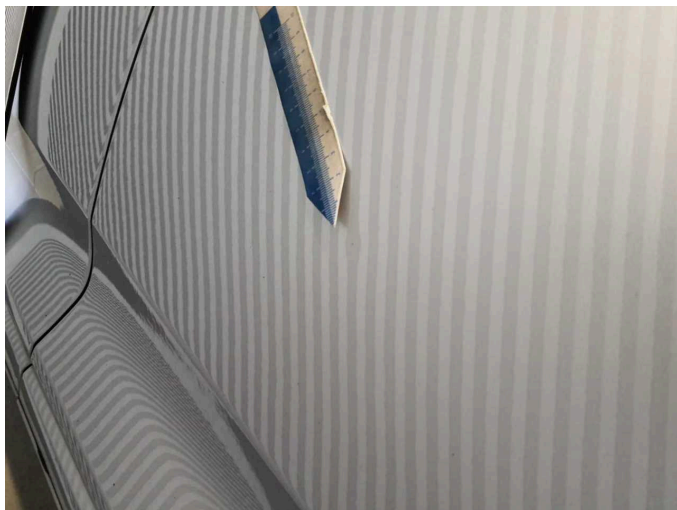
**Damage 1:** Door - rear left side: Door - dent(s) - Smooth repair work

| No. | Component group | Description |
|---|---|---|
| 1 | Door - rear left side | Door - dent(s) - Smooth repair work |

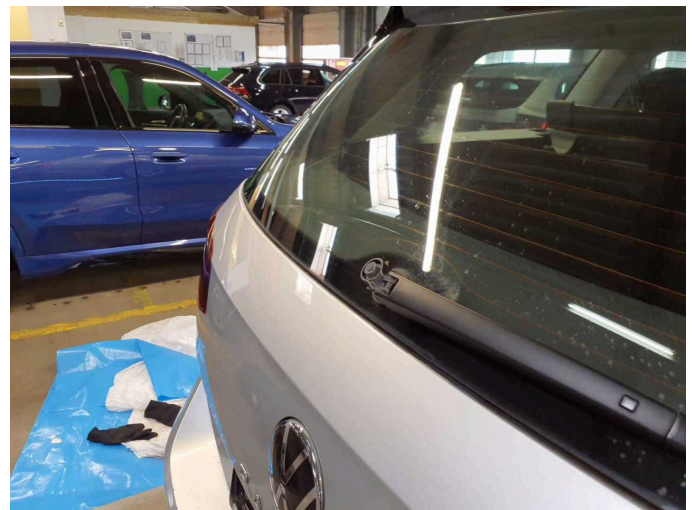
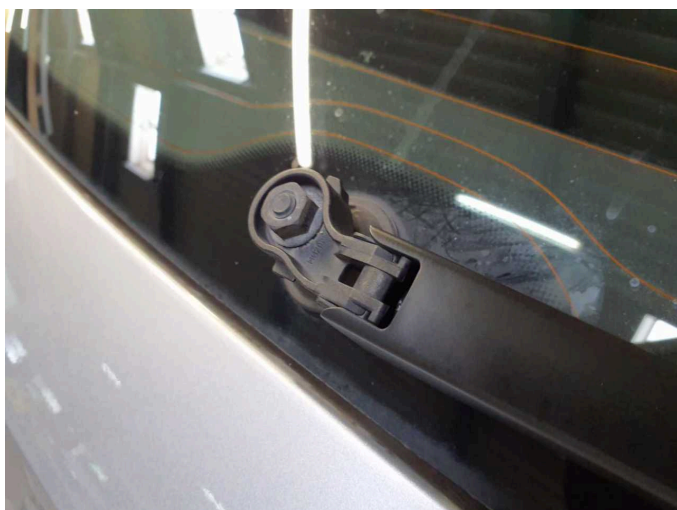
**Damage 2:** Screen cleaning: Wiper arm - rear (Abdeckung) - Missing - Replace

| No. | Component group | Description |
|---|---|---|
| 2 | Screen cleaning | Wiper arm - rear (Abdeckung) - Missing - Replace |

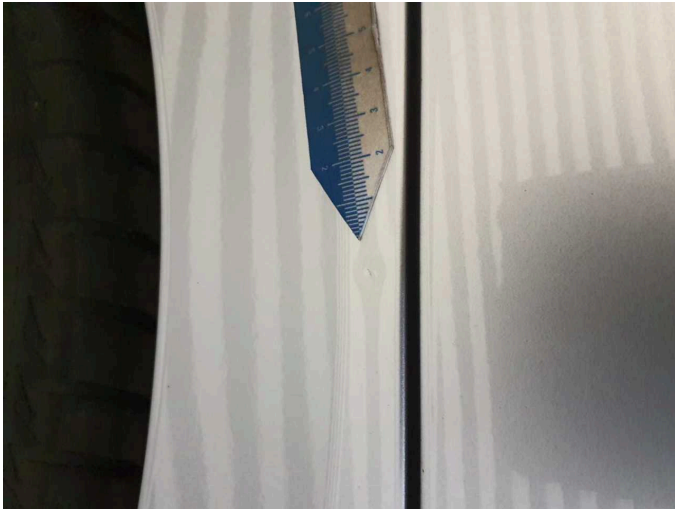
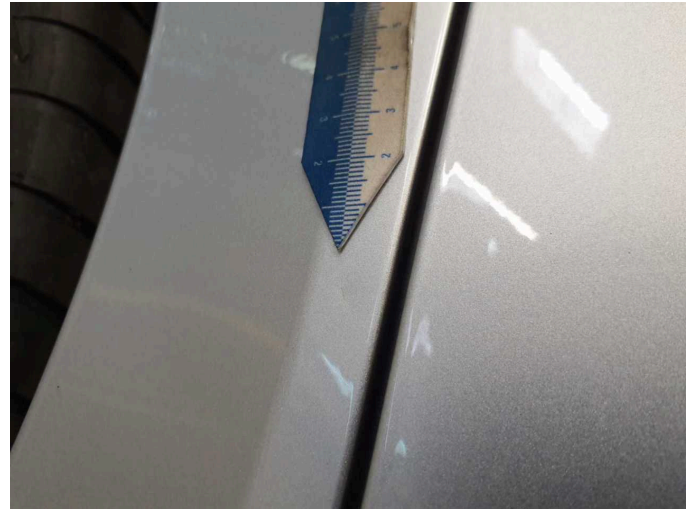
**Damage 3:** Side panel - rear right side: Side panel - Dent / paintcoat damage - Smart repair

| No. | Component group | Description |
|---|---|---|
| 3 | Side panel - rear right side | Side panel - Dent / paintcoat damage - Smart repair |

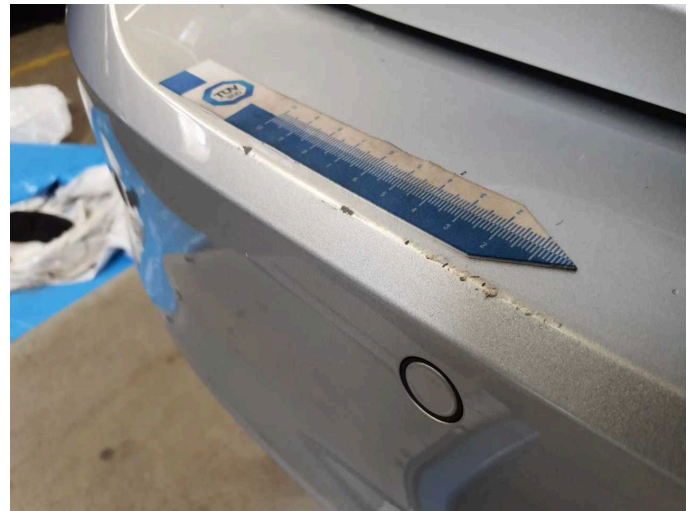
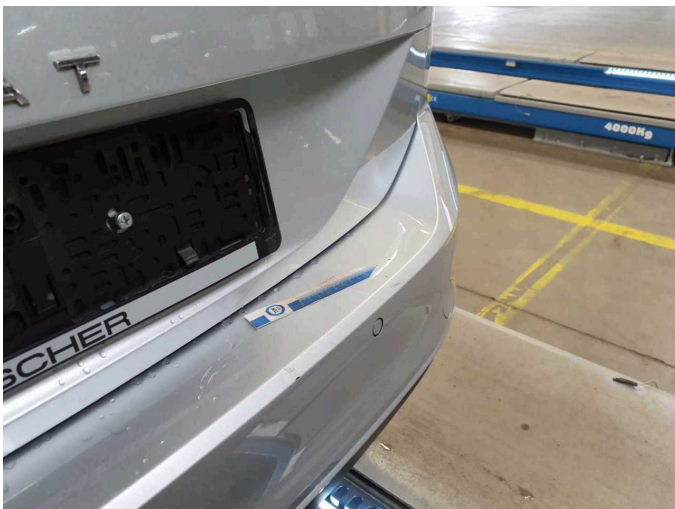
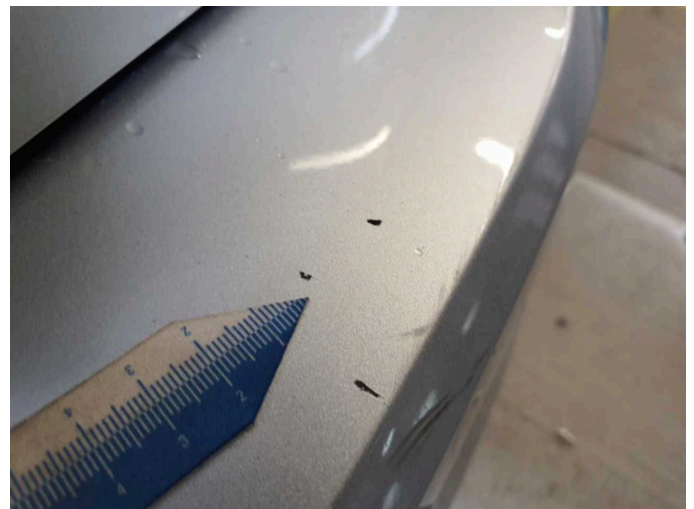
**Damage 4:** Rear bumper: Rear bumper - Scratched - Paint

| No. | Component group | Description |
|---|---|---|
| 4 | Rear bumper | Rear bumper - Scratched - Paint |

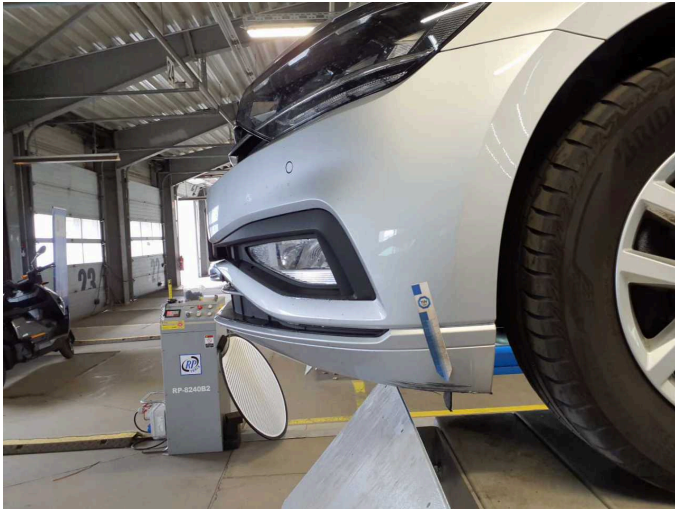
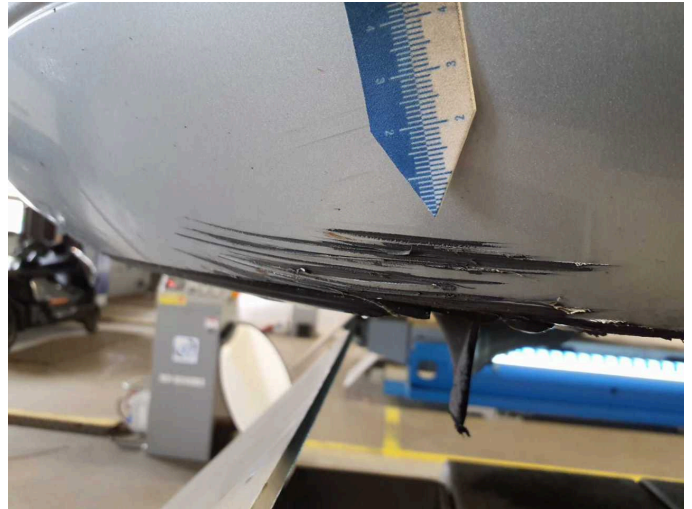
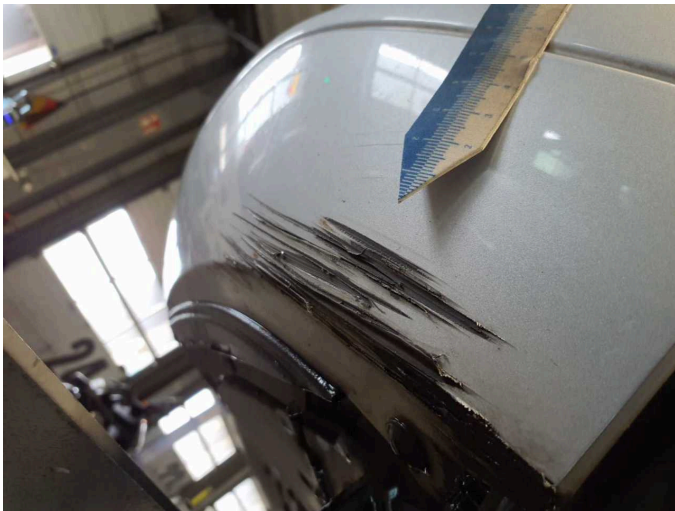
**Damage 5:** Front bumper: Front bumper (Steinschlag) - Scratched - Repair and paint

| No. | Component group | Description |
|---|---|---|
| 5 | Front bumper | Front bumper (Steinschlag) - Scratched - Repair and paint |

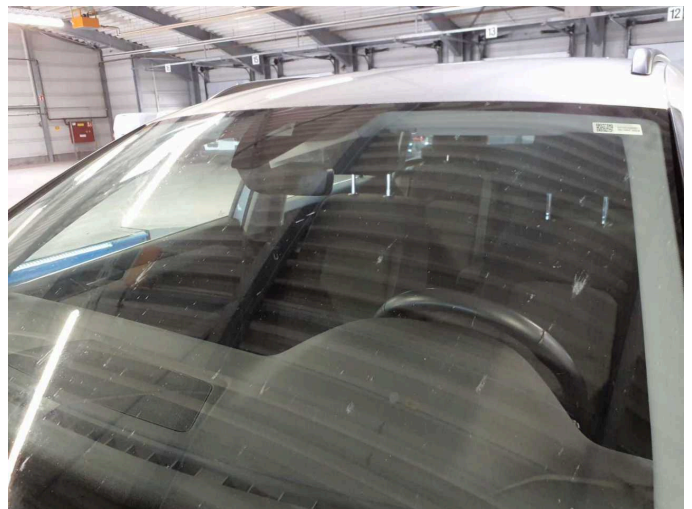
| No. | Component group | Description |
|---|---|---|
| 3 | Vehicle glazing | Windscreen - Stone chips - No deduction |

**Wear and tear 3:** Vehicle glazing: Windscreen - Stone chips - No deduction

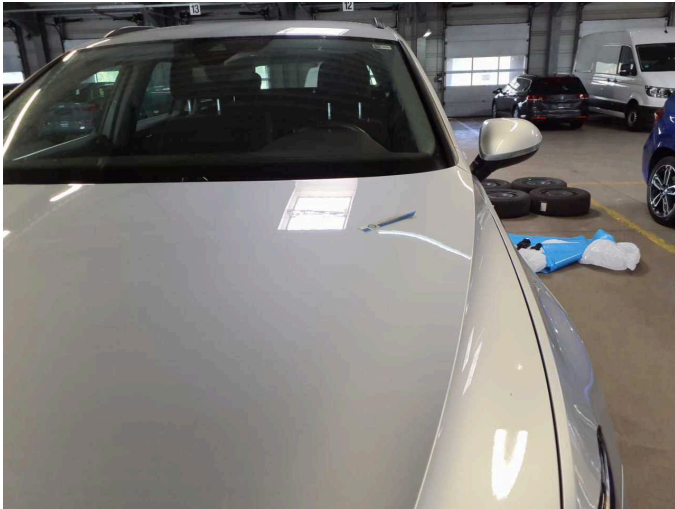
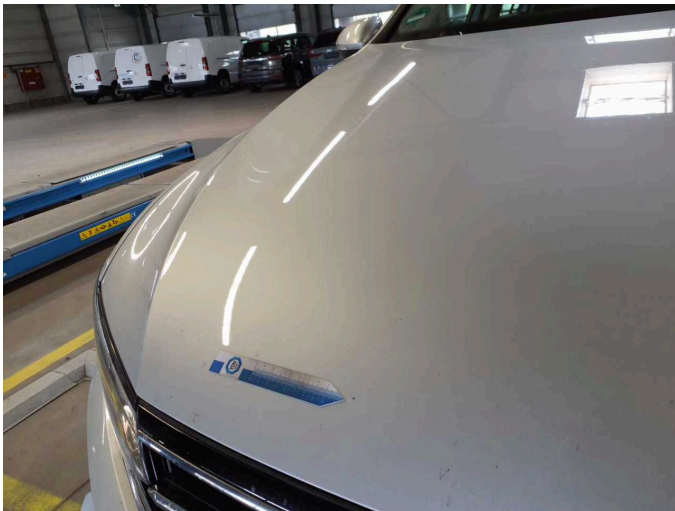
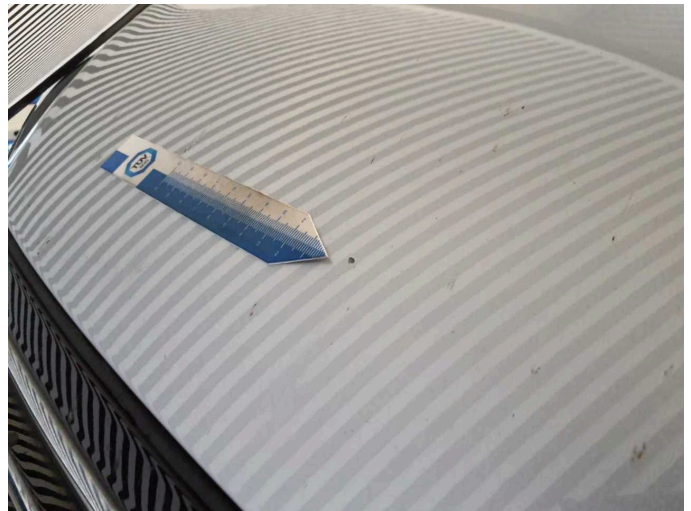
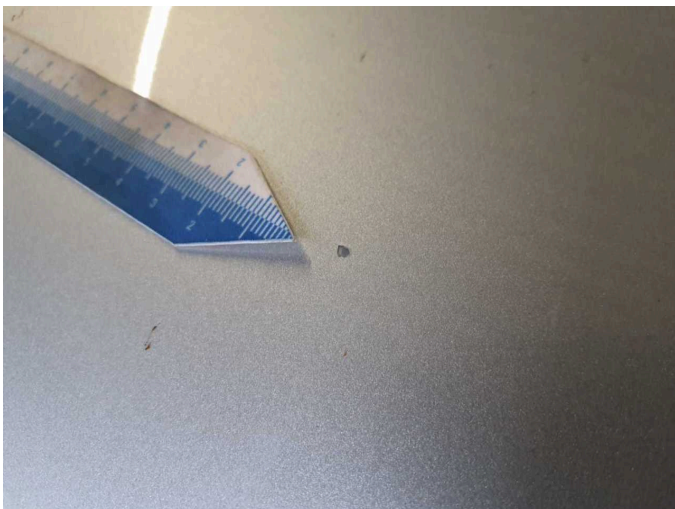
| No. | Component group | Description |
|---|---|---|
| 7 | Bonnet | Bonnet (+ Steinschläge) - dent(s) - No deduction |

**Wear and tear 7:** Bonnet: Bonnet (+ Steinschläge) - dent(s) - No deduction
