Expertise

Protocol number: 41173000  
Order No. / Reference: 25136848  
Inspection date: 21 Aug 2025

Manufacturer: Volkswagen

Model: Passat Variant 2.0 TDI SCR DSG Business

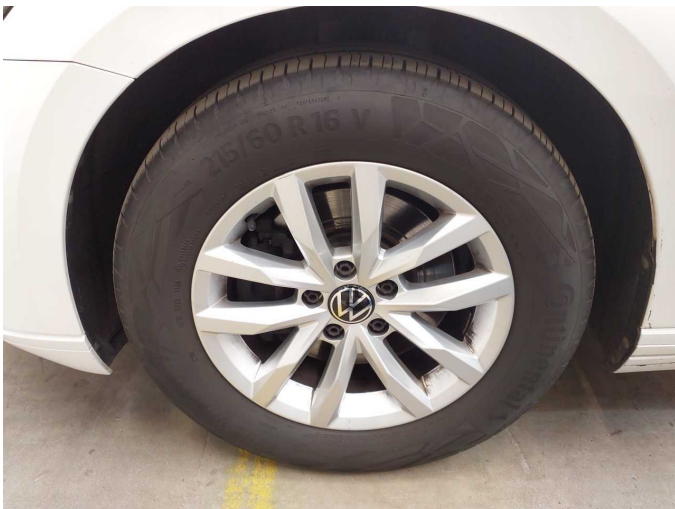
Figure 11: Mounted tyres

| # | Tyre size | Type of tyre | Manufacturer | Tread depth |
|---|---|---|---|---|
| 1) | 215/60 R16 95V | Summer tyres on Light alloy | Continental | 5mm / 5mm |
| 2) | 215/60 R16 95V | Summer tyres on Light alloy | Continental | 5mm / 5mm |

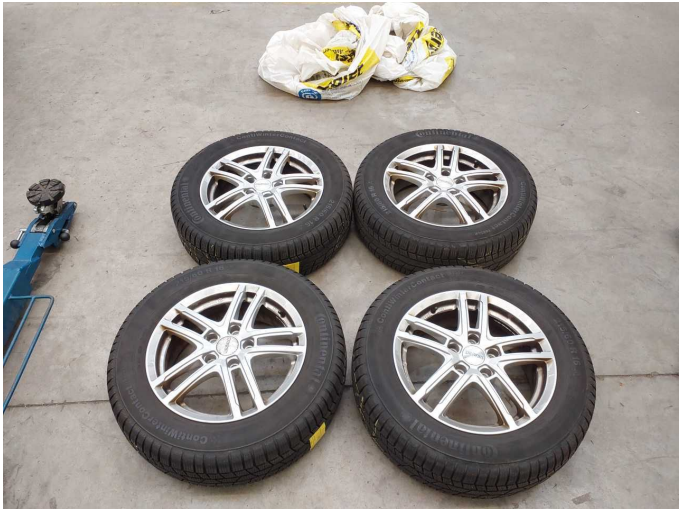
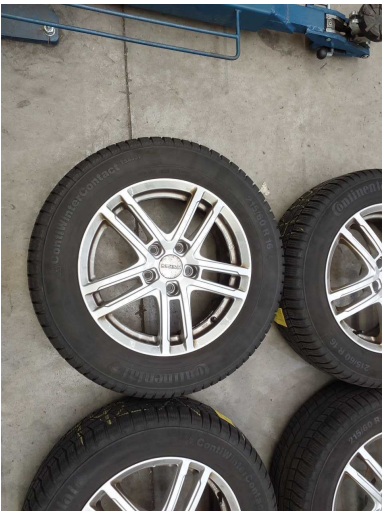
Figure 16: Additional tyres

| # | Tyre size | Type of tyre | Manufacturer | Tread depth |
|---|---|---|---|---|
| 1) | 215/60 R16 99H | Winter tyres on Light alloy | Continental | 6mm / 6mm |
| 2) | 215/60 R16 99H | Winter tyres on Light alloy | Continental | 6mm / 6mm |

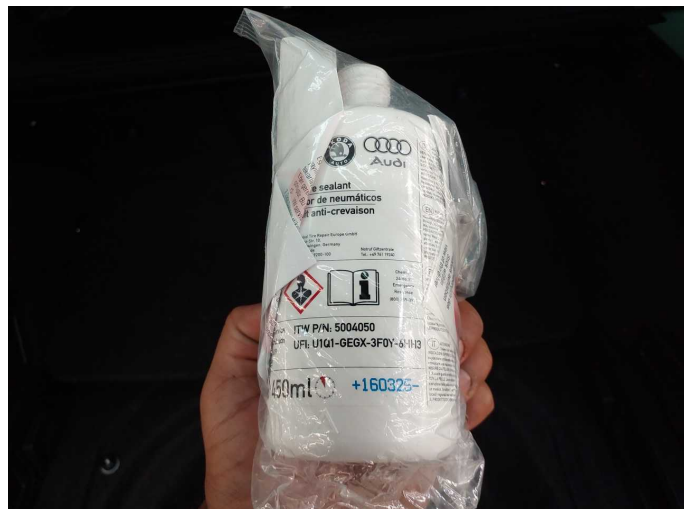
Damage 1: Equipment: Tirefit filler - Expired - Replace

| No. | Component group | Description |
|---|---|---|
| 1 | Equipment | Tirefit filler - Expired - Replace |

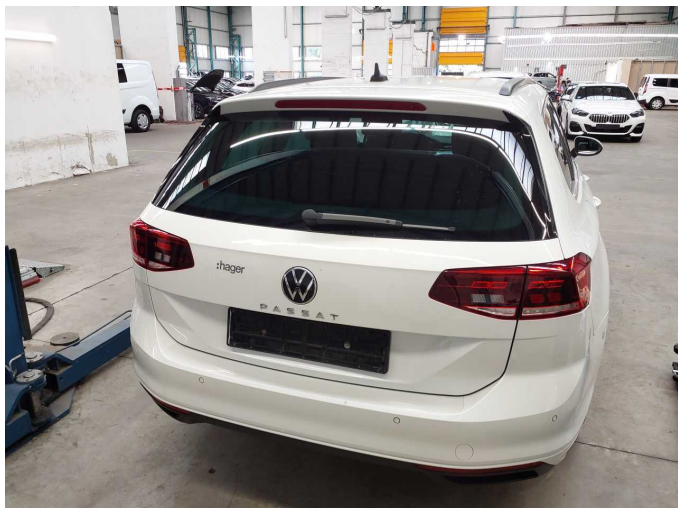
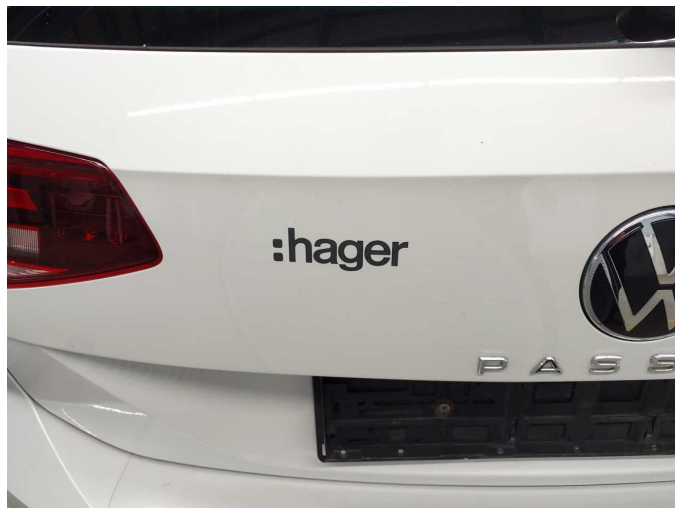
**Damage 2:** Boot lid / rear door: Boot lid - Glued / labelled - De-glue / neutralise

| No. | Component group | Description |
|---|---|---|
| 2 | Boot lid / rear door | Boot lid - Glued / labelled - De-glue / neutralise |

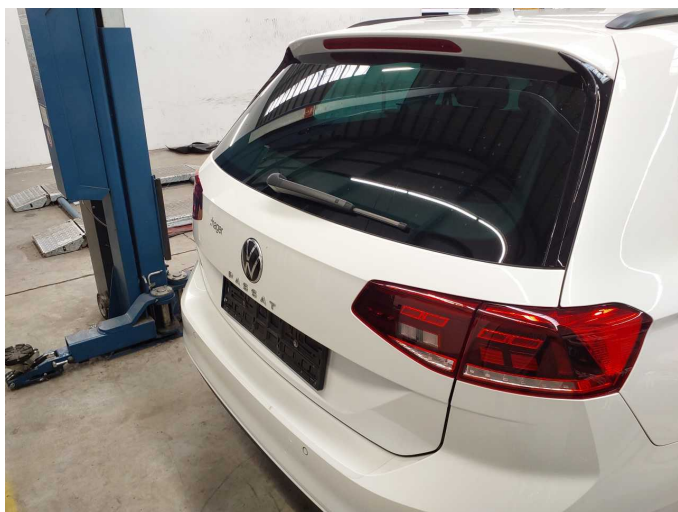
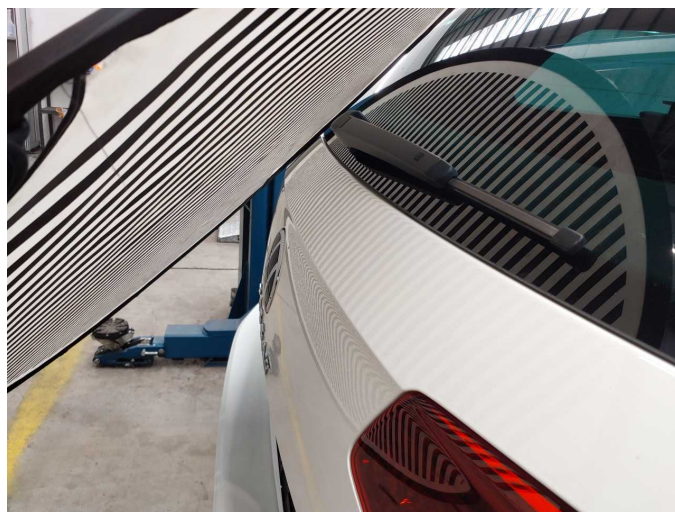
**Damage 3:** Boot lid / rear door: Boot lid - dent(s) - Smooth repair work

| No. | Component group | Description |
|---|---|---|
| 3 | Boot lid / rear door | Boot lid - dent(s) - Smooth repair work |

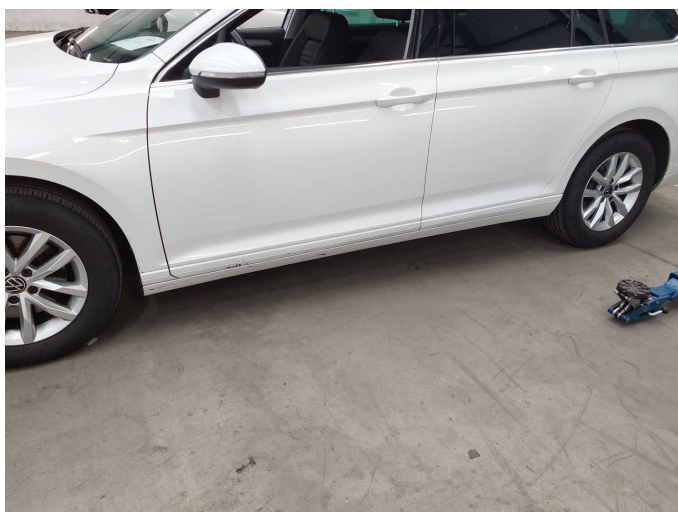
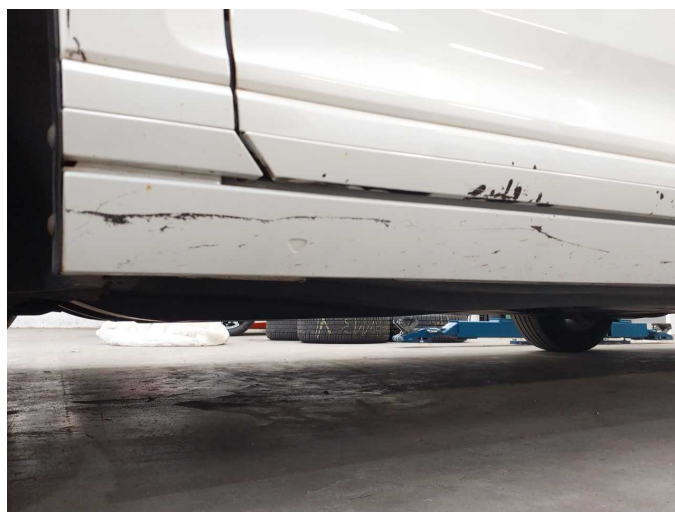
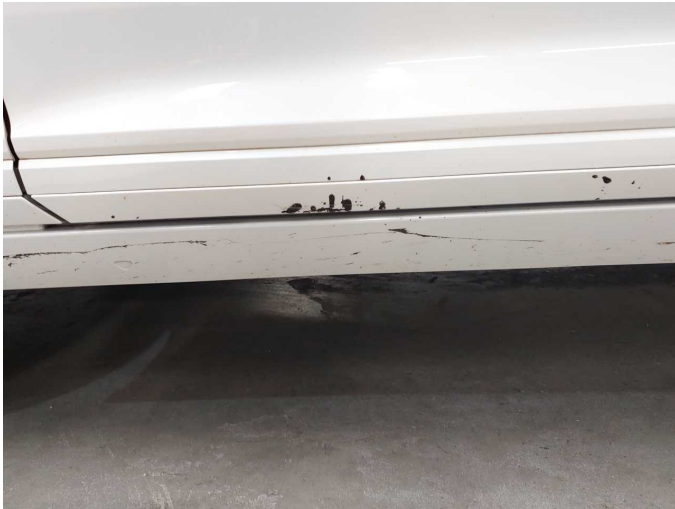
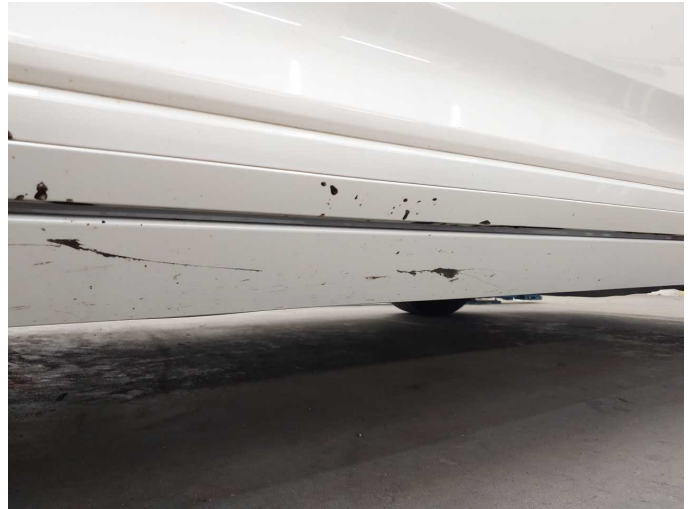
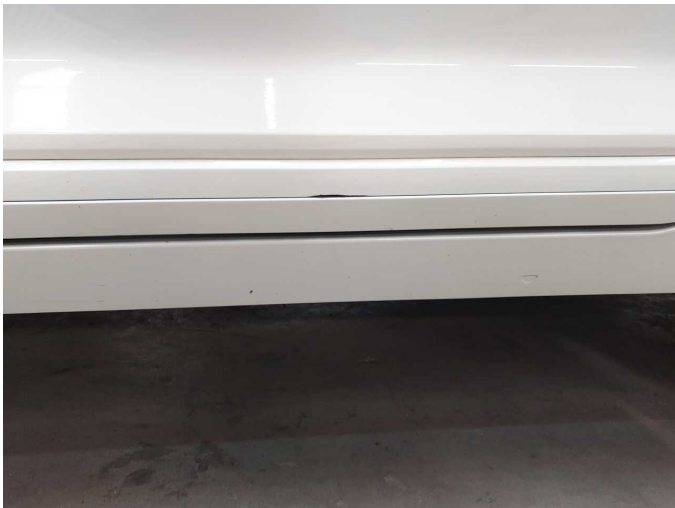
**Damage 4:** Body: Body (linke Fahrzeugseite) - Scratched - Repair and paint

| No. | Component group | Description |
|---|---|---|
| 4 | Body | Body (linke Fahrzeugseite) - Scratched - Repair and paint |

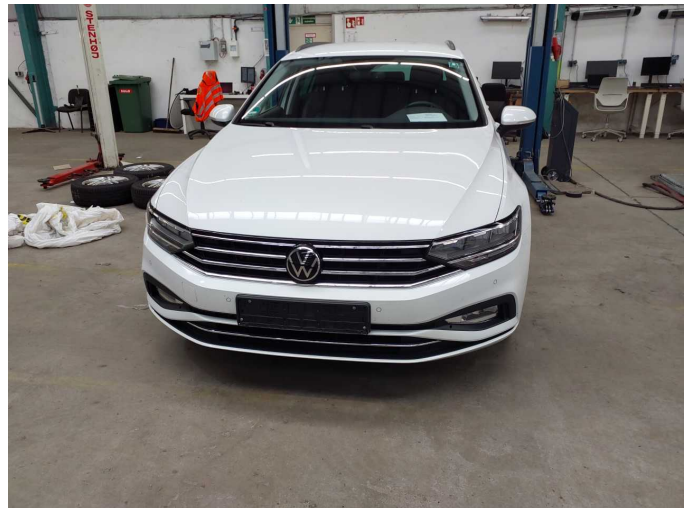
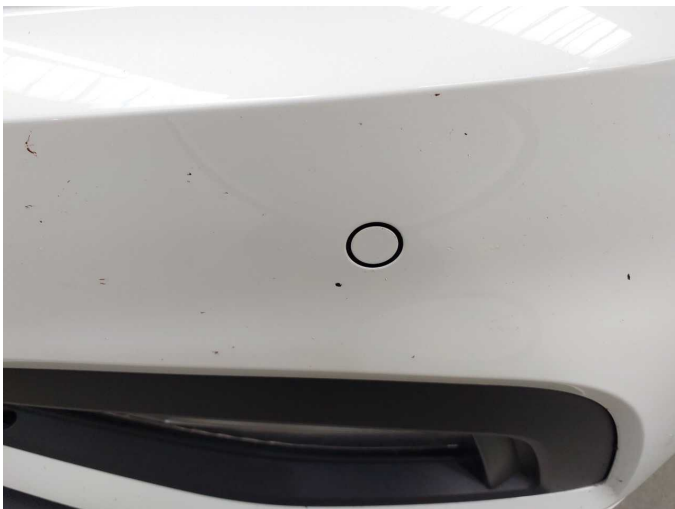
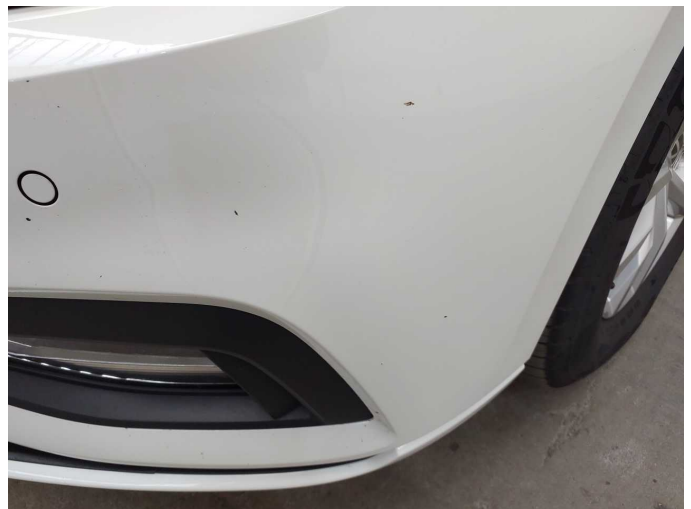
**Wear and tear 1:** Front bumper: Front bumper - Stone chips - No deduction

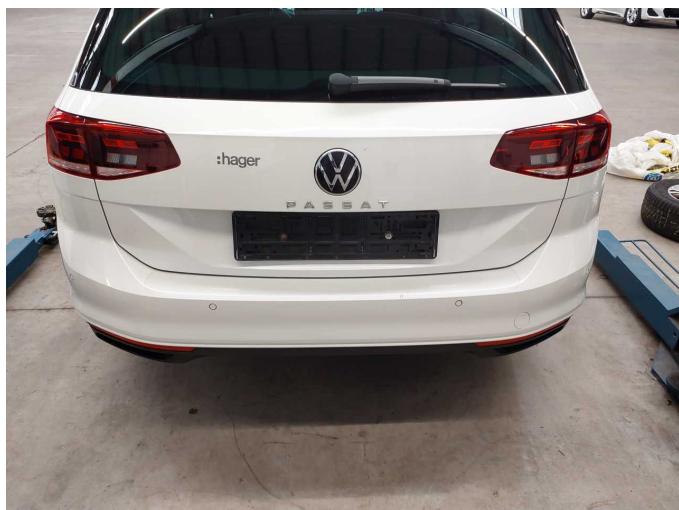
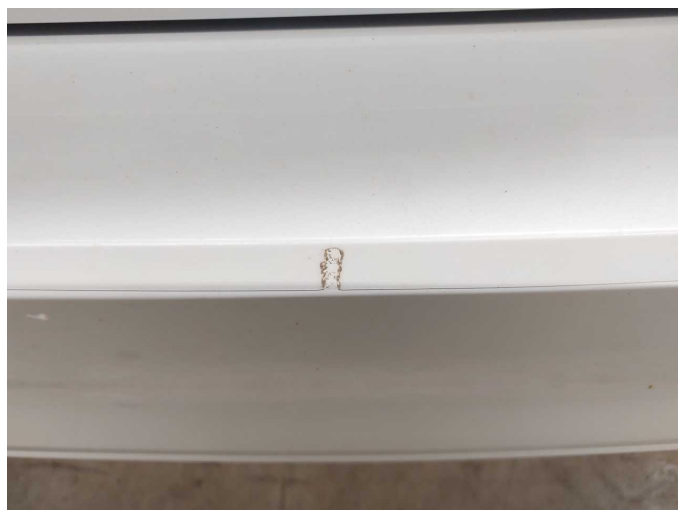
**Wear and tear 2:** Rear bumper: Rear bumper (Schutzfolie) - Scratch(es)  
- No deduction
