Expertise

Protocol number: 41575522  
Order No. / Reference: 25074427  
Inspection date: 15 Sept 2025

Manufacturer: Volkswagen

Model: Passat Variant 2.0 TDI SCR DSG Elegance

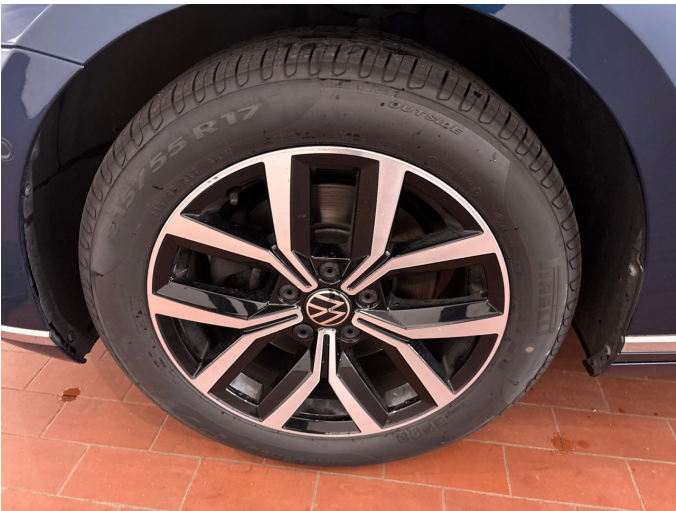
#	Tyre size	Type of tyre	Manufacturer	Tread depth
1)	215/55 R17 94W	Summer tires (with run-flat tires) on Light alloy	Continental	5mm / 5mm
2)	215/55 R17 94W	Summer tires (with run-flat tires) on Light alloy	Continental	5mm / 5mm

Figure 13: Mounted tyres

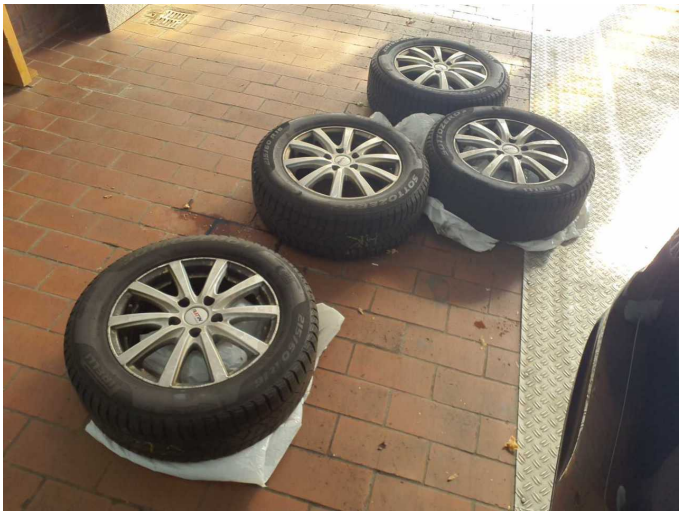
#	Tyre size	Type of tyre	Manufacturer	Tread depth
1)	215/60 R16 95H	Winter tires (with run-flat tires) on Light alloy	Pirelli	6mm / 6mm
2)	215/60 R16 95H	Winter tires (with run-flat tires) on Light alloy	Pirelli	4mm / 4mm

Figure 18: Additional tyres

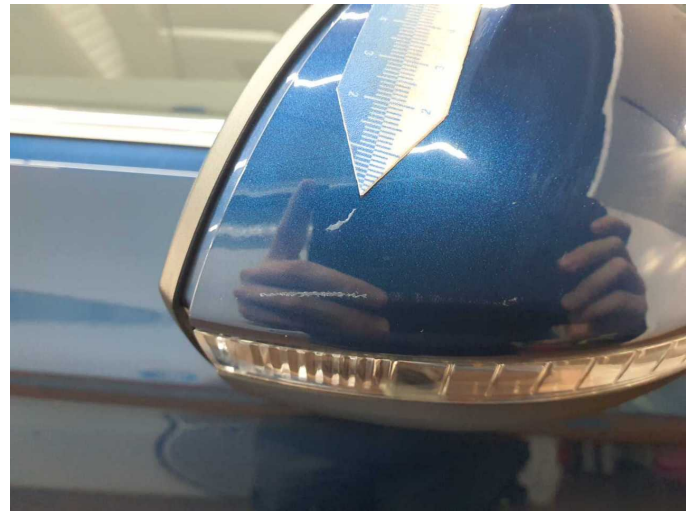
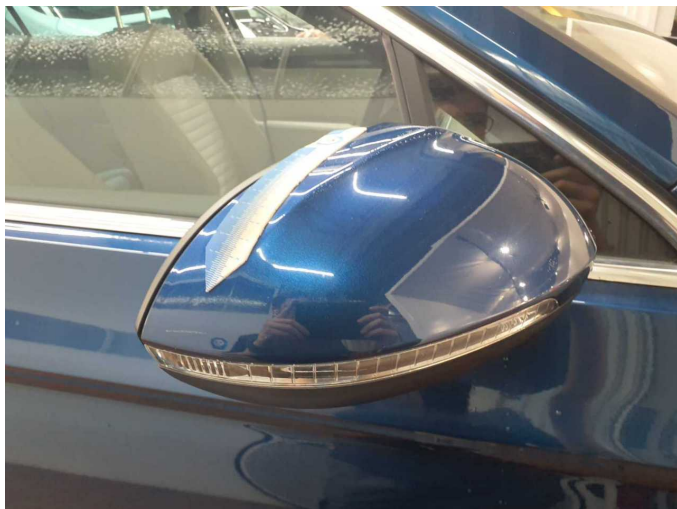
Damage 1: Wing mirror - right side: Cap - Scratch(es) - Smart repair

No.	Component group	Description
1	Wing mirror - right side	Cap - Scratch(es) - Smart repair
2	Side panel - rear right side	Side panel - Dent / paintcoat damage - Repair and paint
3	Body	Body - Damage by hail - repair according to calculation

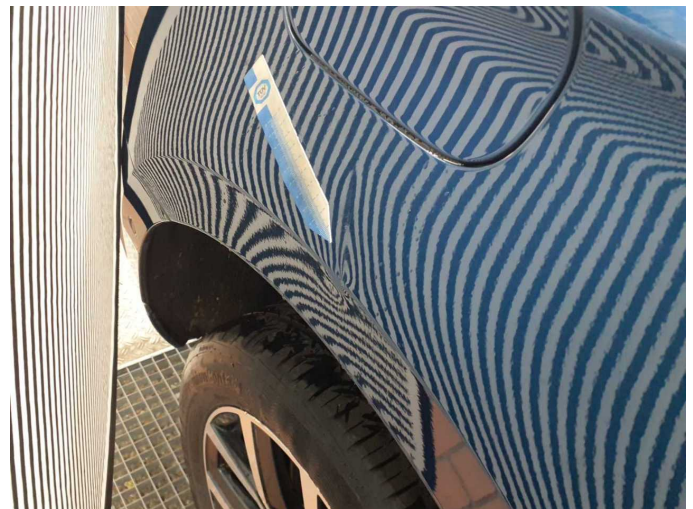
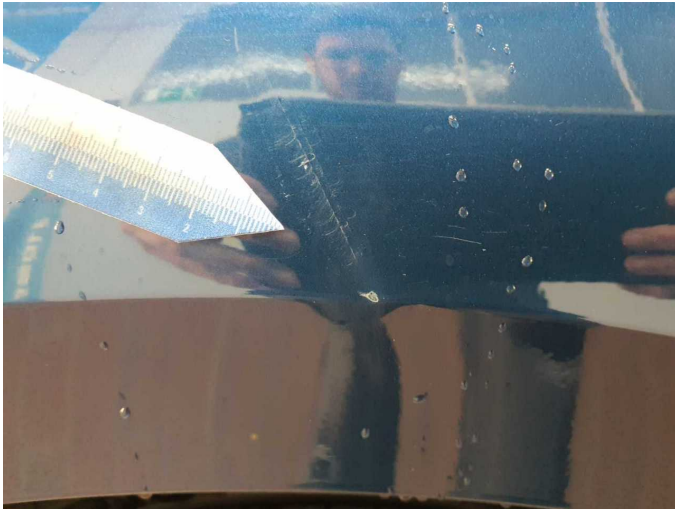
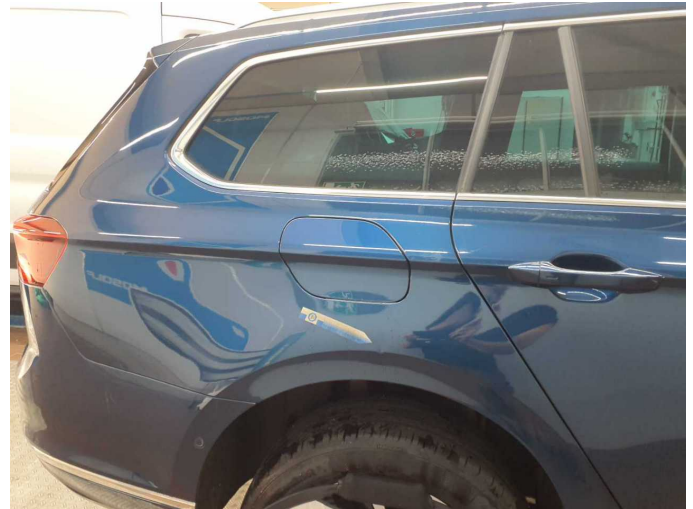
Damage 2: Side panel - rear right side: Side panel - Dent / paintcoat damage - Repair and paint

**Damage 2:** Side panel - rear right side: Side panel - Dent / paintcoat damage - Repair and paint

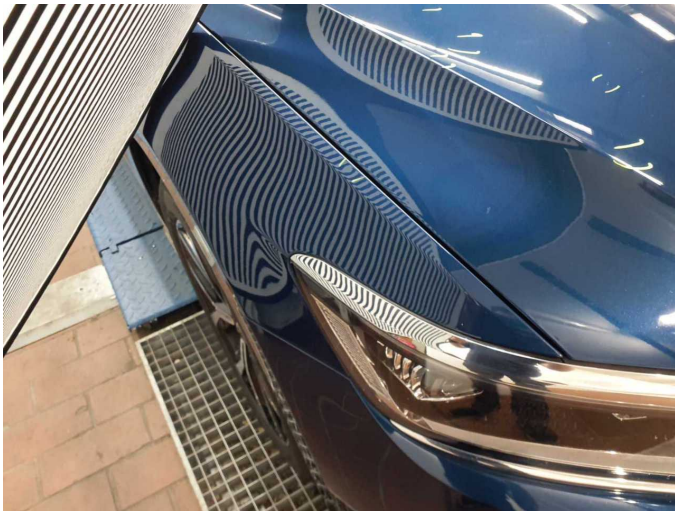
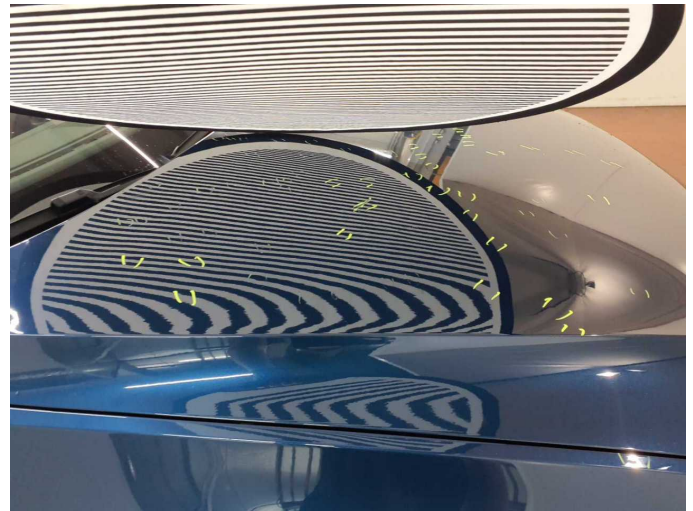
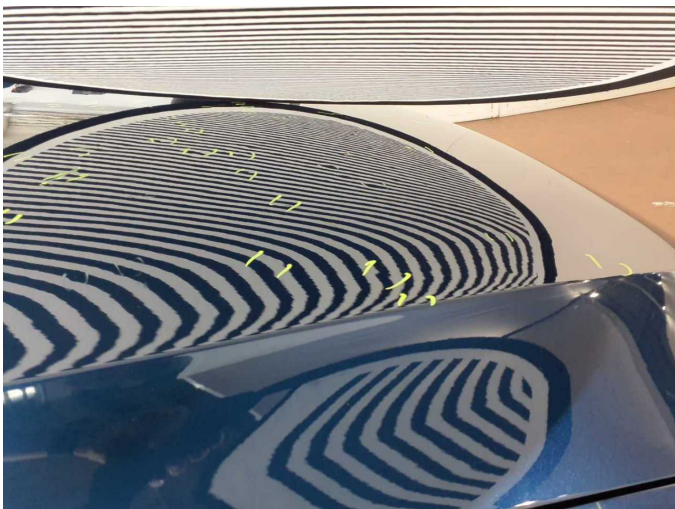
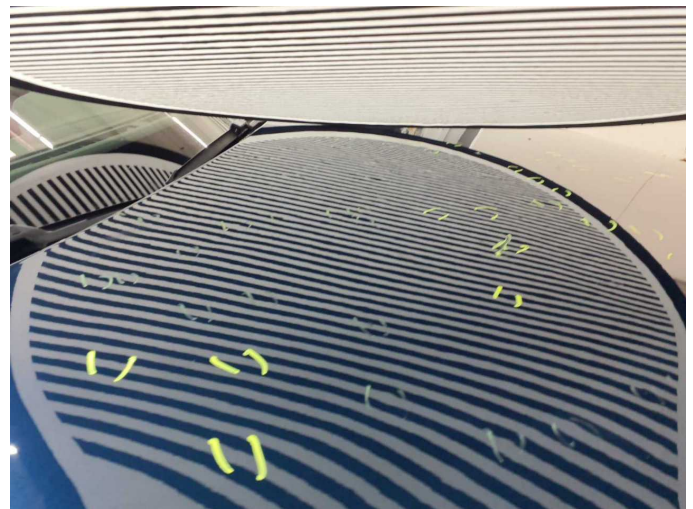
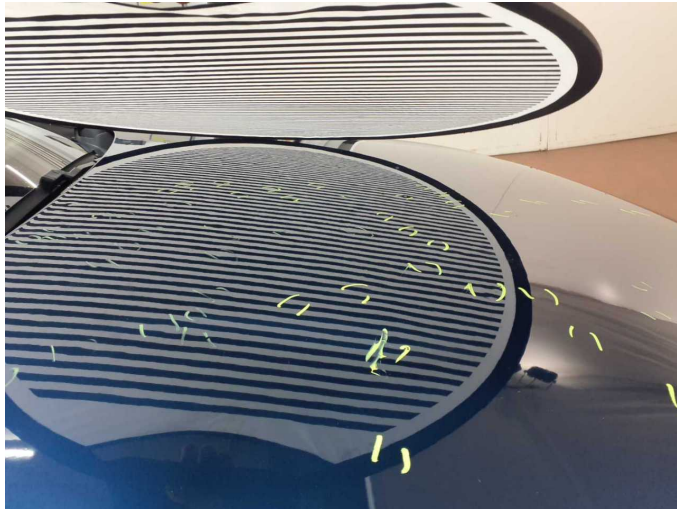
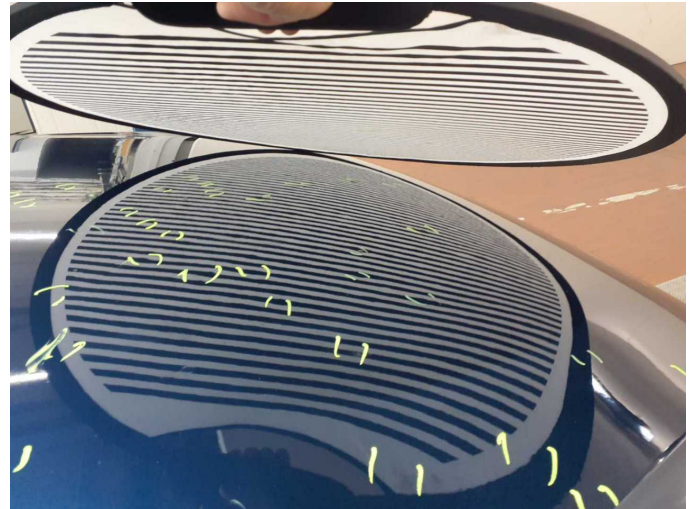
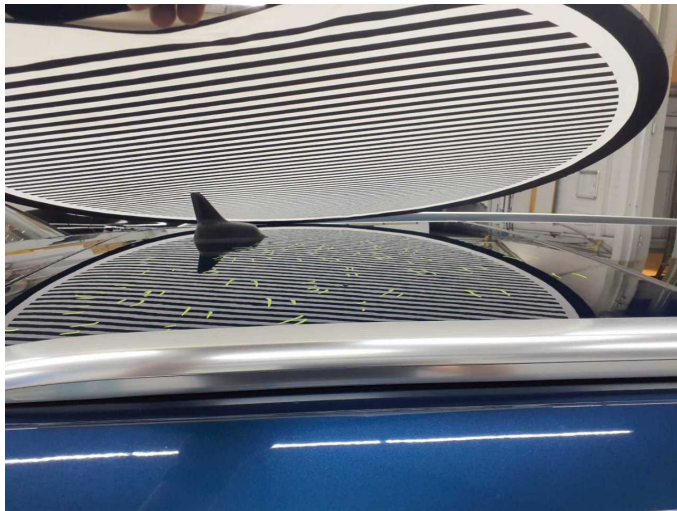
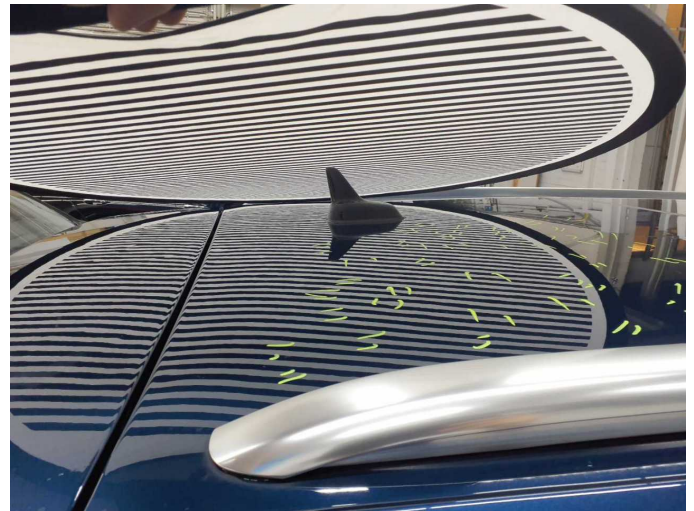
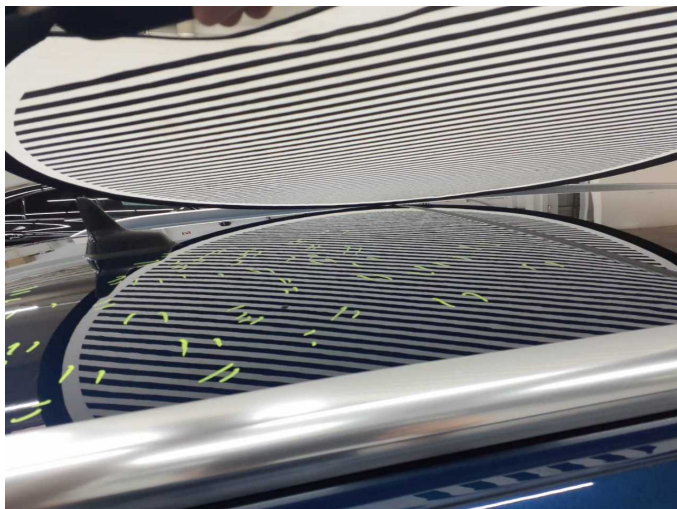
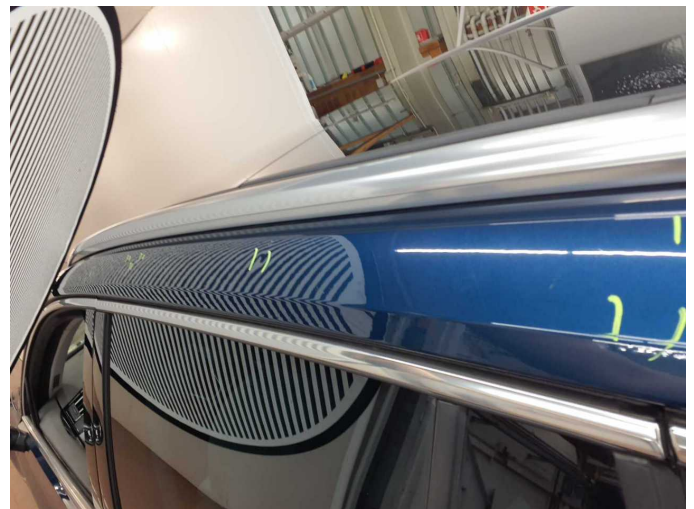
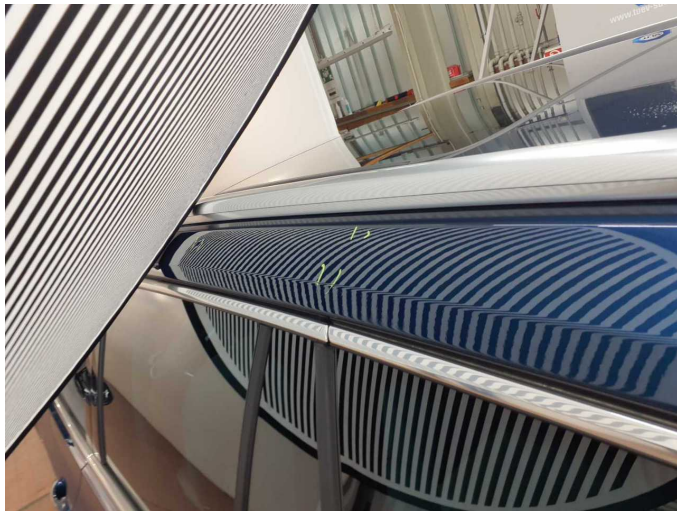
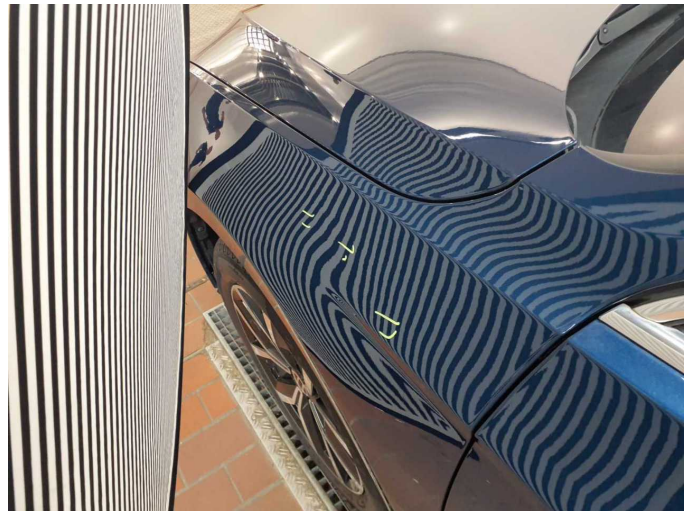
**Damage 3:** Body: Body - Damage by hail - repair according to calculation

Der kalkulierte Hagelschaden wurde nach bestem Wissen und Gewissen unter eingeschränkten Besichtigungsbedingung im demontagefreien Zustand erstellt. Es können aufgrund verdeckter Beschädigung, Mehrkosten und somit Abweichung der für den Schaden ausgewiesenen Reparaturkosten nicht ausgeschlossen werden.

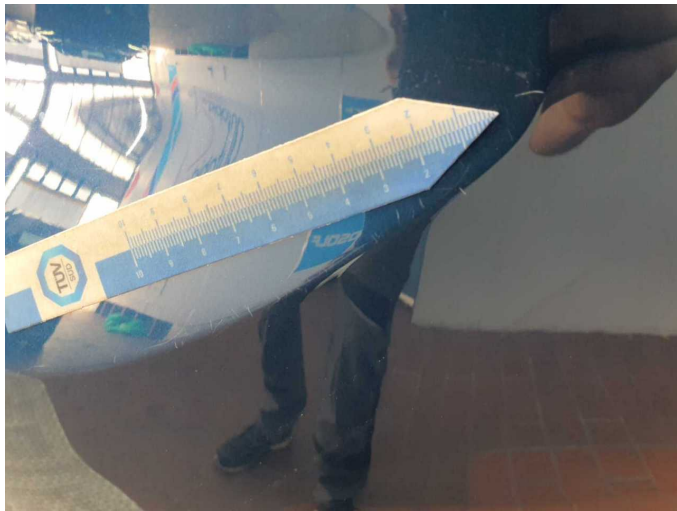
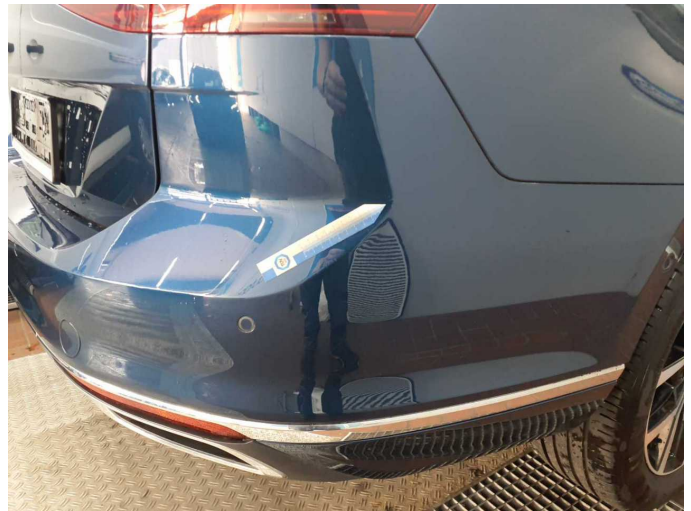
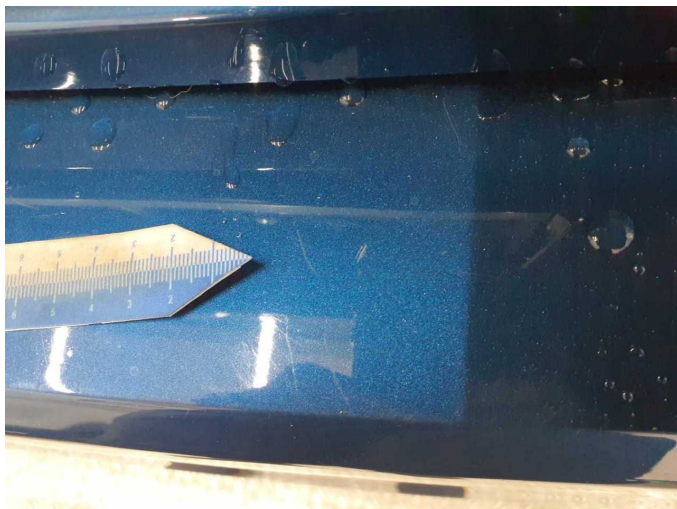
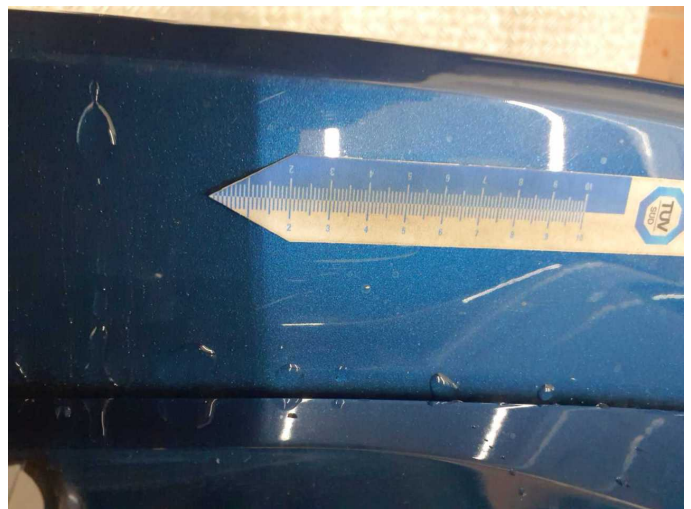
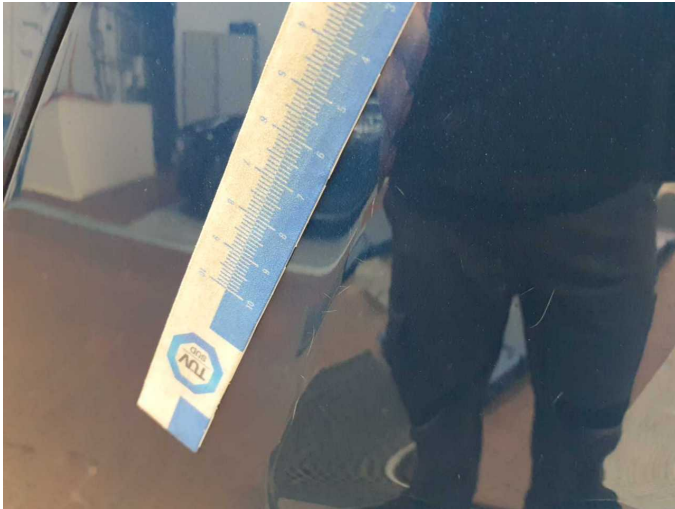
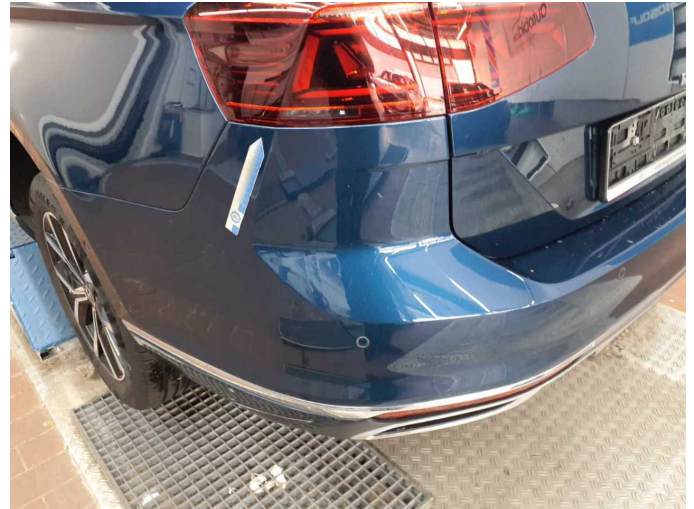
**Wear and tear 5:** Rear bumper: Rear bumper - Scratch(es) - No deduction

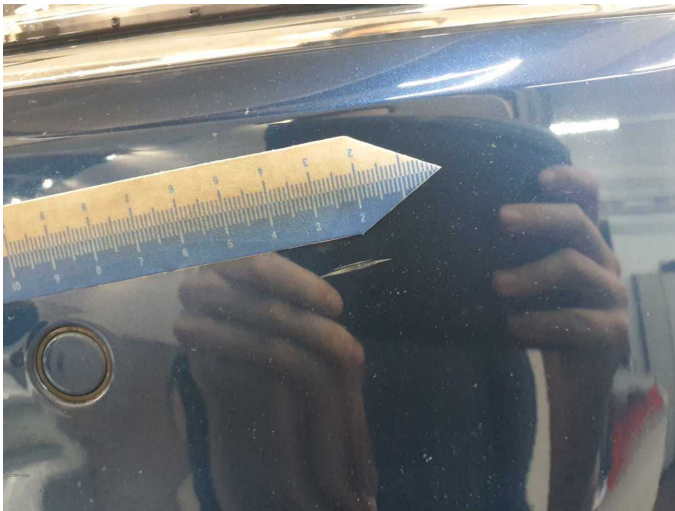
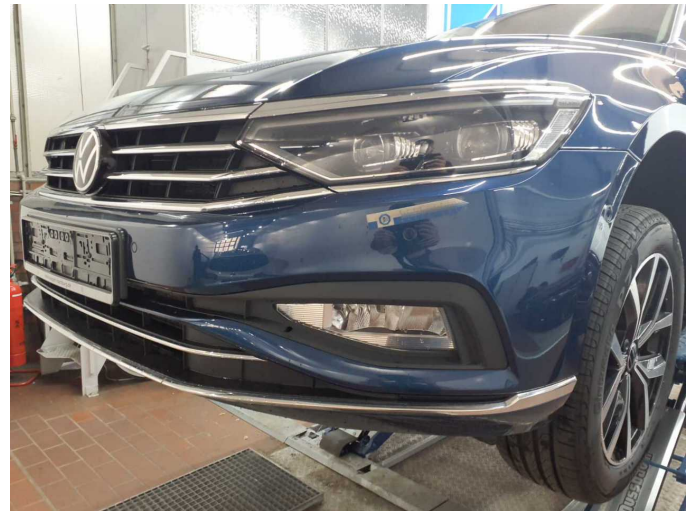
**Wear and tear 6:** Front bumper: Front bumper - Scratch(es) - No deduction

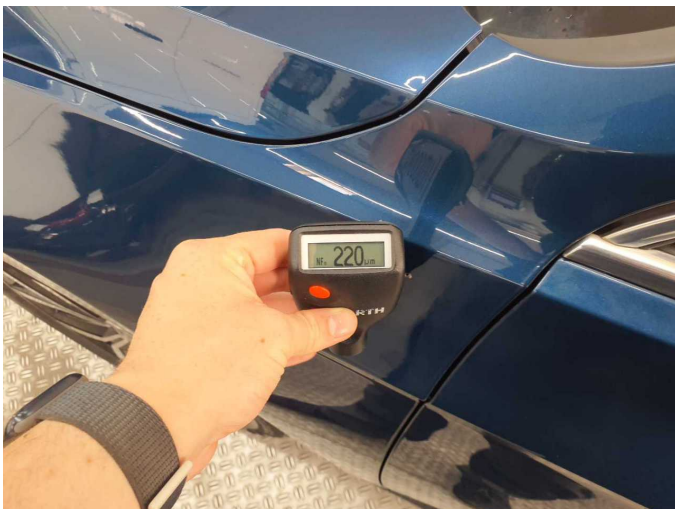
Mudguard - left side	220 µm	Mudguard - right side	218 µm
Side panel - rear left side	209 µm	Door - rear left side	213 µm
Door - front left side	216 µm

**Repainting 1:** Mudguard - left side

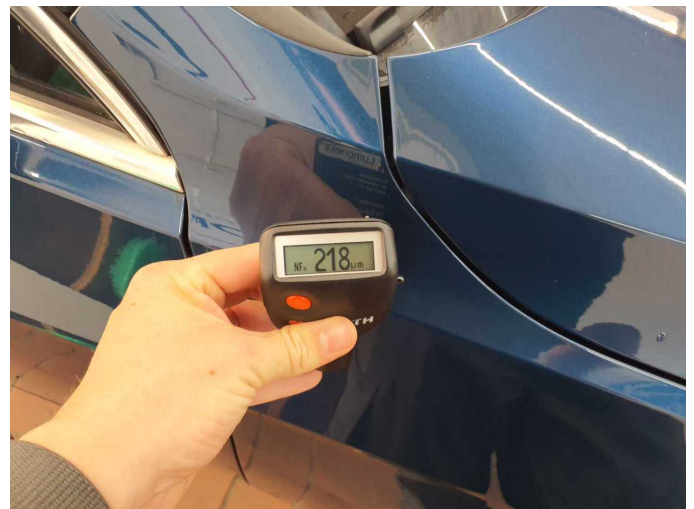
**Repainting 2:** Mudguard - right side

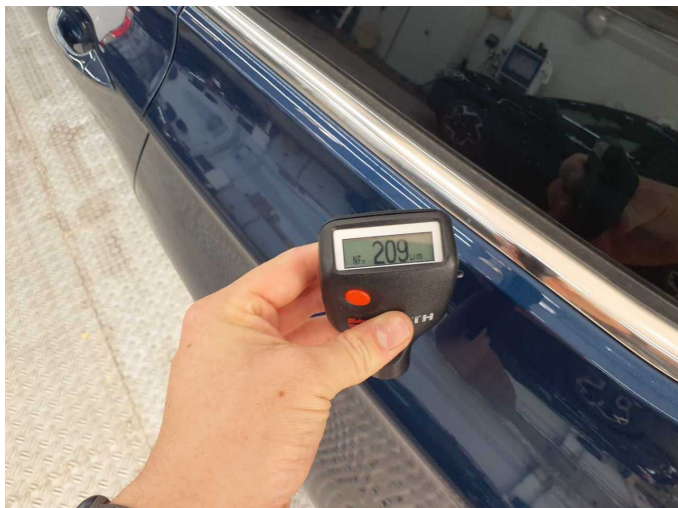
**Repainting 3:** Side panel - rear left side

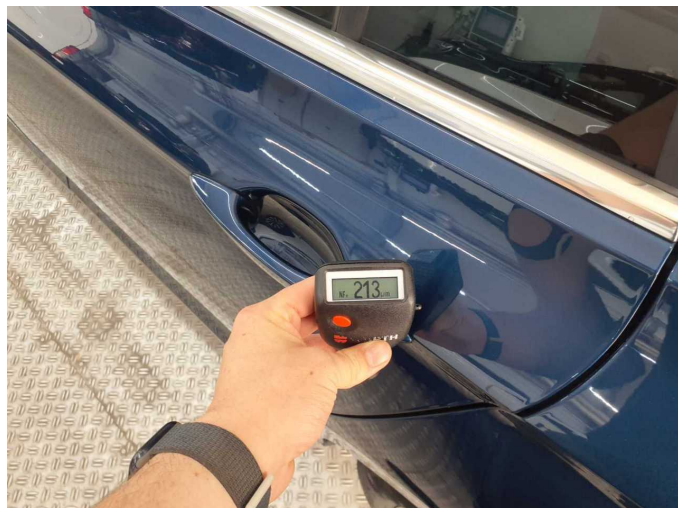
**Repainting 4:** Door - rear left side

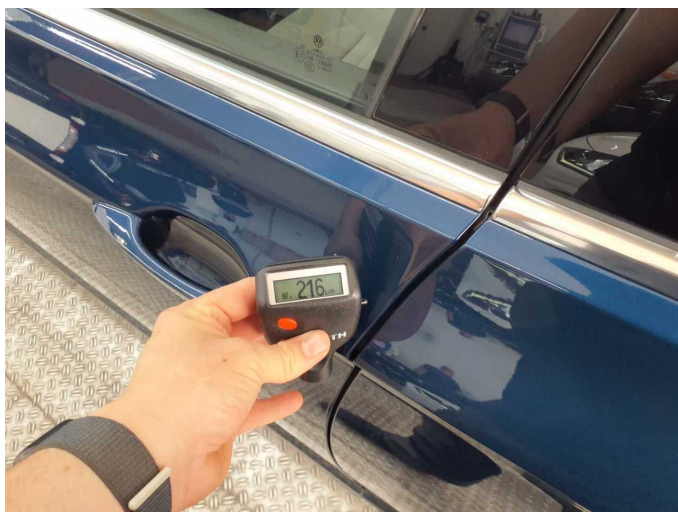
**Repainting 5:** Door - front left side
