Expertise

Protocol number: 41427732  
Order No. / Reference: 25146155  
Inspection date: 8 Sept 2025

Manufacturer: Volkswagen

Model: Passat Variant 2.0 TDI SCR DSG Business

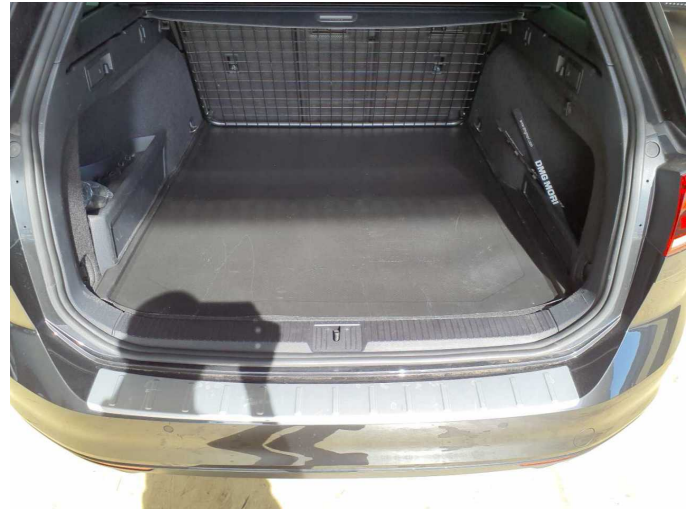
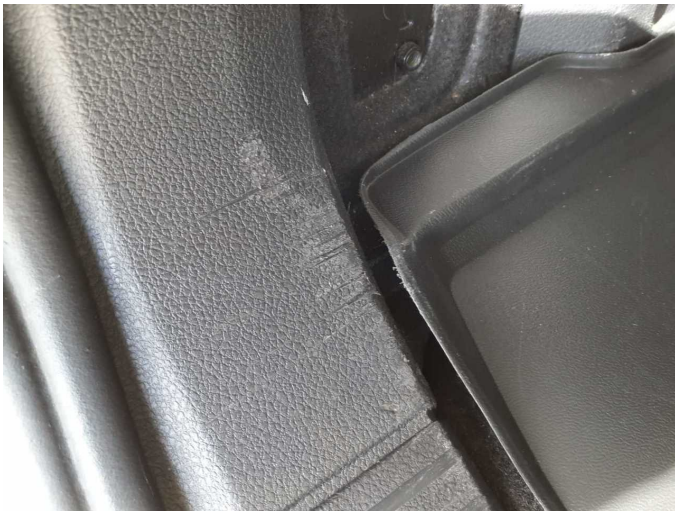
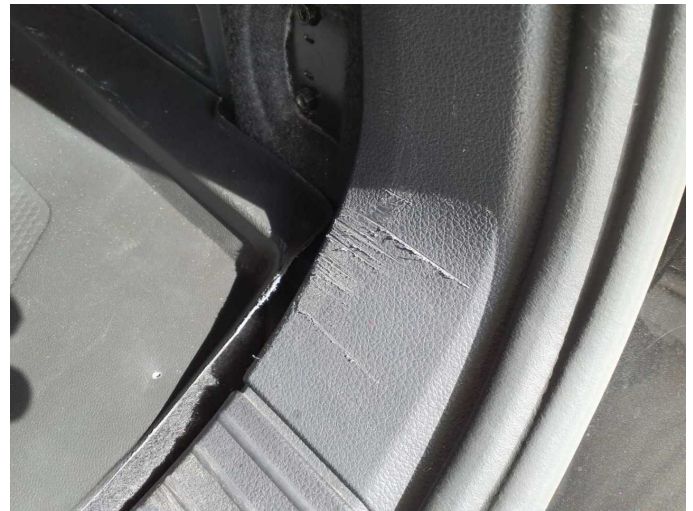
**Damage 1:** Trim / covers: Boot lining - Scratch(es) - Loss in value

| No. | Component group | Description |
|---|---|---|
| 1 | Trim / covers | Boot lining - Scratch(es) - Loss in value |

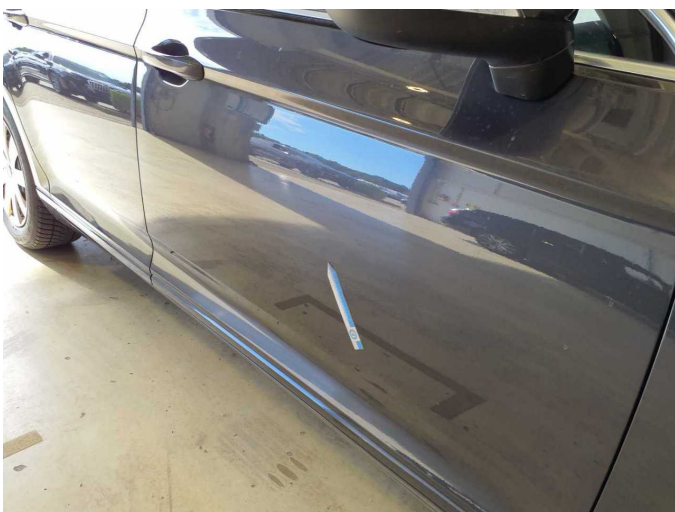
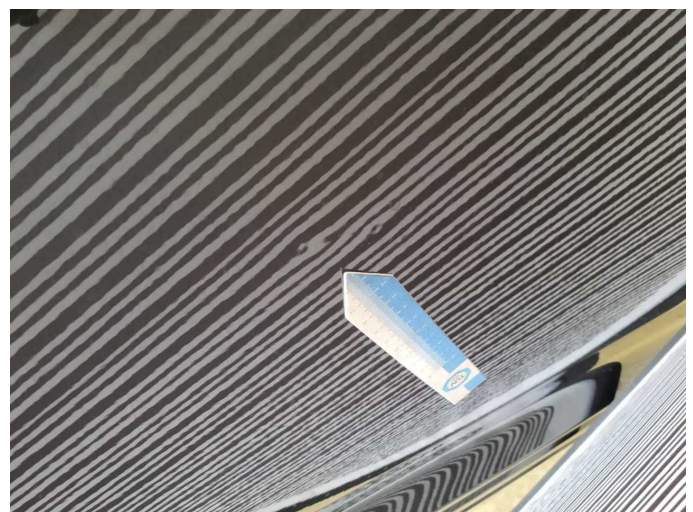
**Damage 2:** Door - front right side: Door - dent(s) - Smart repair

| No. | Component group | Description |
|---|---|---|
| 2 | Door - front right side | Door - dent(s) - Smart repair |

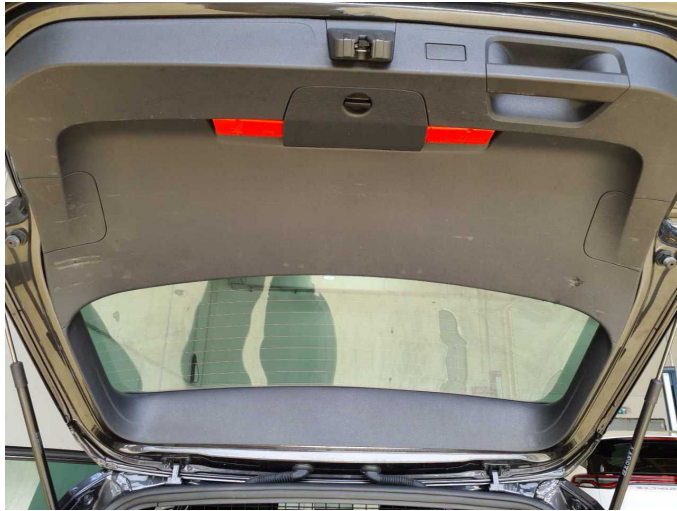
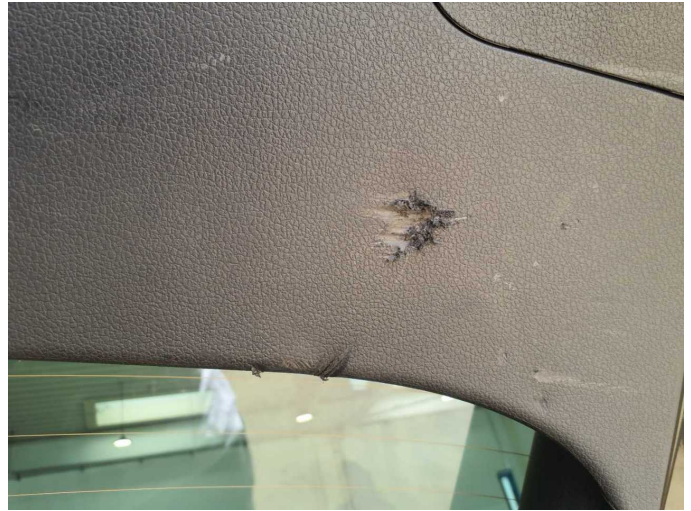
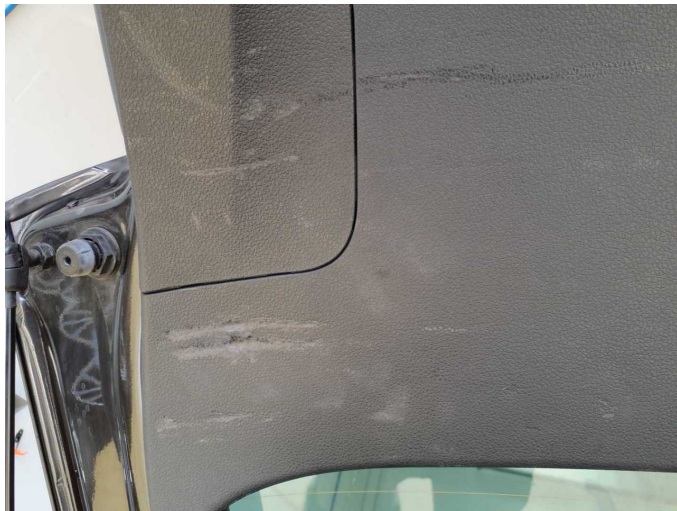
**Damage 3:** Boot lid / rear door: Trim - standard - lower - Scratched - Replace

| No. | Component group | Description |
|---|---|---|
| 3 | Boot lid / rear door | Trim - standard - lower - Scratched - Replace |

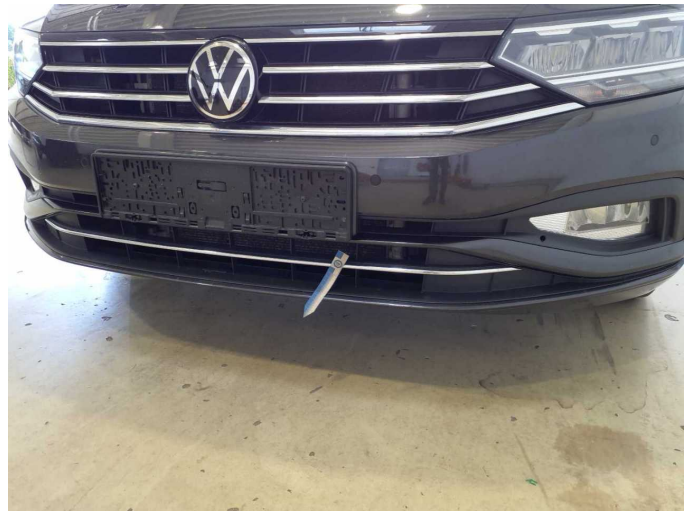
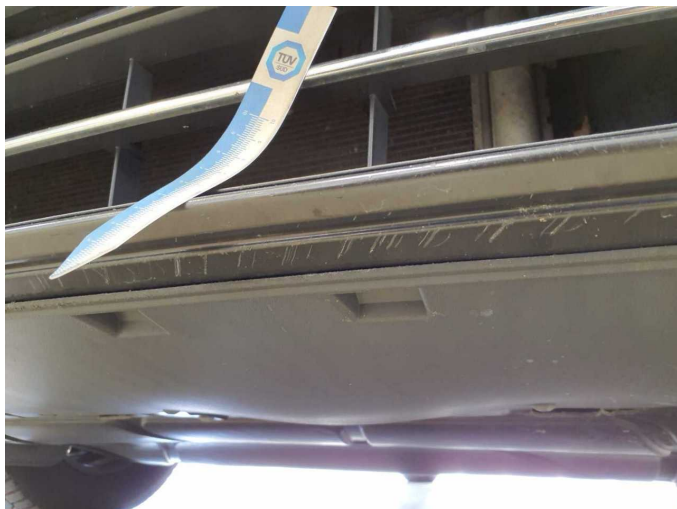
**Damage 4:** Front bumper: Front bumper - Scratch(es) - Paint

| No. | Component group | Description |
|---|---|---|
| 4 | Front bumper | Front bumper - Scratch(es) - Paint |

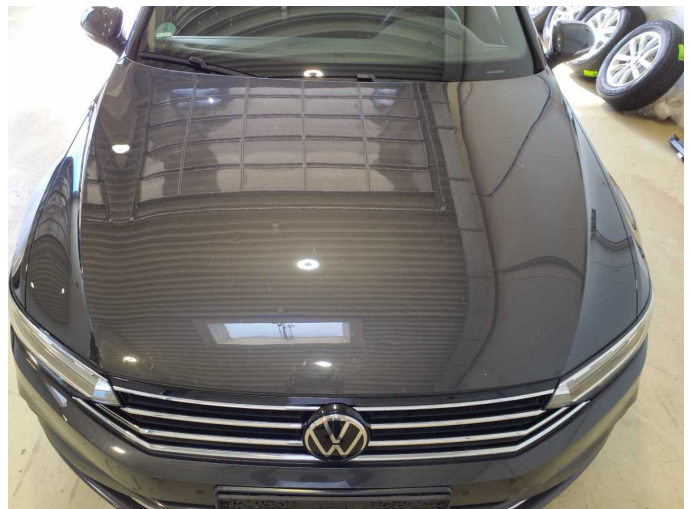
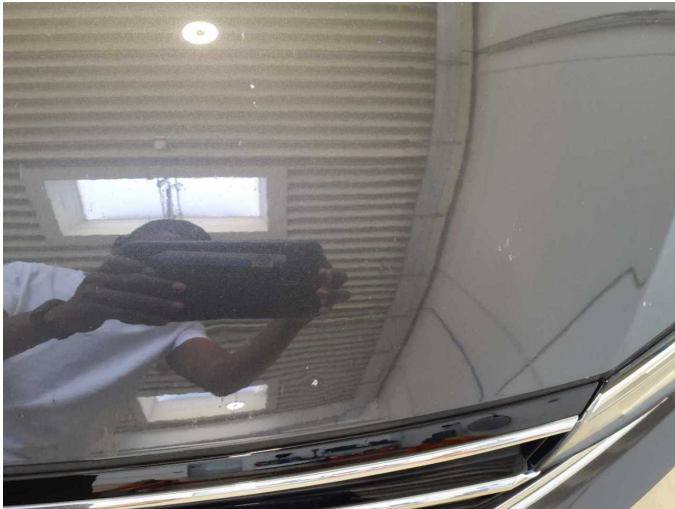
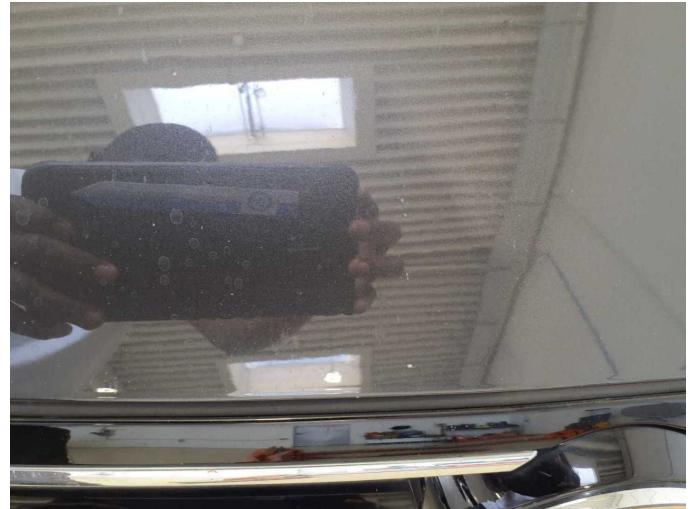
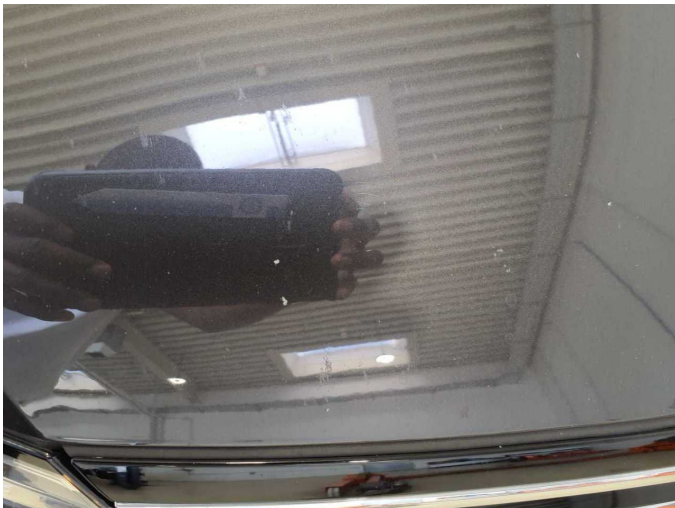
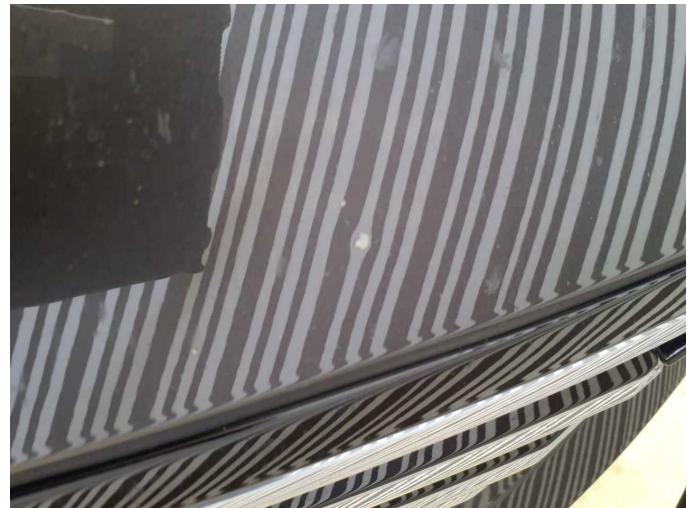
**Damage 5:** Bonnet: Bonnet - Dent / paintcoat damage - Repair and paint

| No. | Component group | Description |
|---|---|---|
| 5 | Bonnet | Bonnet - Dent / paintcoat damage - Repair and paint |

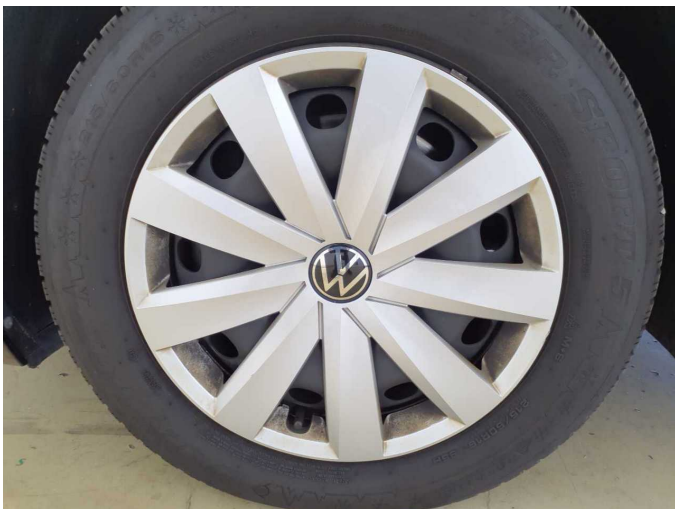
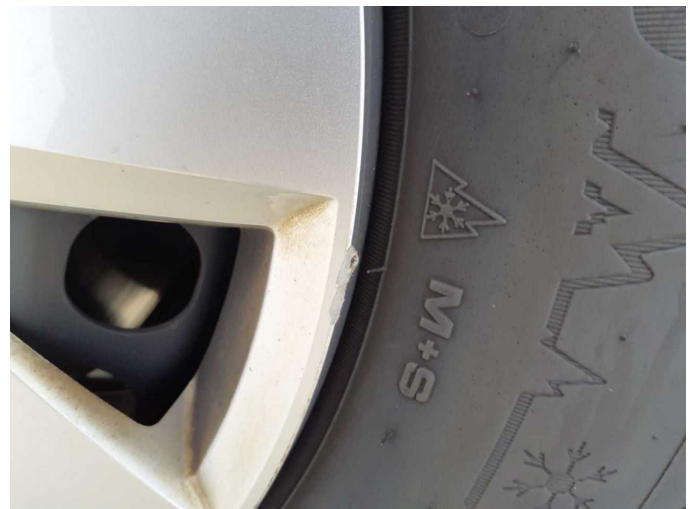
**Wear and tear 1:** Wheel / tyres: Wheel cover - front left side - Scratch(es)  
- No deduction

| No. | Component group | Description |
|---|---|--|
| 1 | Wheel / tyres | Wheel cover - front left side - Scratch(es) - No deduction |
