Expertise

Protocol number: 40673189
Order No. / Reference: 24911080
Inspection date: 16 Jul 2025

Manufacturer: Volkswagen	Model: Passat Variant 2.0 TDI SCR DSG Business
VIN: WVGZZZ3CZNE063140

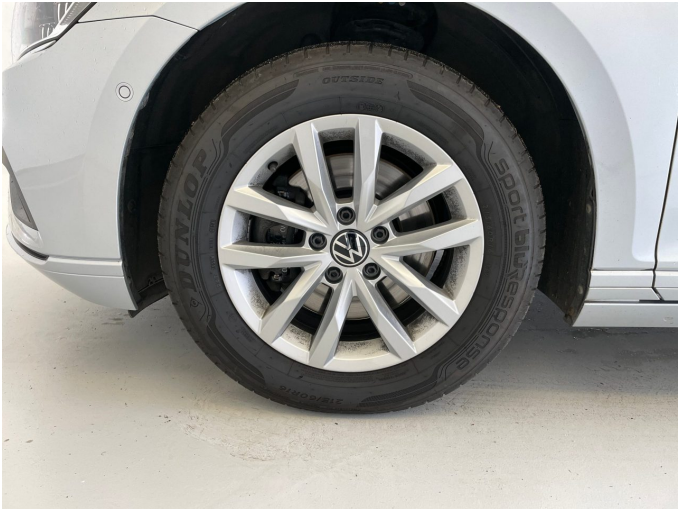
Figure 12: Mounted tyres

#	Tyre size	Type of tyre	Manufacturer	Tread depth
1)	215/60 R16 95V	Summer tyres on Light alloy	Dunlop	4mm / 4mm
2)	215/60 R16 95V	Summer tyres on Light alloy	Dunlop	4mm / 4mm

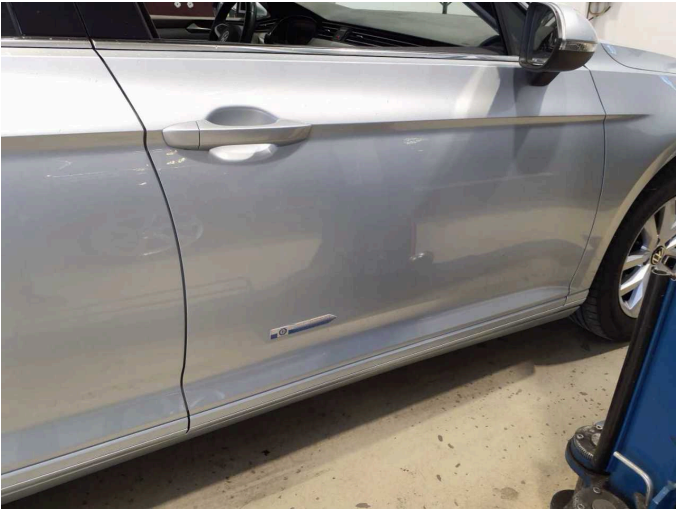
Damage 1: Door - front right side: Door - dent(s) - Smart repair

No.	Component group	Description
1	Door - front right side	Door - dent(s) - Smart repair
2	Boot lid / rear door	Rear spoiler (rechts) - Damaged - Replace

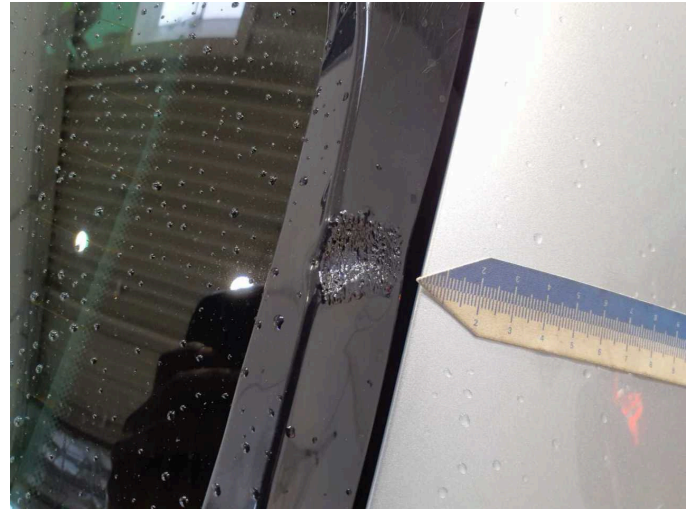
Damage 2: Boot lid / rear door: Rear spoiler (rechts) - Damaged - Replace

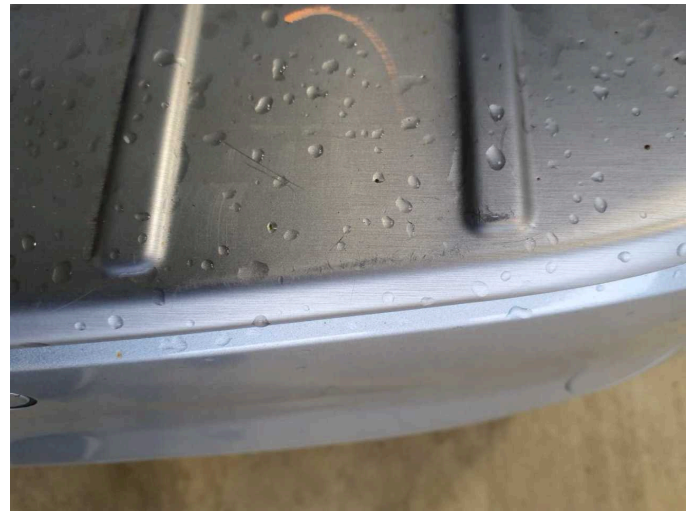
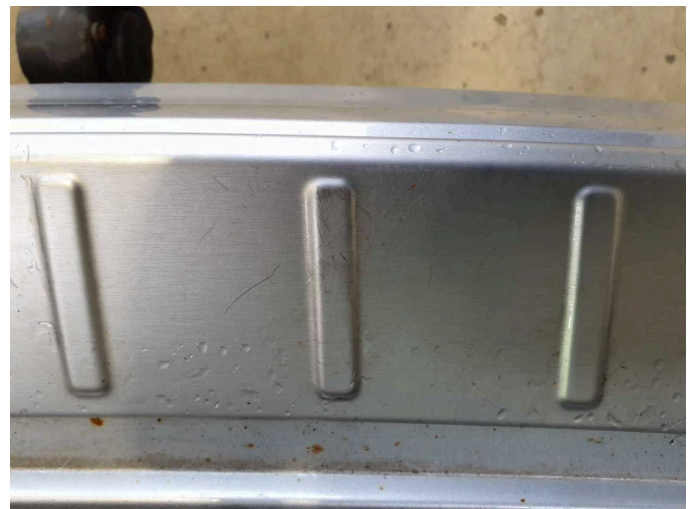
Wear and tear 1: Trim / covers: Boot sill cover - Scratch(es) - No deduction

No.	Component group	Description
1	Trim / covers	Boot sill cover - Scratch(es) - No deduction
2	Trim / covers	Boot lid - interior trim - Scratch(es) - No deduction
