Expertise

Protocol number: 40673189
Order No. / Reference: 24911080
Inspection date: 16 Jul 2025

Manufacturer: Volkswagen

Model: Passat Variant 2.0 TDI SCR DSG Business

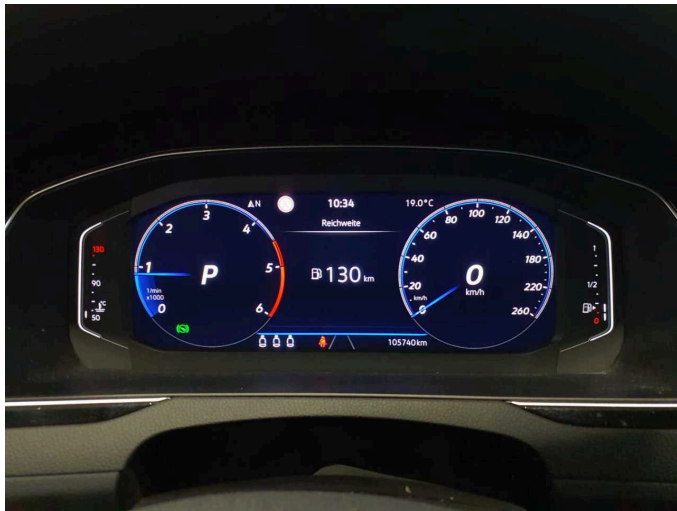
Figure 7: Instrument cluster

Vehicle Identification number WVGZZZ3CZNE063140
Mileage (Read) 105,740 km
First registration 3 May 2022
Number of holders 1
Next periodical technical inspection 05/2027
(Report on hand)

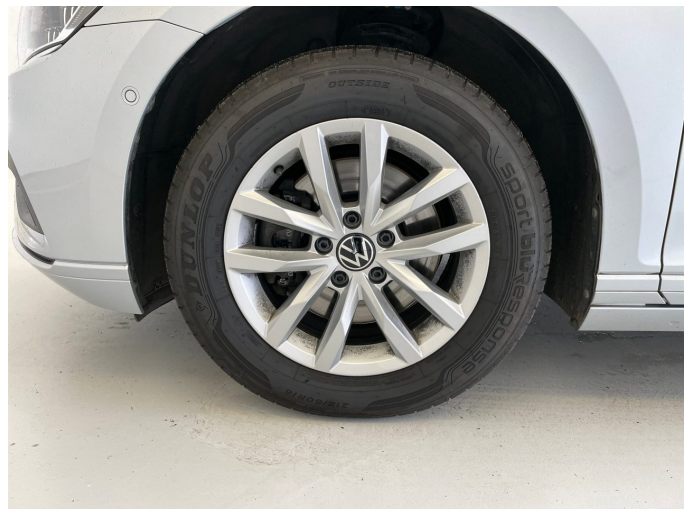
Figure 12: Mounted tyres

#	Tyre size	Type of tyre	Manufacturer	Tread depth
1)	215/60 R16 95V	Summer tyres on Light alloy	Dunlop	4mm / 4mm
2)	215/60 R16 95V	Summer tyres on Light alloy	Dunlop	4mm / 4mm

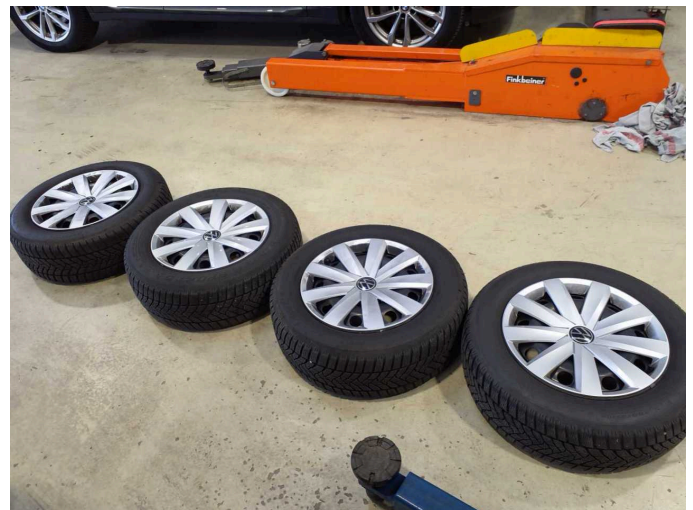
Figure 16: Additional tyres

#	Tyre size	Type of tyre	Manufacturer	Tread depth
1)	215/60 R16 95H	Winter tyres on Steel rim with wheel cover	Dunlop	6mm / 6mm
2)	215/60 R16 95H	Winter tyres on Steel rim with wheel cover	Dunlop	7mm / 7mm

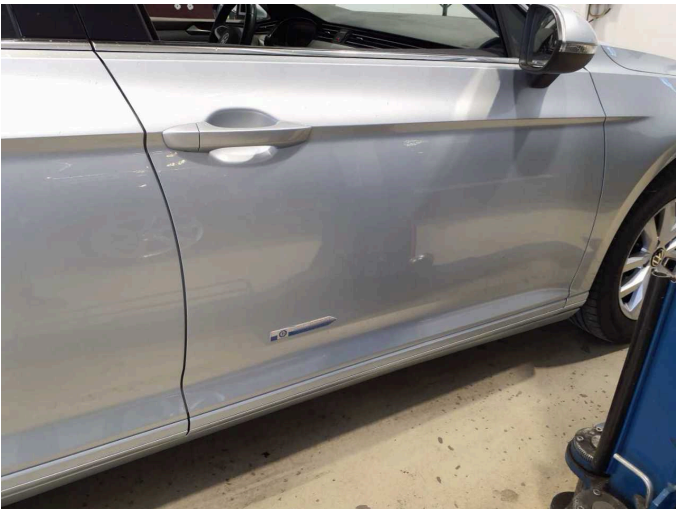
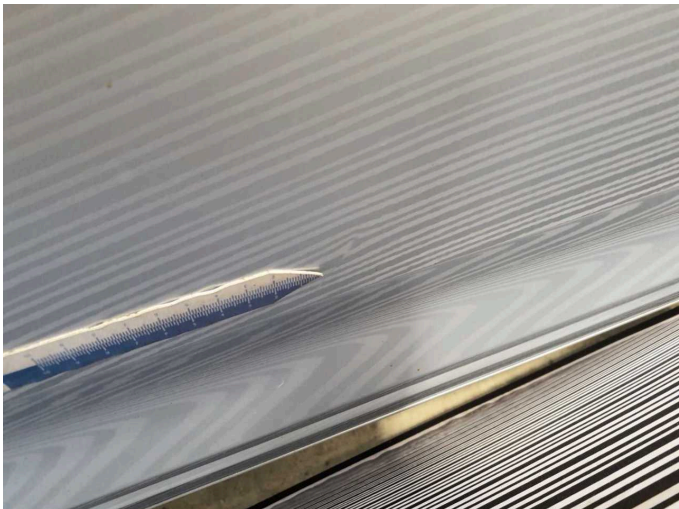
Damage 1: Door - front right side: Door - dent(s) - Smart repair

No.	Component group	Description
1	Door - front right side	Door - dent(s) - Smart repair
2	Boot lid / rear door	Rear spoiler (rechts) - Damaged - Replace

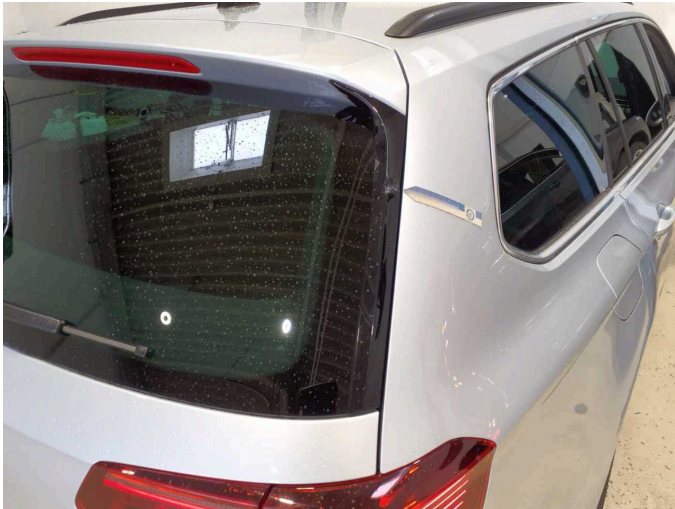
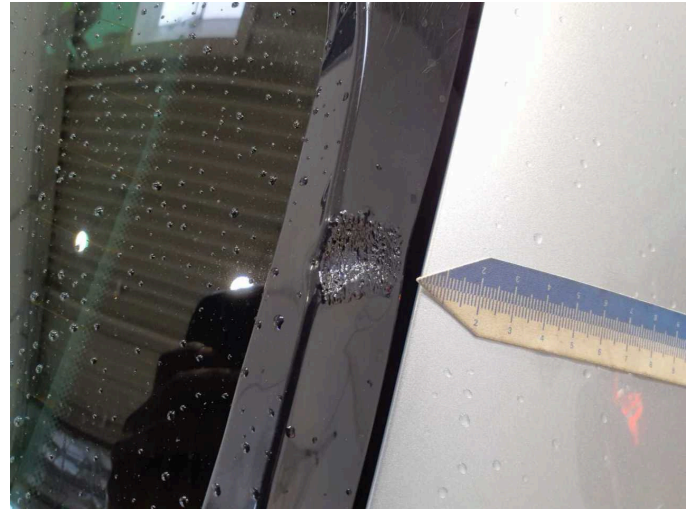
Damage 2: Boot lid / rear door: Rear spoiler (rechts) - Damaged - Replace

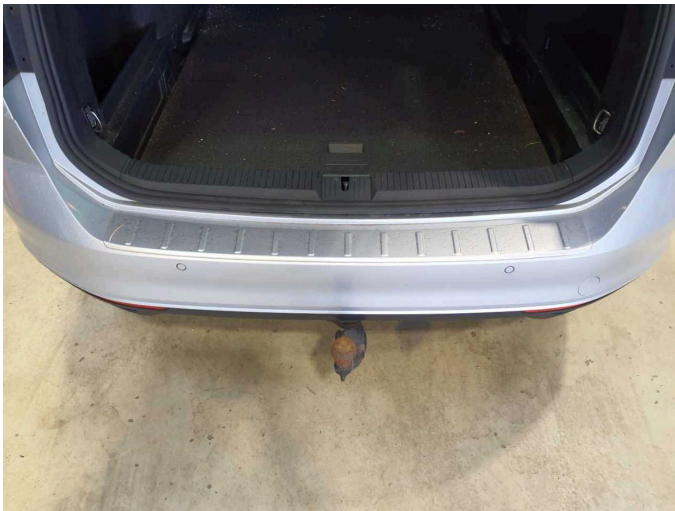
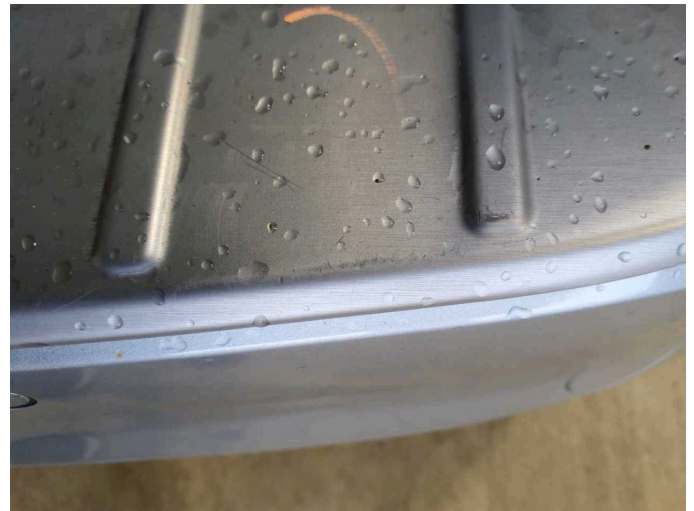
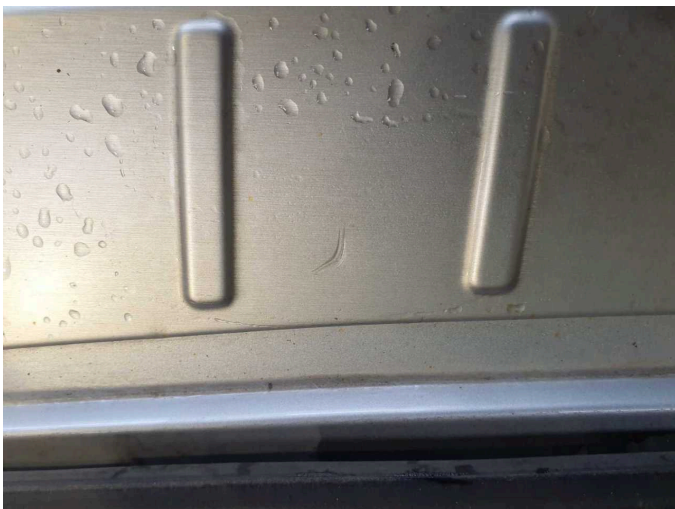
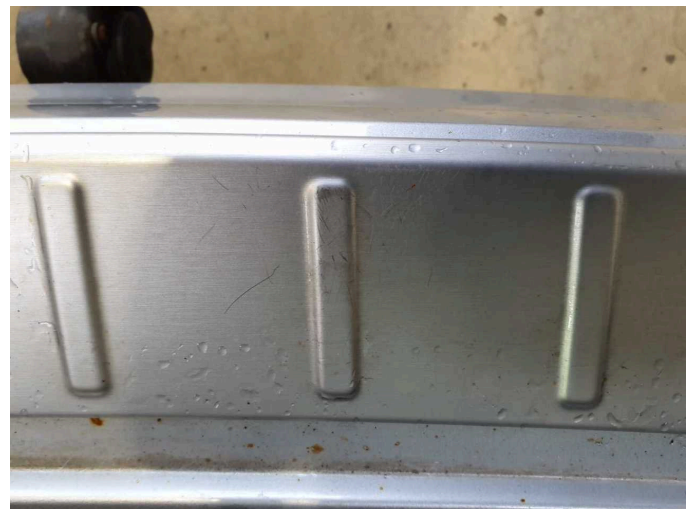
Wear and tear 1: Trim / covers: Boot sill cover - Scratch(es) - No deduction

No.	Component group	Description
1	Trim / covers	Boot sill cover - Scratch(es) - No deduction
2	Trim / covers	Boot lid - interior trim - Scratch(es) - No deduction

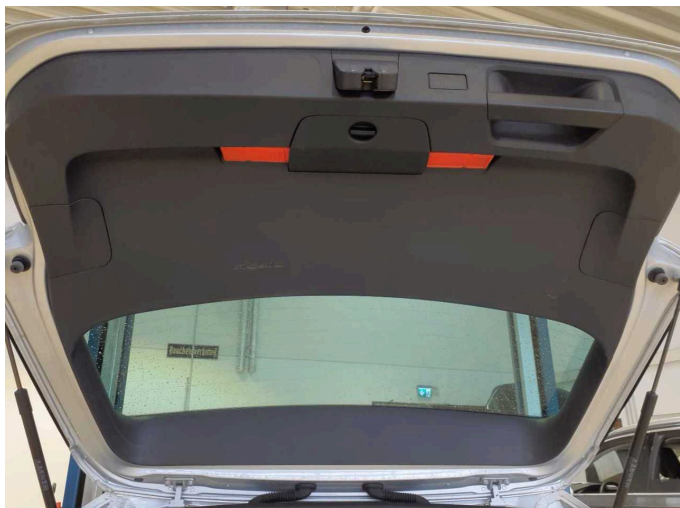
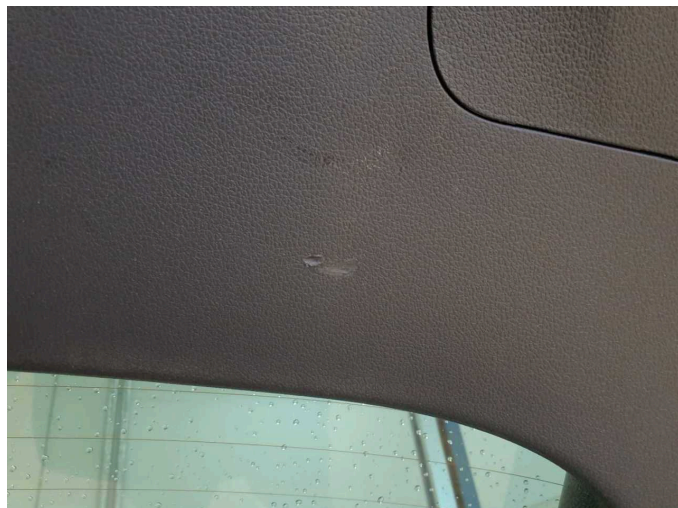
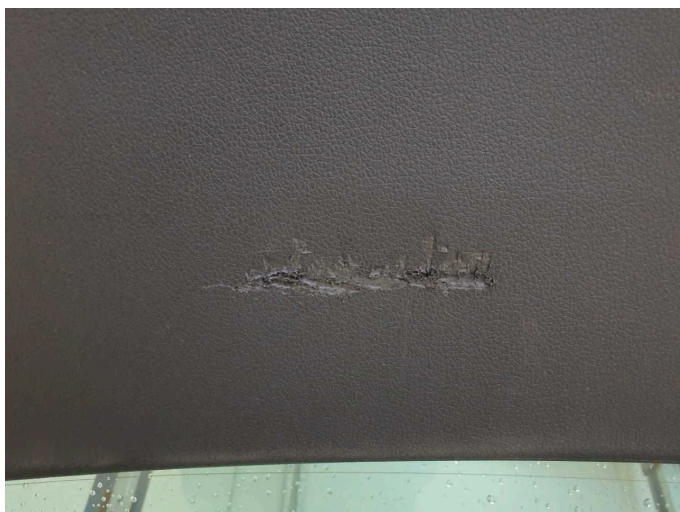
Wear and tear 2: Trim / covers: Boot lid - interior trim - Scratch(es) - No deduction
