Expertise

Protocol number: 41417591  
Order No. / Reference: 25076390  
Inspection date: 8 Sept 2025

Manufacturer: Volkswagen

Model: Passat Variant 1.4 TSI Plug-In-Hybrid DSG GTE

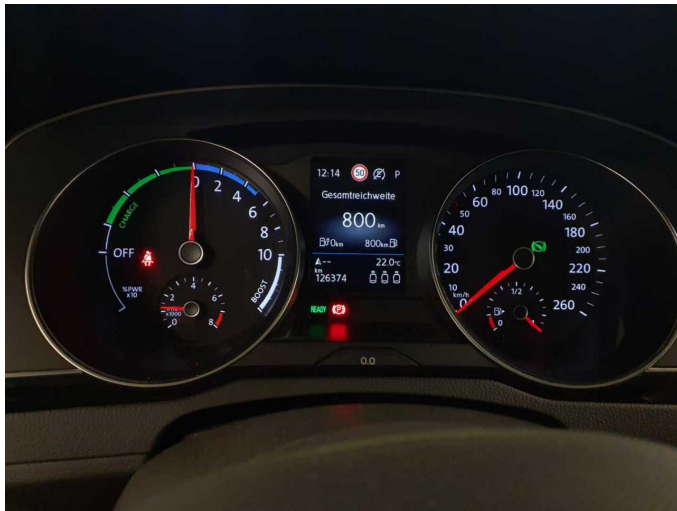
Figure 7: Instrument cluster

| Vehicle details | |
|---|---|
| Mileage (Read) | 126,374 km |

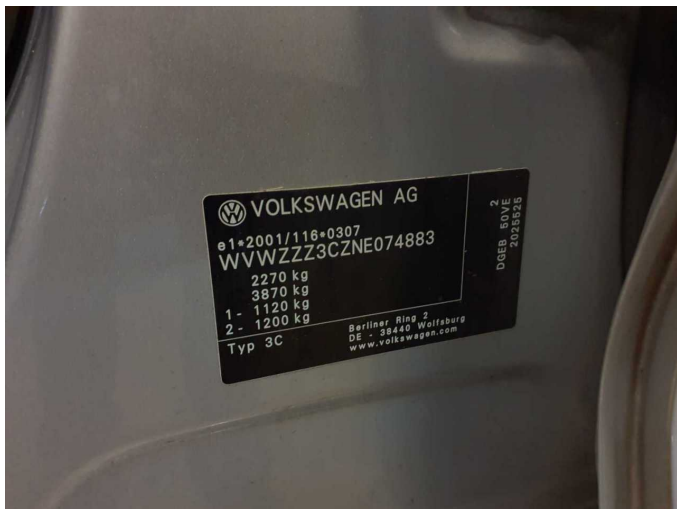
Figure 11: VIN

| VIN comparison | The vehicle identification number (VIN) was read from the vehicle and its conformity with the submitted documents was verified during the inspection by the undersigned. |

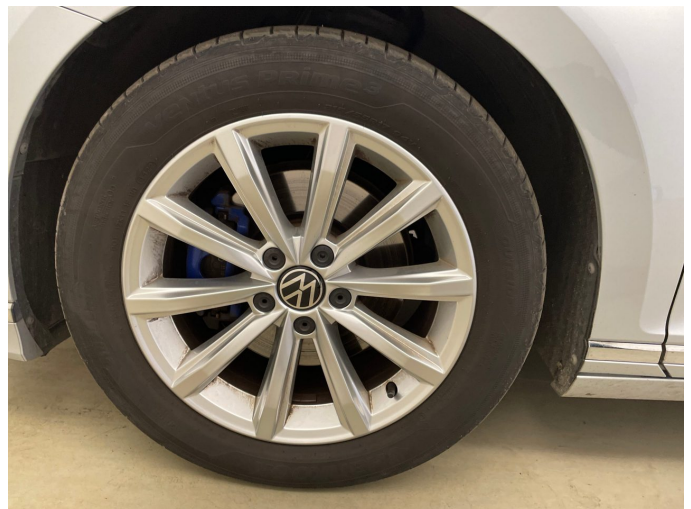
Figure 12: Mounted tyres

| # | Tyre size | Type of tyre | Manufacturer | Tread depth |
|---|---|---|---|---|
| 1) | 215/55 R17 94V | Summer tyres on Light alloy | Hankook | 4mm / 4mm |
| 2) | 215/55 R17 94V | Summer tyres on Light alloy | Hankook | 5mm / 5mm |

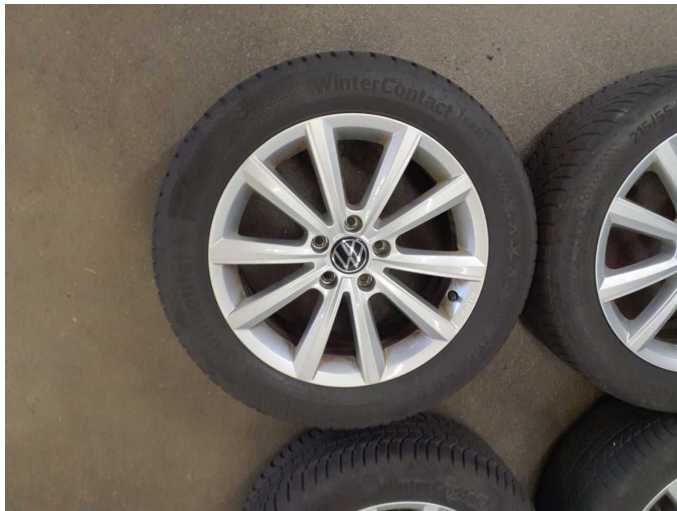
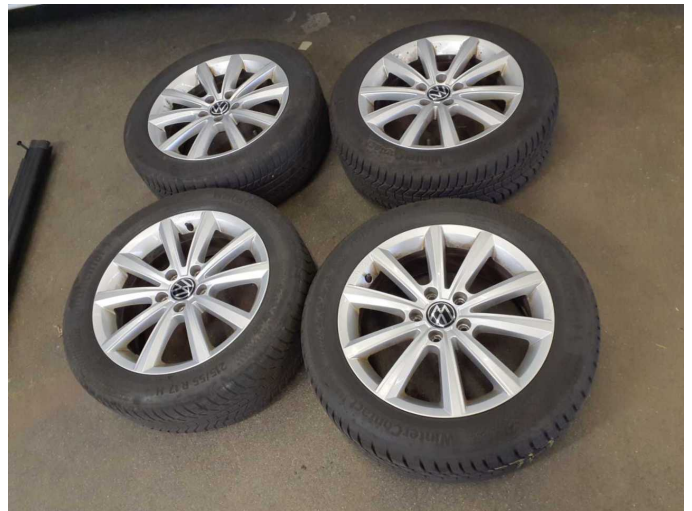
Figure 19: Additional tyres

| # | Tyre size | Type of tyre | Manufacturer | Tread depth |
|---|---|---|---|---|
| 1) | 215/55 R17 94H | Winter tyres on Light alloy | Continental | 3mm / 3mm |
| 2) | 215/55 R17 94H | Winter tyres on Light alloy | Continental | 7mm / 7mm |

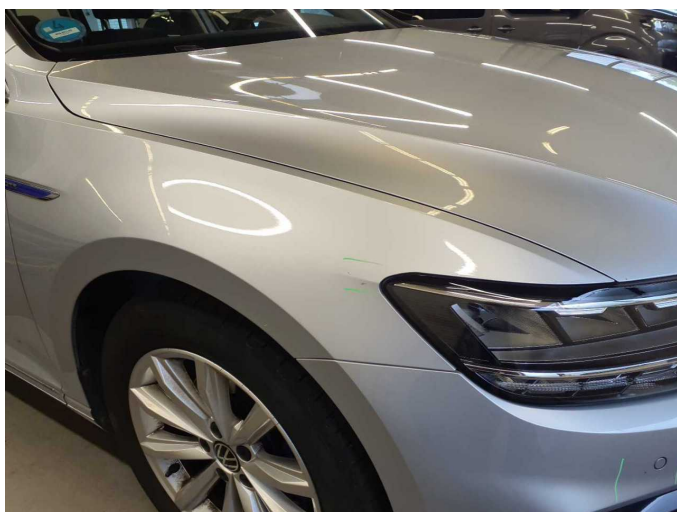
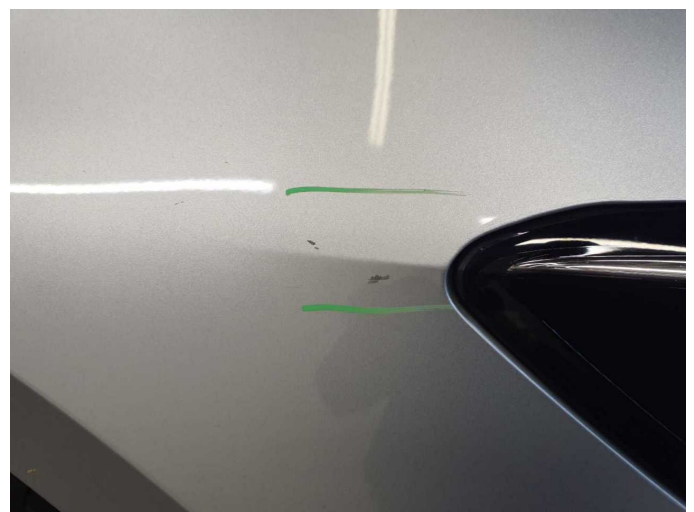
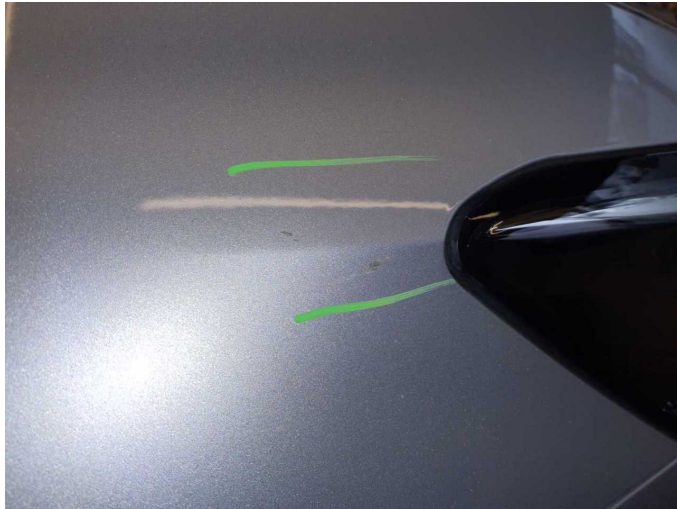
**Damage 1:** Mudguard - right side: Mudguard - right side - Scratch(es) - Smart repair

| No. | Component group | Description |
|---|---|---|
| 1 | Mudguard - right side | Mudguard - right side - Scratch(es) - Smart repair |

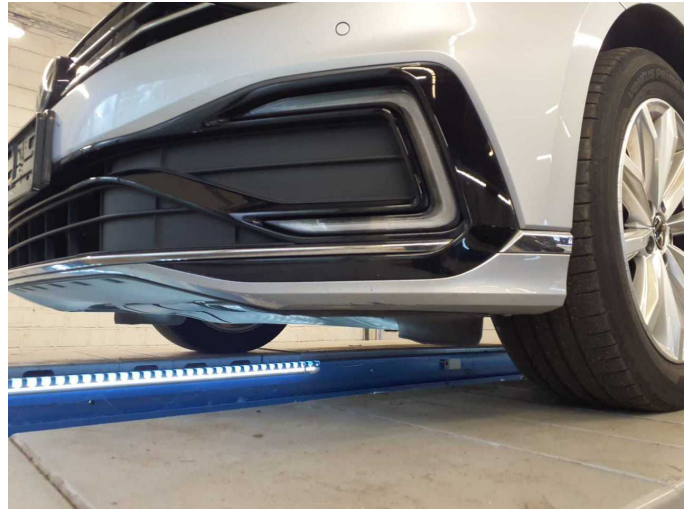
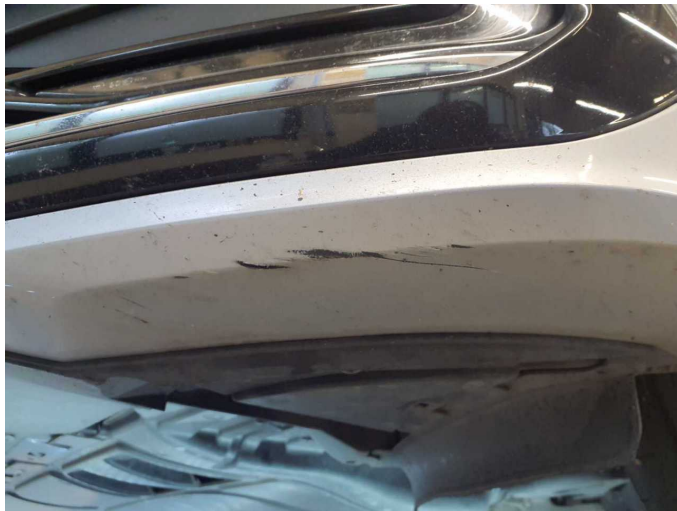
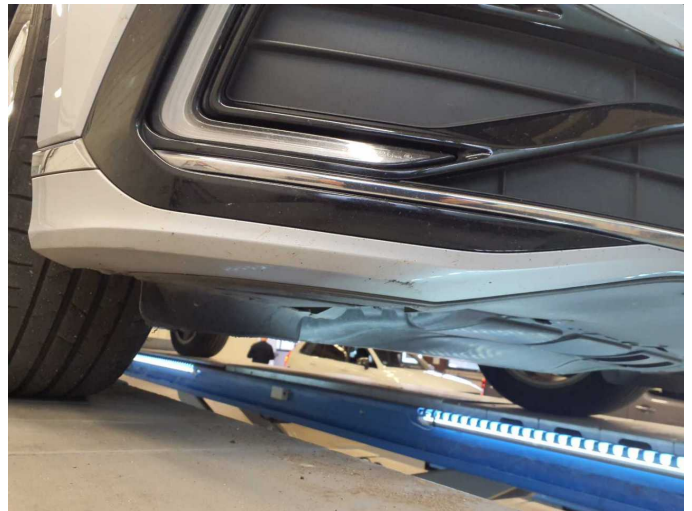
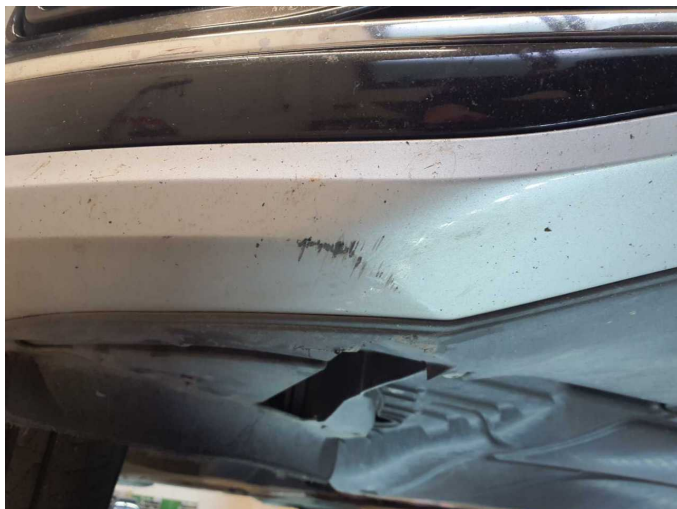
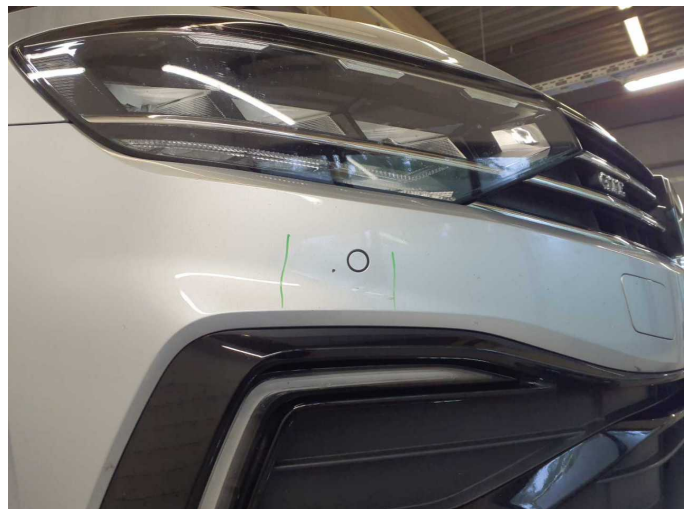
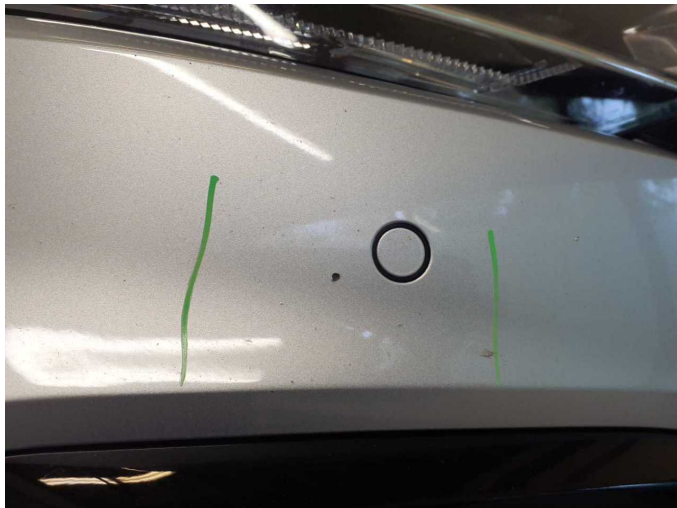
**Damage 2:** Front bumper: Front bumper - Scratch(es) - Paint

| No. | Component group | Description |
|---|---|---|
| 2 | Front bumper | Front bumper - Scratch(es) - Paint |

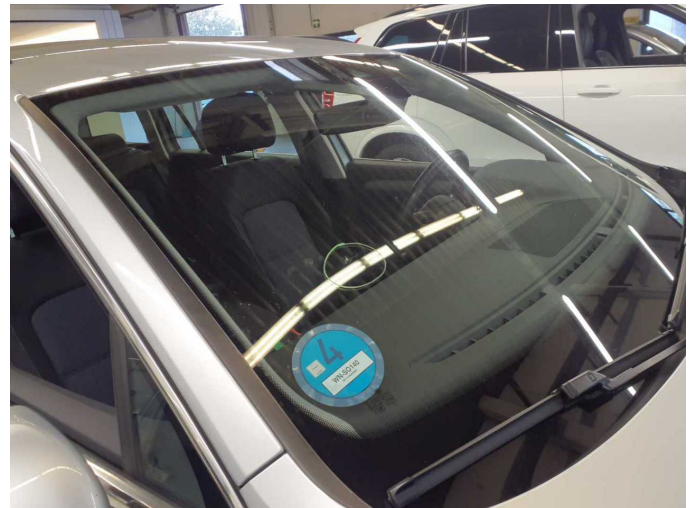
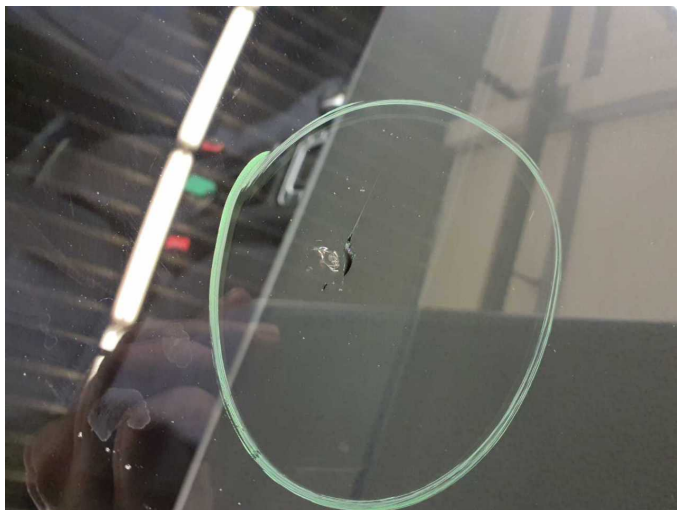
**Damage 3:** Vehicle glazing: Windscreen - Broken / torn - Replace

| No. | Component group | Description |
|---|---|---|
| 3 | Vehicle glazing | Windscreen - Broken / torn - Replace |
