Expertise

Protocol number: 40616922  
Order No. / Reference: 24986293  
Inspection date: 16 Jul 2025

Manufacturer: Volkswagen

Model: Passat Variant 2.0 TDI SCR DSG Business

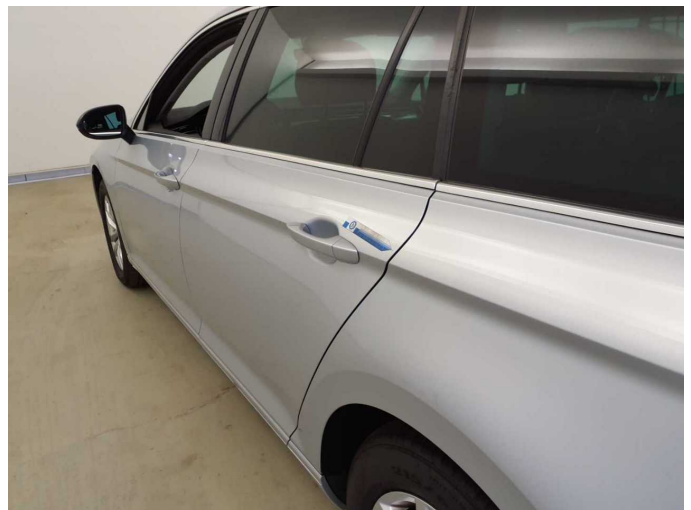
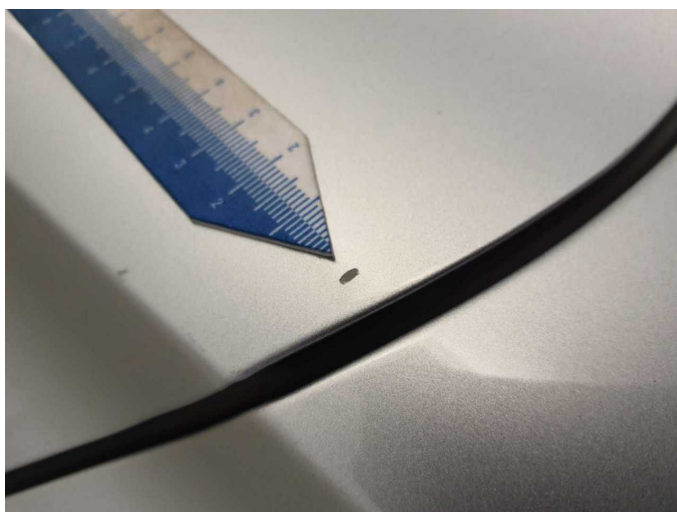
| No. | Component group | Description |
|---|---|---|
| 1 | Door - rear left side | Door - Scratched - Smart repair |

Damage 1: Door - rear left side: Door - Scratched - Smart repair

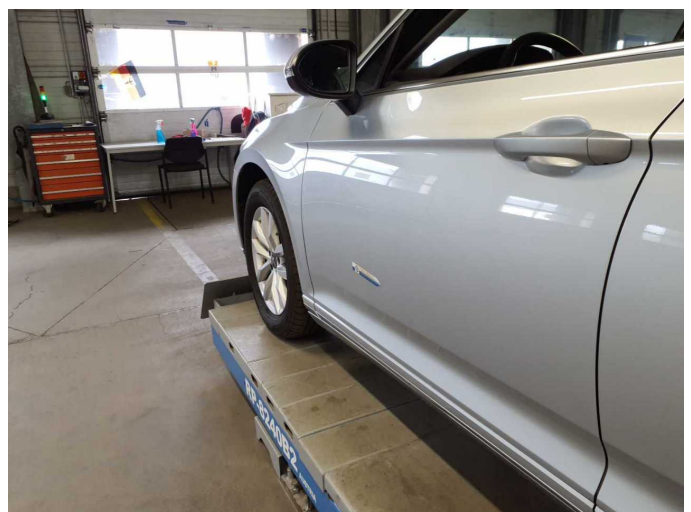
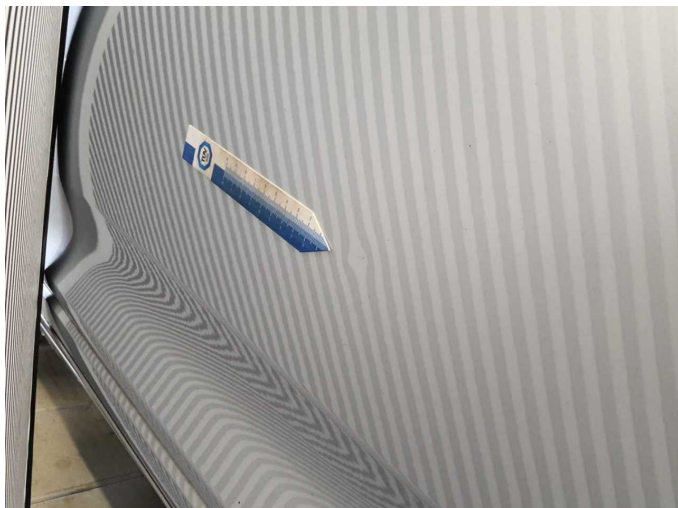
| No. | Component group | Description |
|---|---|---|
| 2 | Door - front left side | Door - dent(s) - Smooth repair work |

Damage 2: Door - front left side: Door - dent(s) - Smooth repair work

**Damage 2:** Door - front left side: Door - dent(s) - Smooth repair work

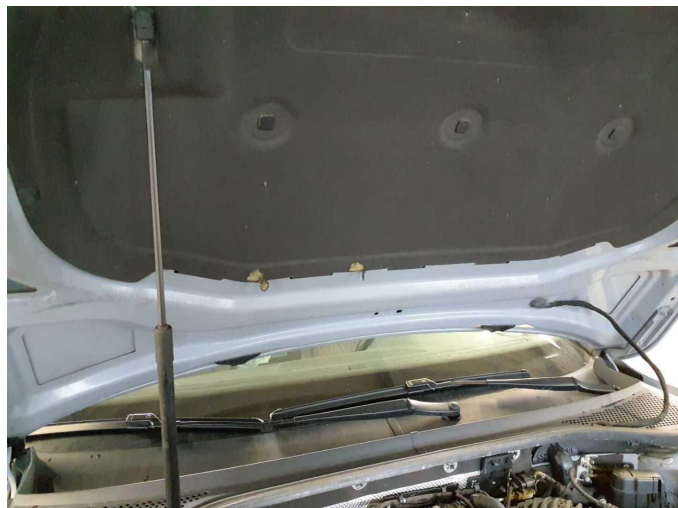
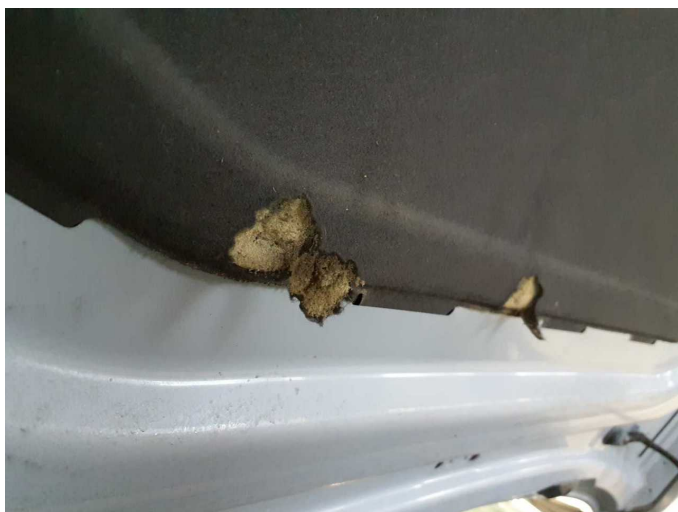
| No. | Component group | Description |
|---|---|---|
| 3 | Bonnet | Insulation lining - Holes - Replace |

**Damage 3:** Bonnet: Insulation lining - Holes - Replace

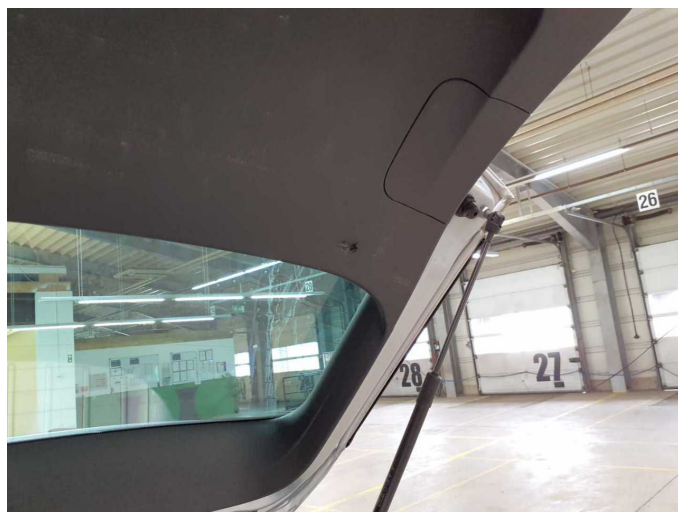
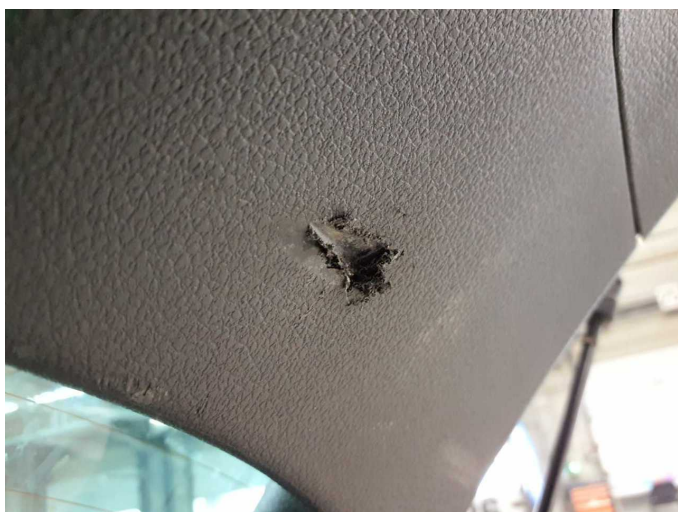
| No. | Component group | Description |
|---|---|---|
| 4 | Trim / covers | Boot lid - interior trim - Scratched - Replace |

**Damage 4:** Trim / covers: Boot lid - interior trim - Scratched - Replace

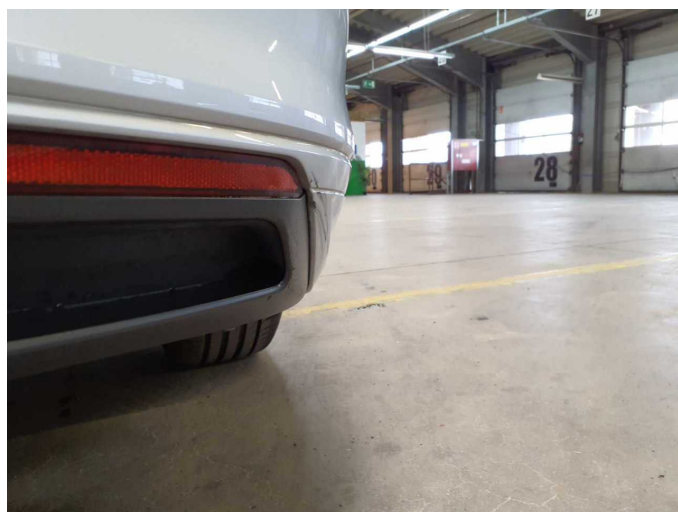
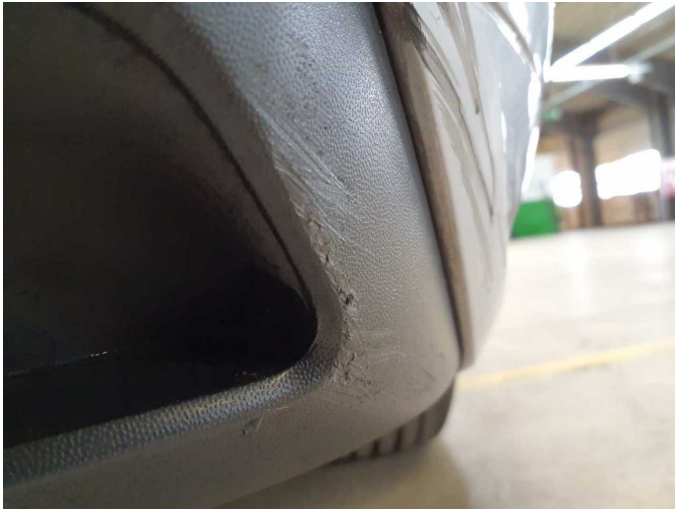
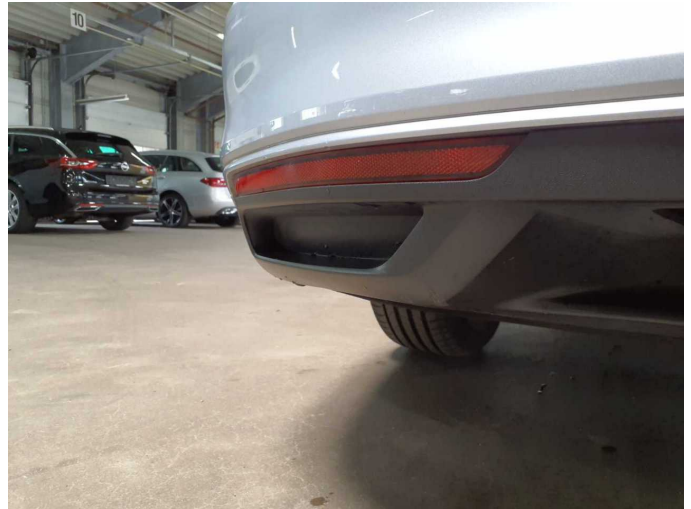
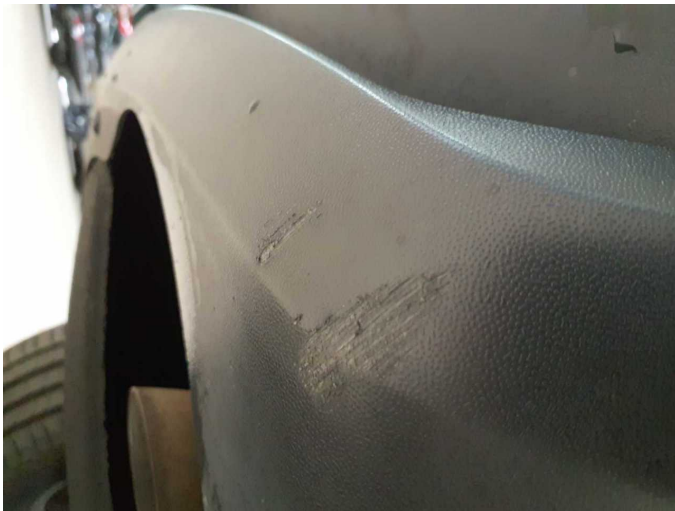
| No. | Component group | Description |
|---|---|---|
| 5 | Rear bumper | Spoiler - Scratched - Replace |

**Damage 5:** Rear bumper: Spoiler - Scratched - Replace

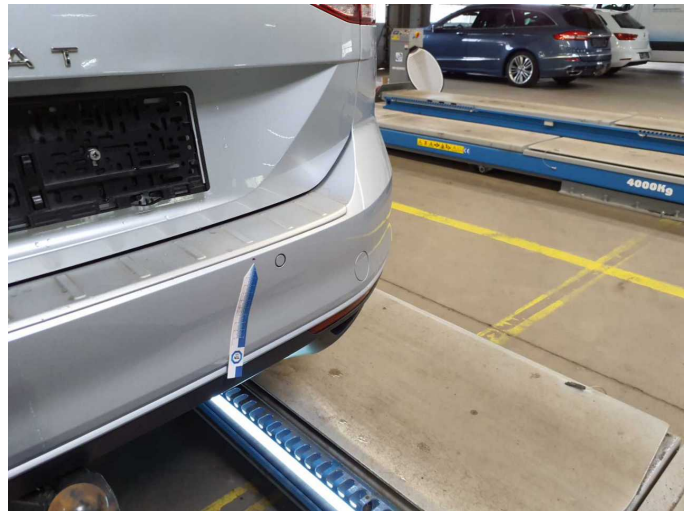
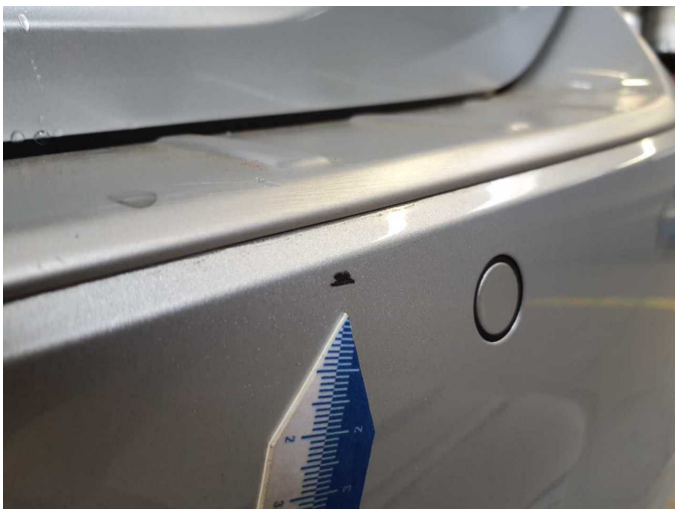
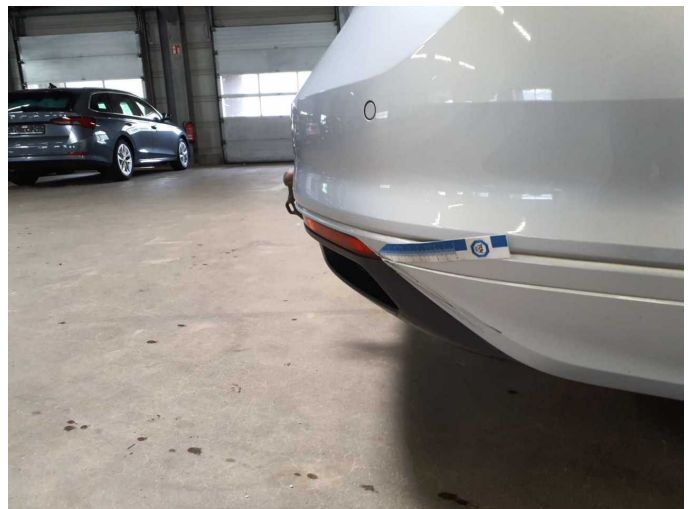
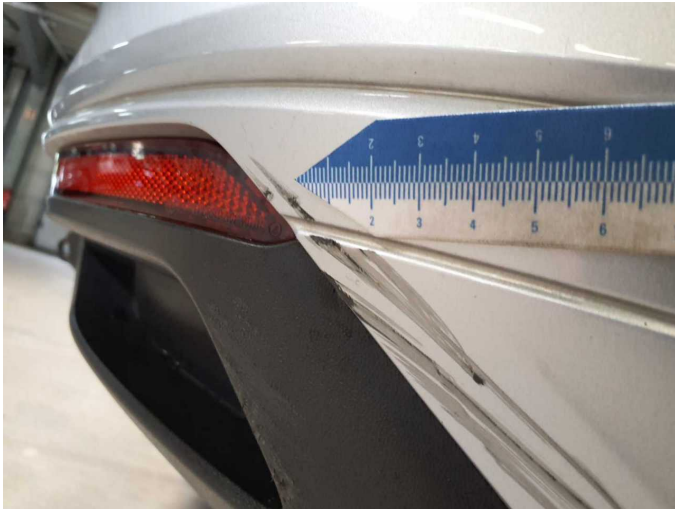
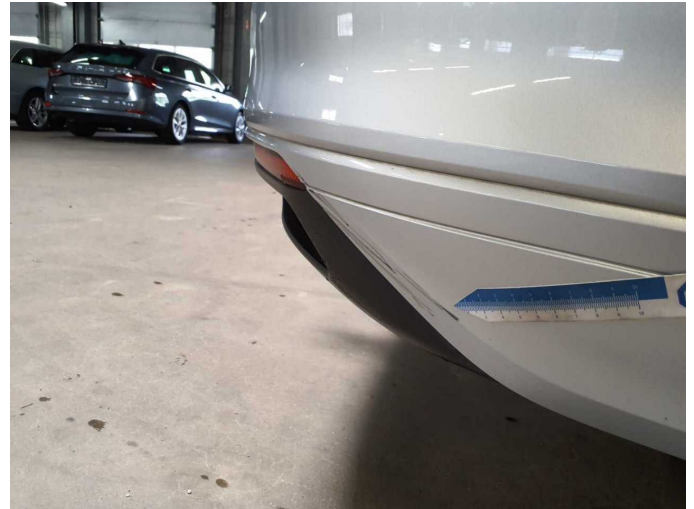
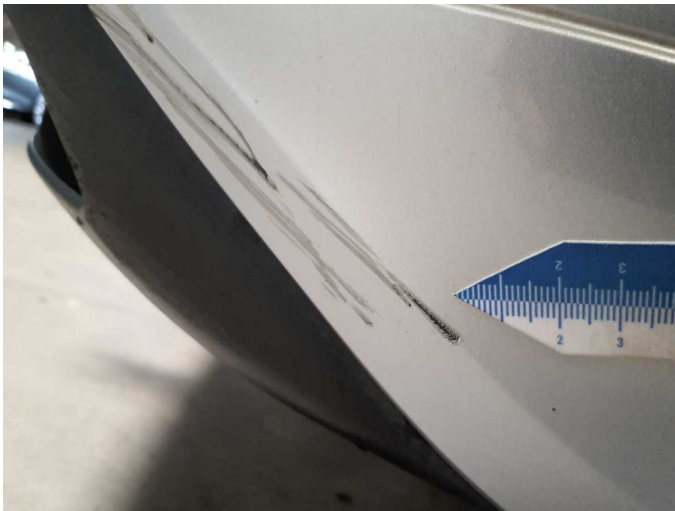
| No. | Component group | Description |
|---|---|---|
| 6 | Rear bumper | Rear bumper - Scratched - Paint |

**Damage 6:** Rear bumper: Rear bumper - Scratched - Paint

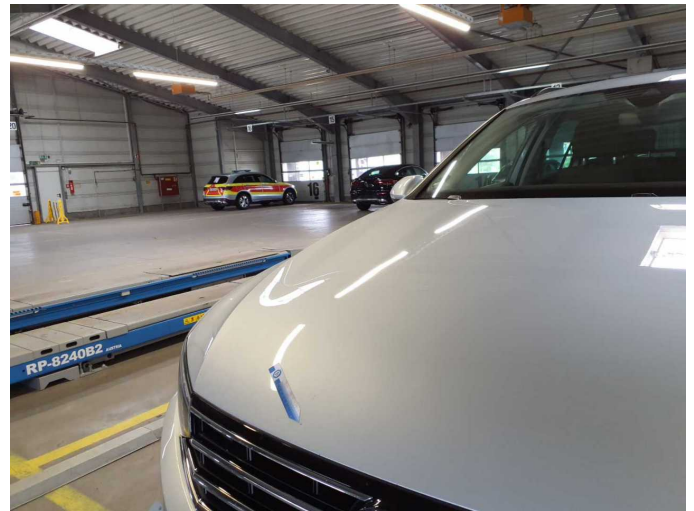
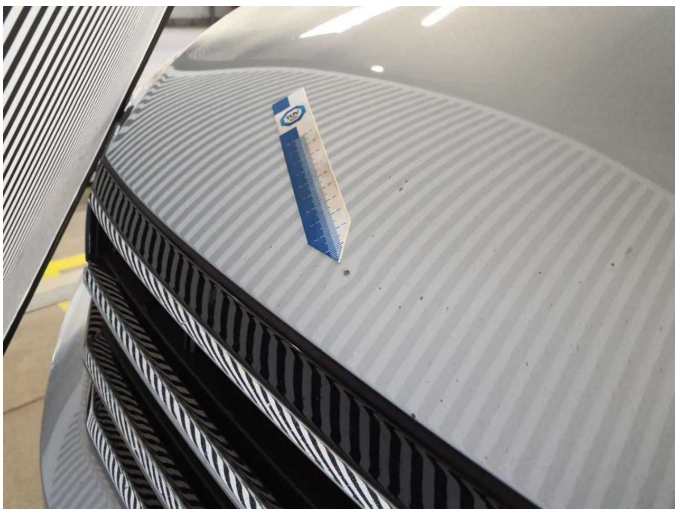
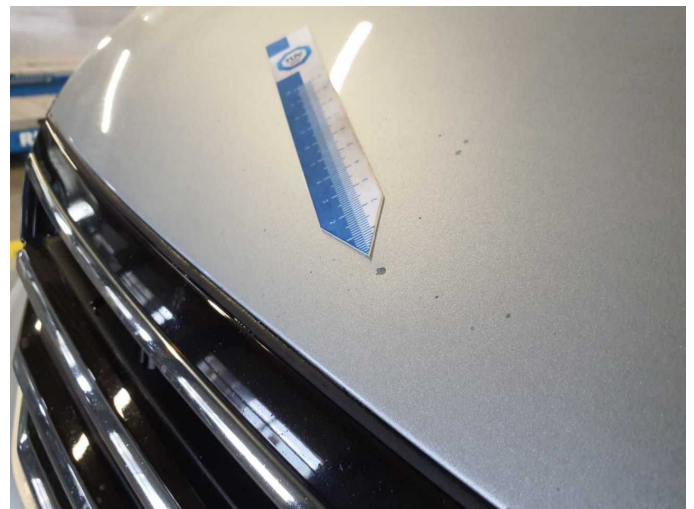
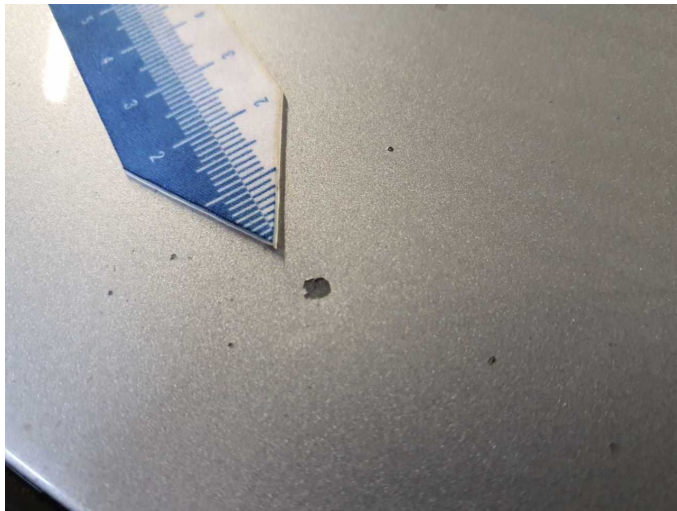
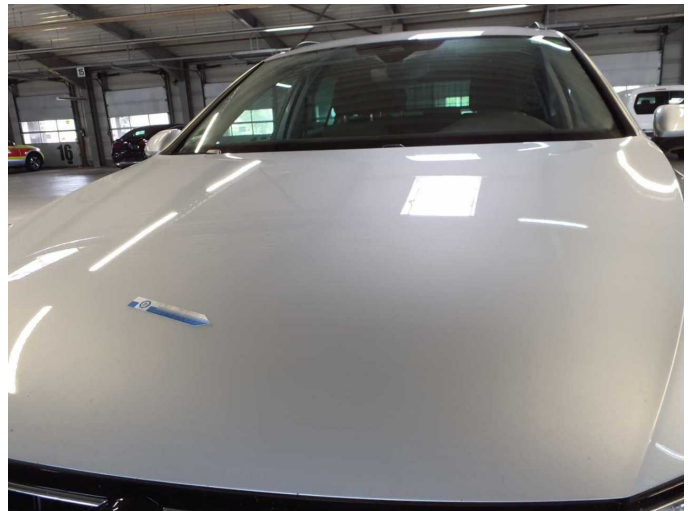
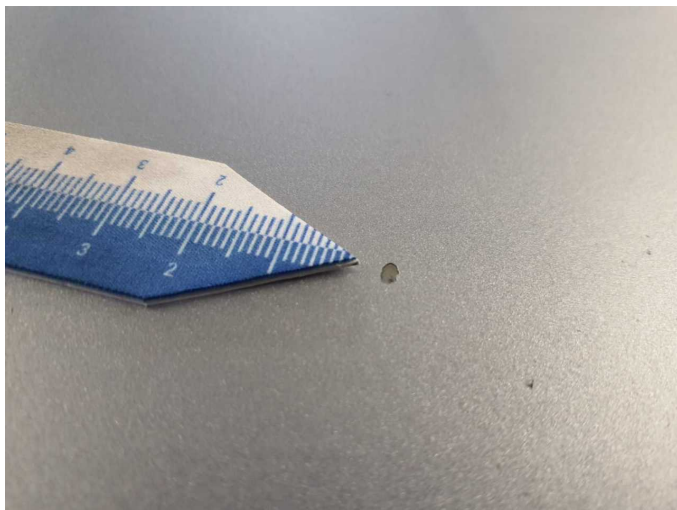
| No. | Component group | Description |
|---|---|---|
| 7 | Bonnet | Bonnet - Dent / paintcoat damage - Repair and paint |

**Damage 7:** Bonnet: Bonnet - Dent / paintcoat damage - Repair and paint

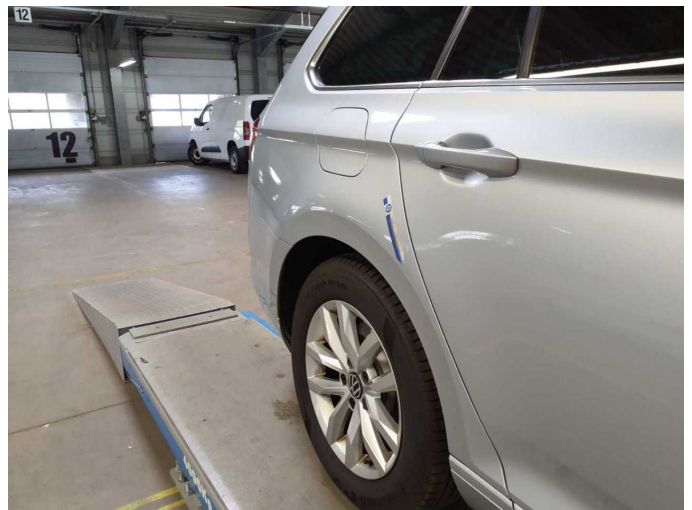
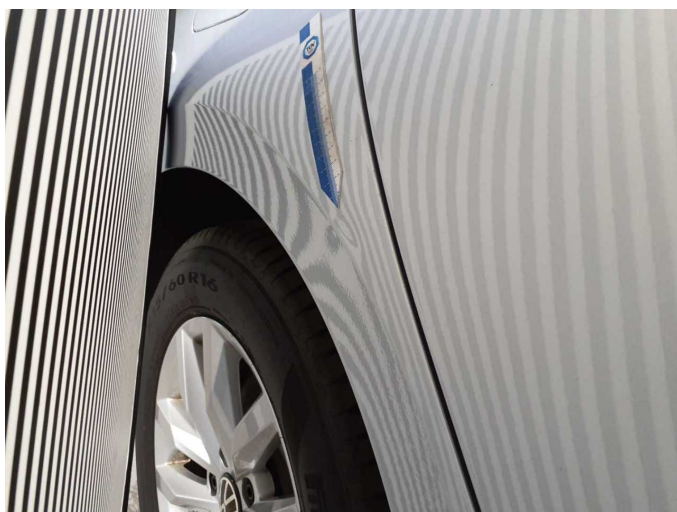
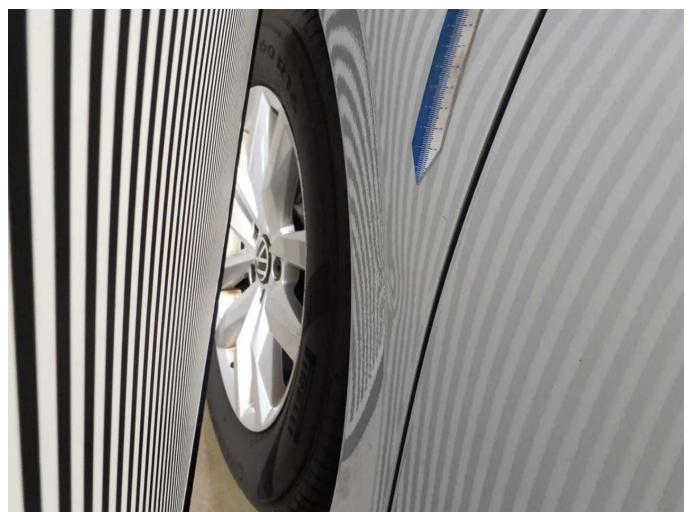
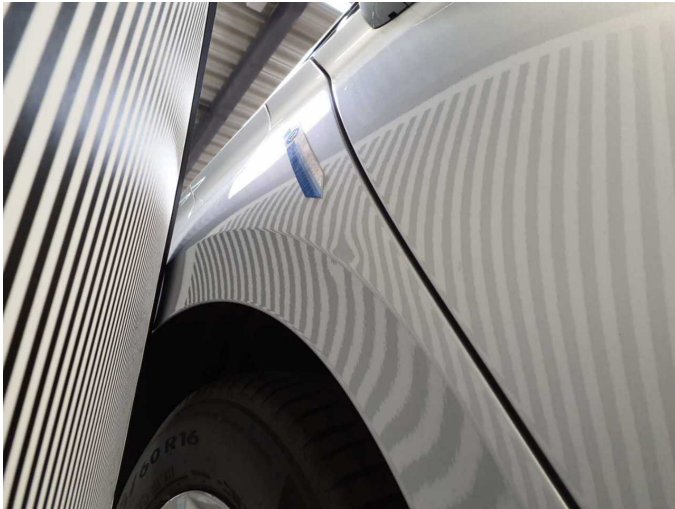
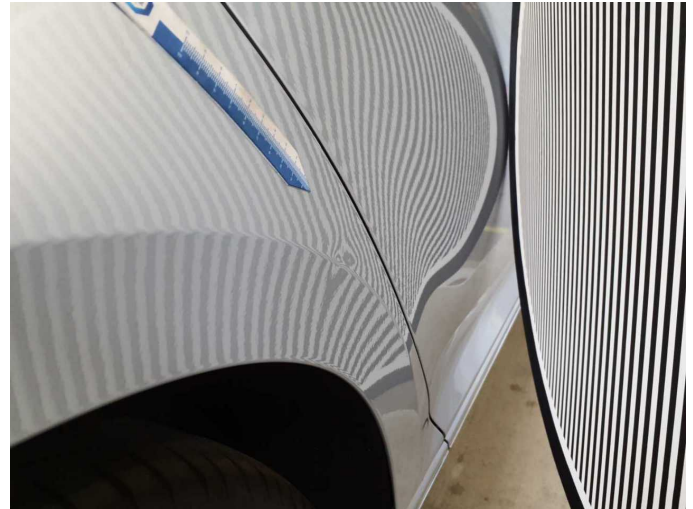
| No. | Component group | Description |
|---|---|---|
| 8 | Side panel - rear right side | Side panel - Deformed - Repair and paint |

**Damage 8:** Side panel - rear right side: Side panel - Deformed - Repair and paint

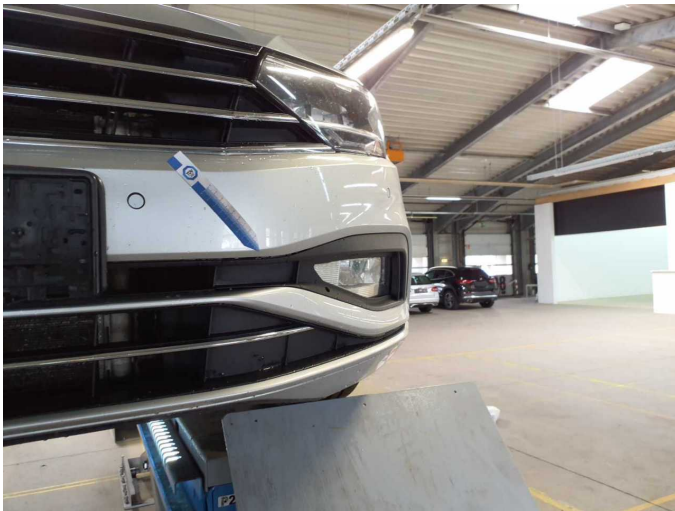
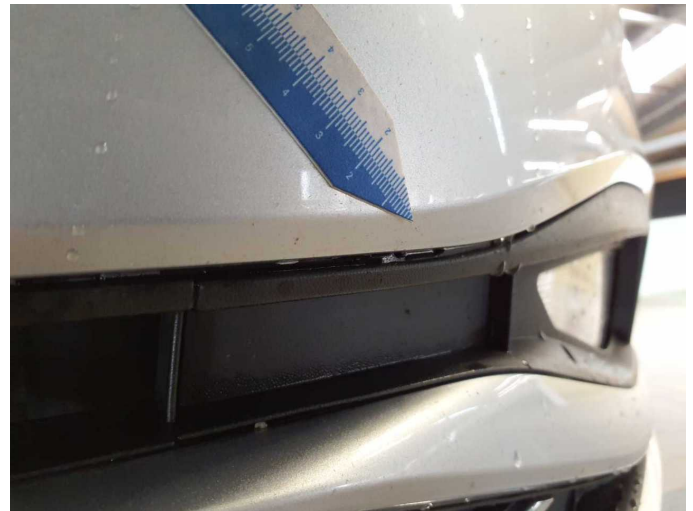
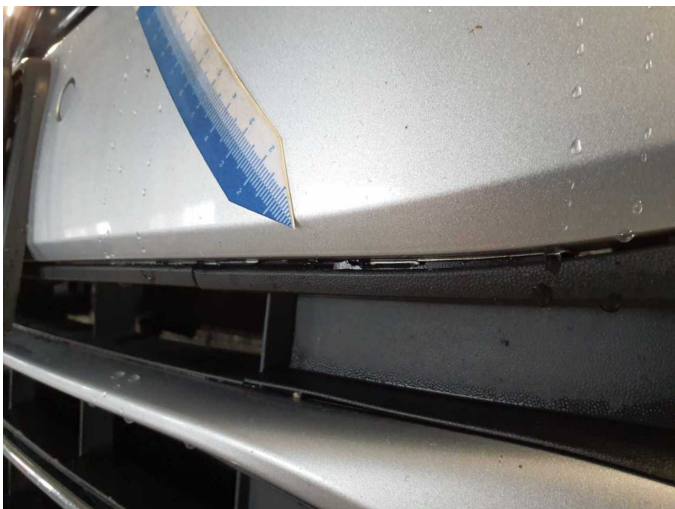
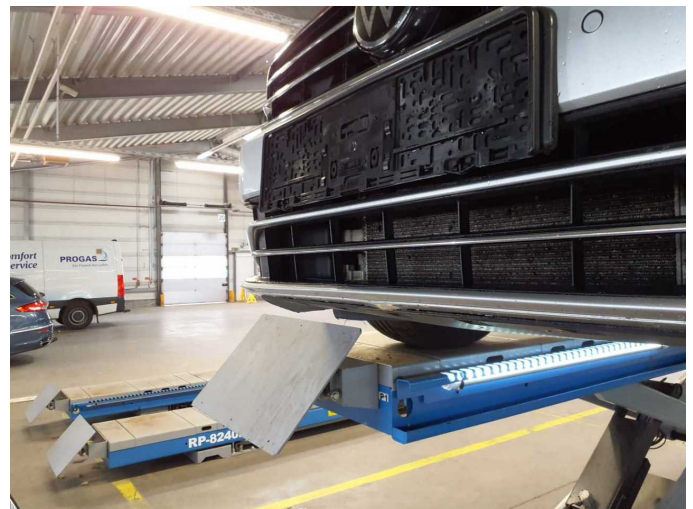
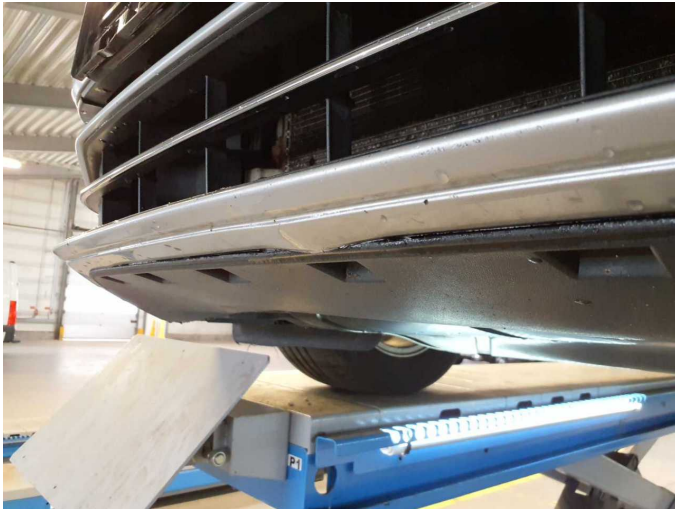
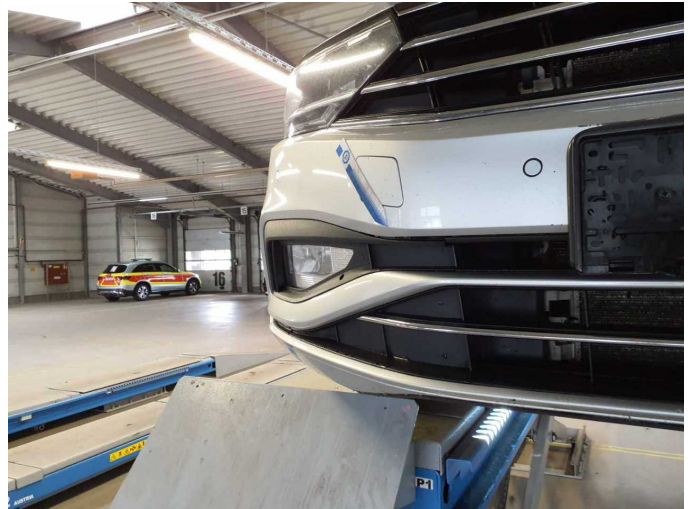
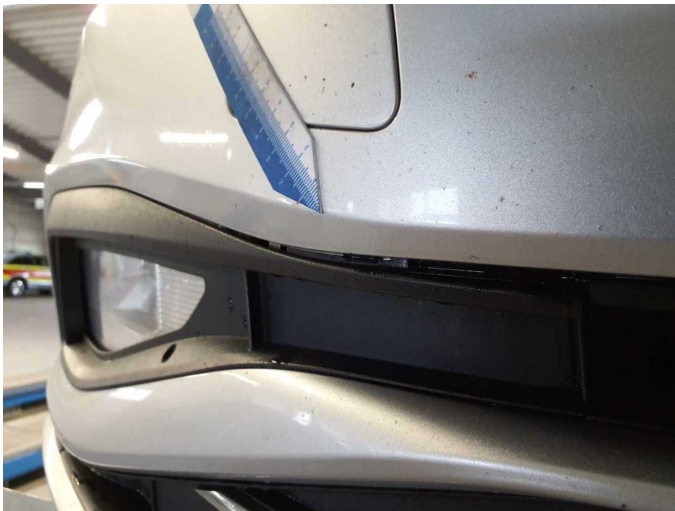
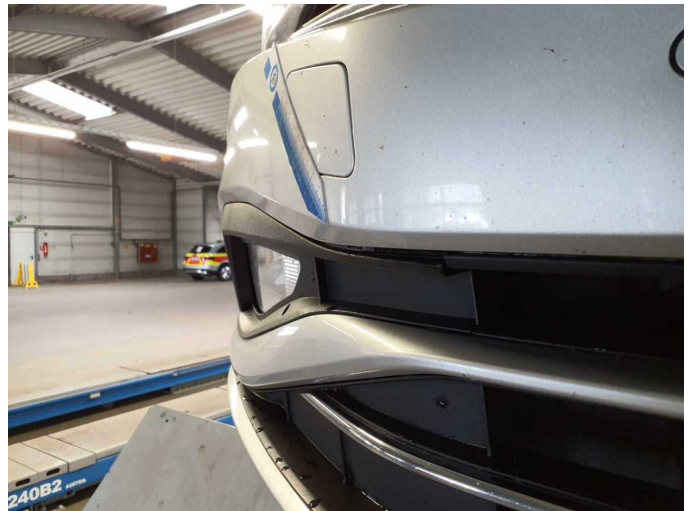
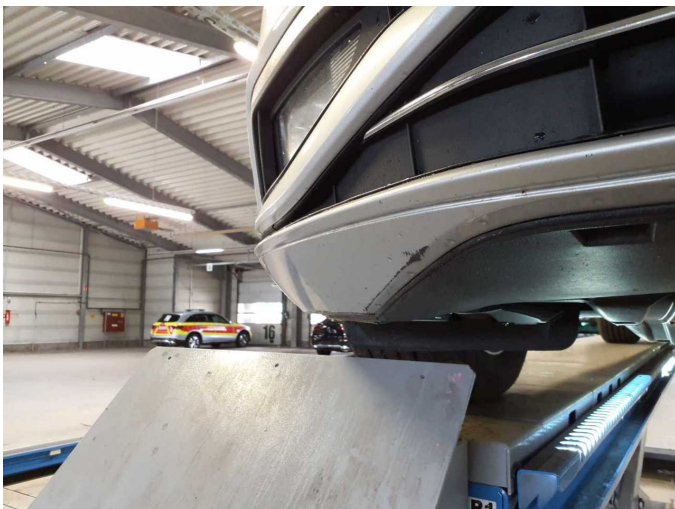
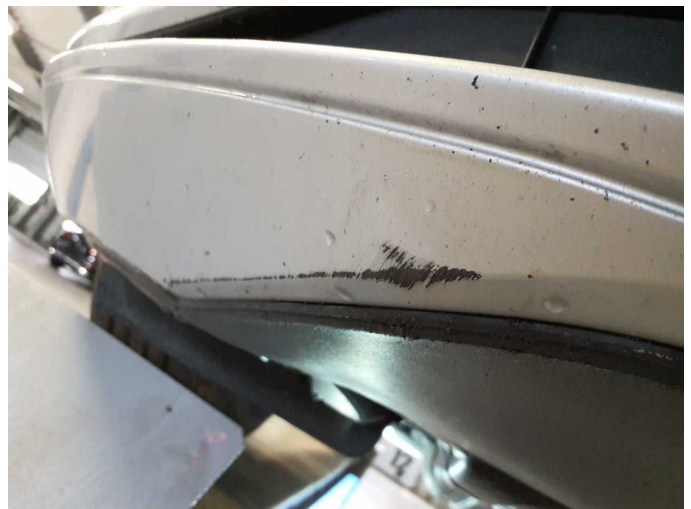
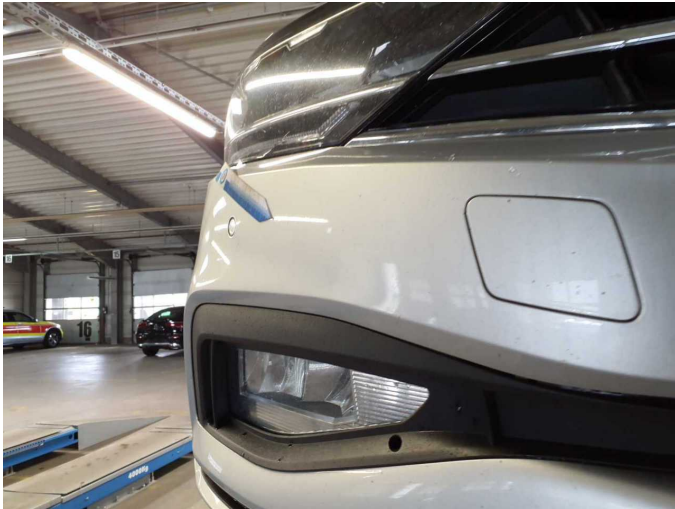
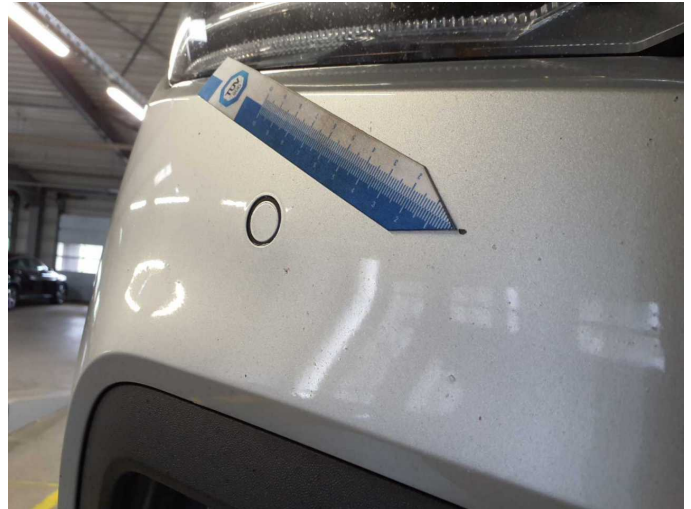
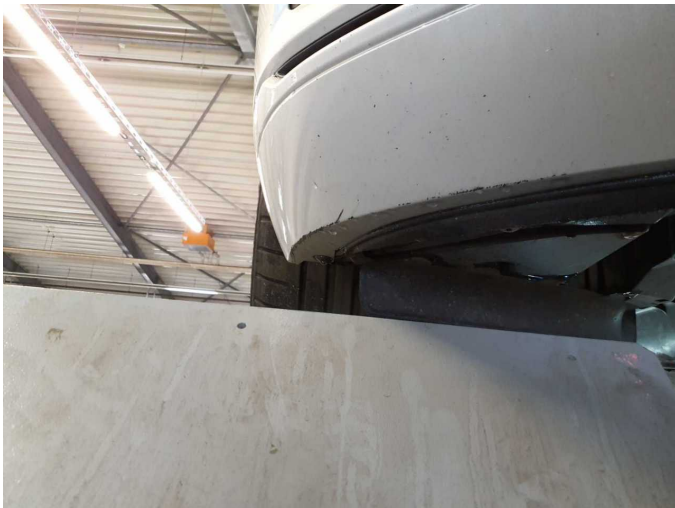
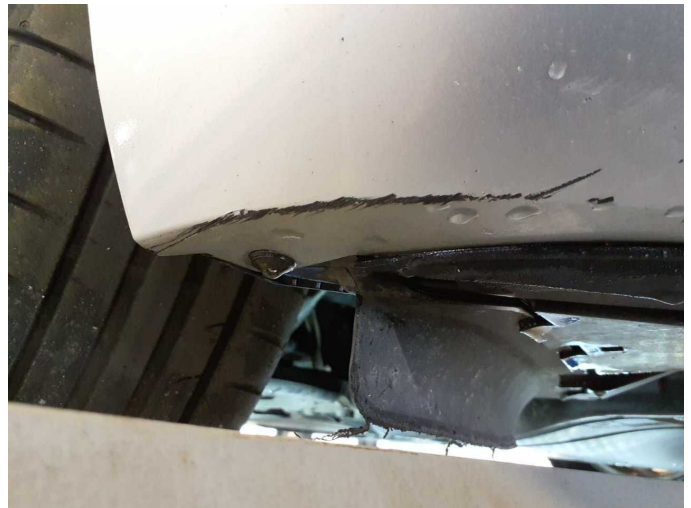
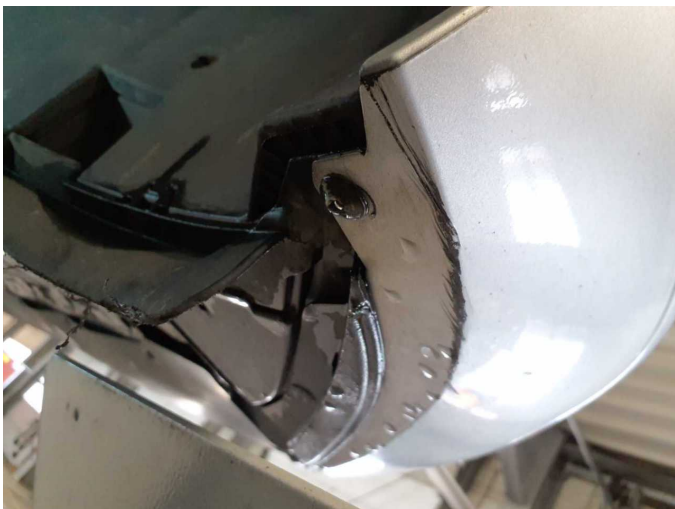
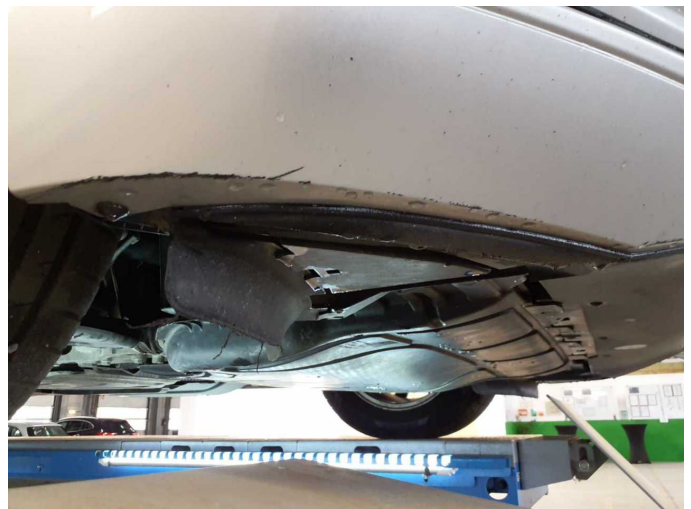
| No. | Component group | Description |
|---|---|---|
| 9 | Front bumper | Front bumper (inkl. prüfen Lichtabdeckung) - Scratched - Repair and paint |

**Damage 9:** Front bumper: Front bumper (inkl. prüfen Lichtabdeckung) - Scratched - Repair and paint

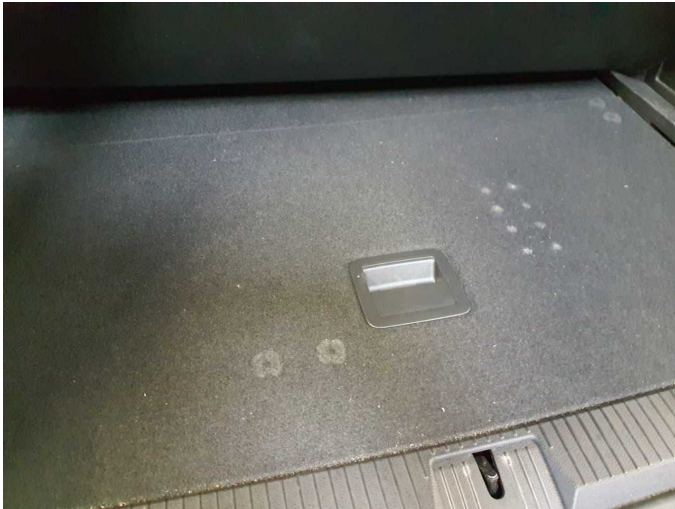
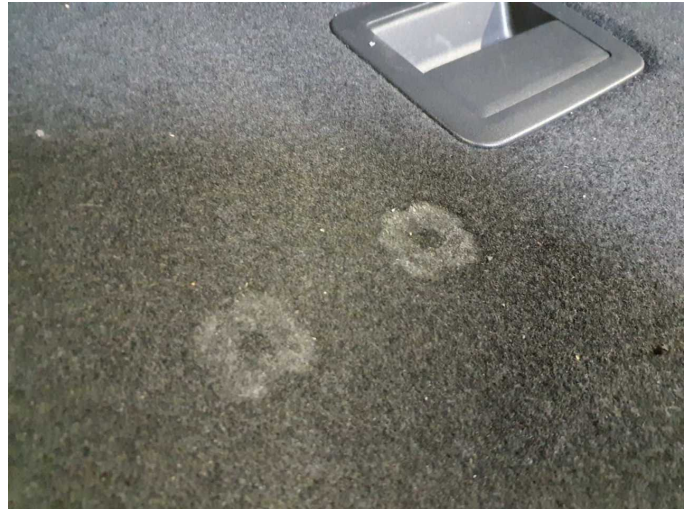
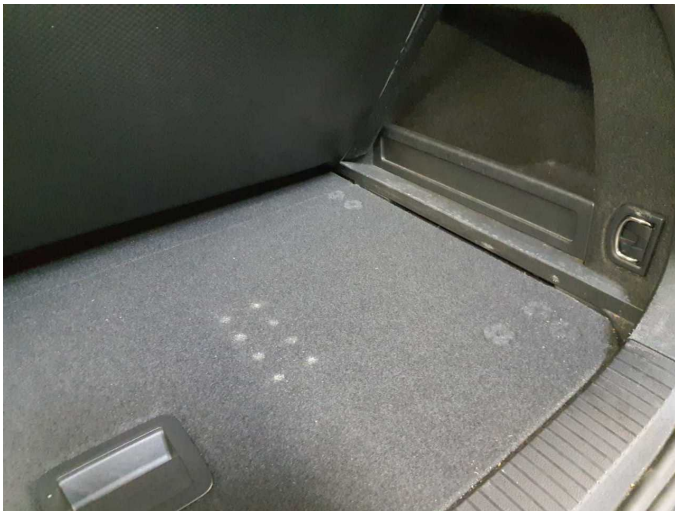
| No. | Component group | Description |
|---|---|---|
| 1 | Interior | Cargo area floor - Holes - No deduction |

**Wear and tear 1:** Interior: Cargo area floor - Holes - No deduction

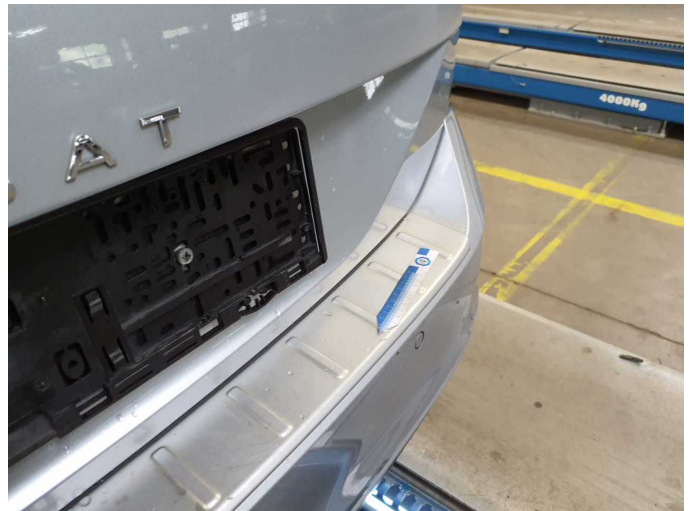
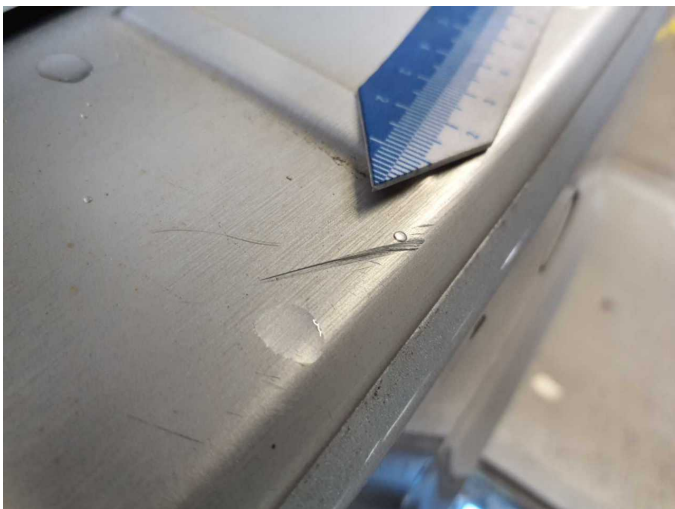
| No. | Component group | Description |
|---|---|---|
| 6 | Trim / covers | Boot sill cover - Scratched - No deduction |

**Wear and tear 6:** Trim / covers: Boot sill cover - Scratched - No deduction
