Expertise

Protocol number: 40805553
Order No. / Reference: 25040593
Inspection date: 30 Jul 2025

Manufacturer: Volkswagen

Model: Passat Variant 2.0 TDI SCR DSG Business

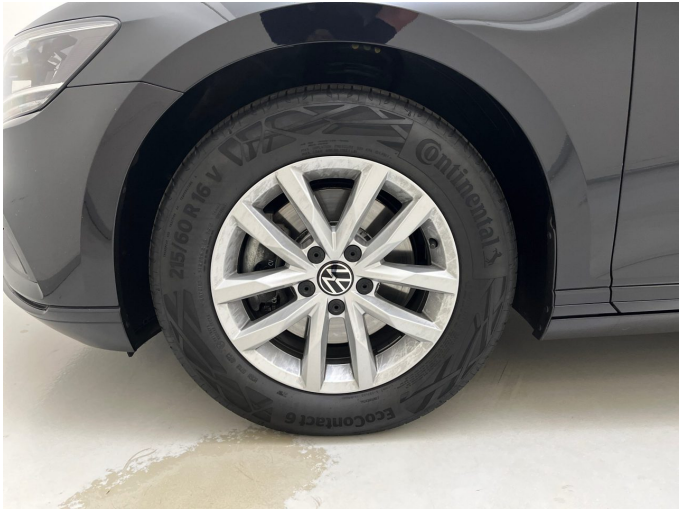
Figure 12: Mounted tyres

#	Tyre size	Type of tyre	Manufacturer	Tread depth
1)	215/60 R16 95V	Summer tyres on Light alloy	Continental	5mm / 4mm
2)	215/60 R16 95V	Summer tyres on Light alloy	Dunlop	4mm / 4mm

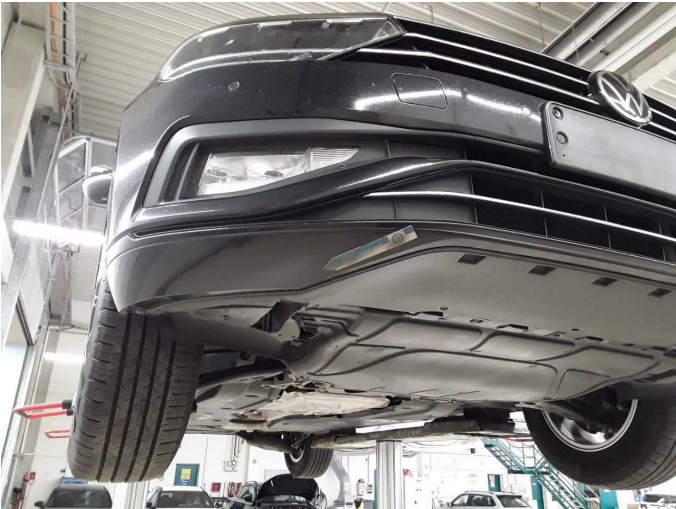
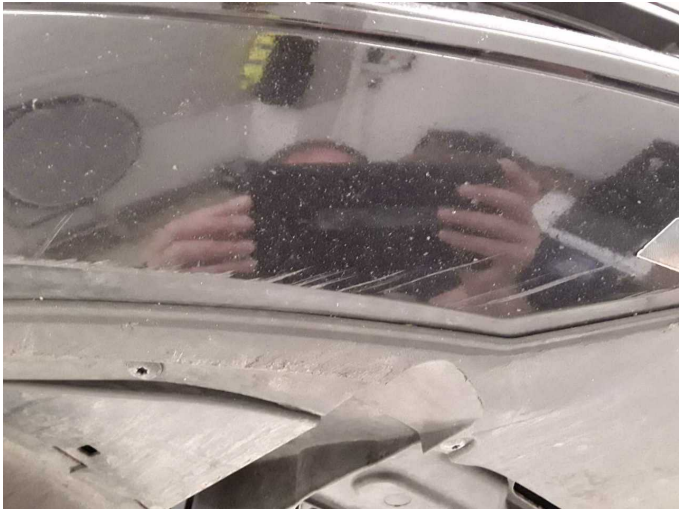
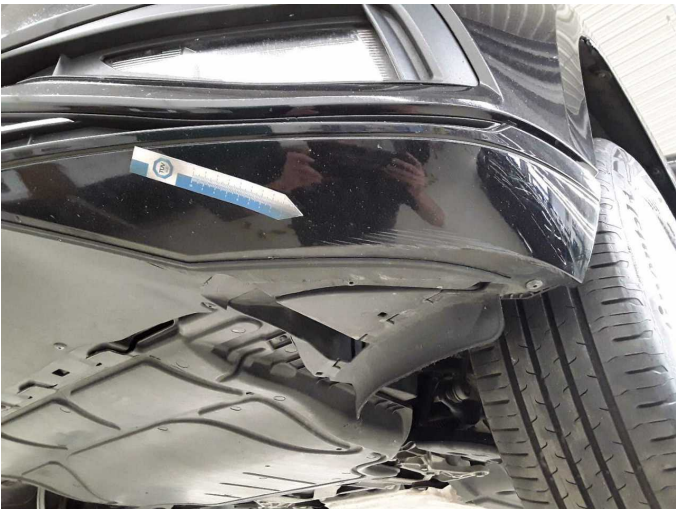
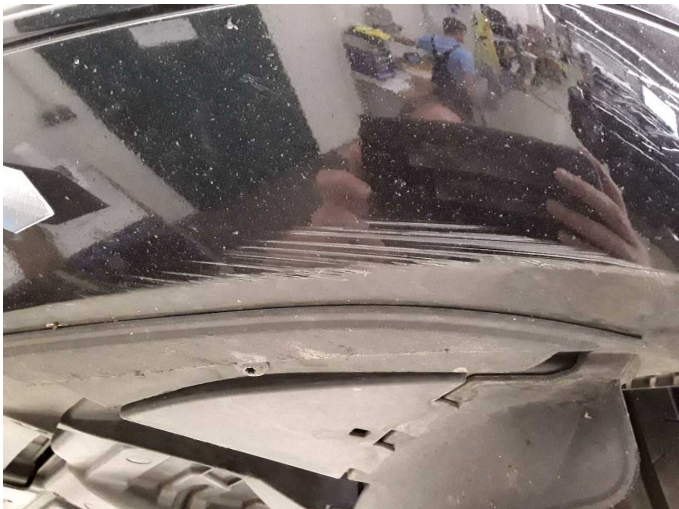
No.	Component group	Description
1	Front bumper	Bumper with Parktronic - Scratch(es) - Smart repair

Damage 1: Front bumper: Bumper with Parktronic - Scratch(es) - Smart repair

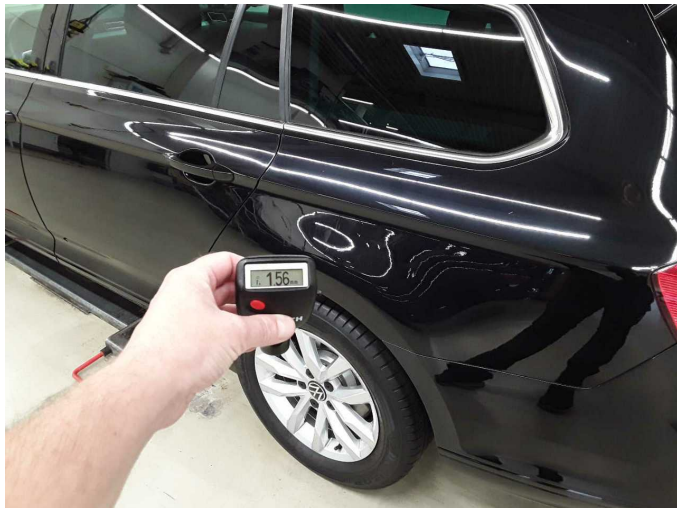
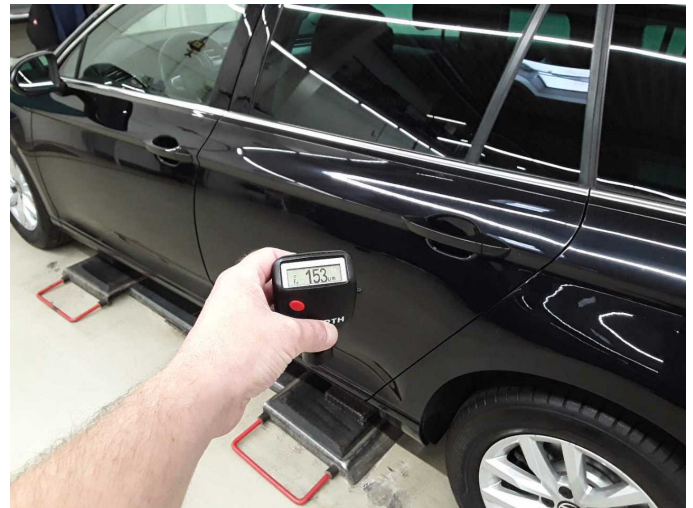
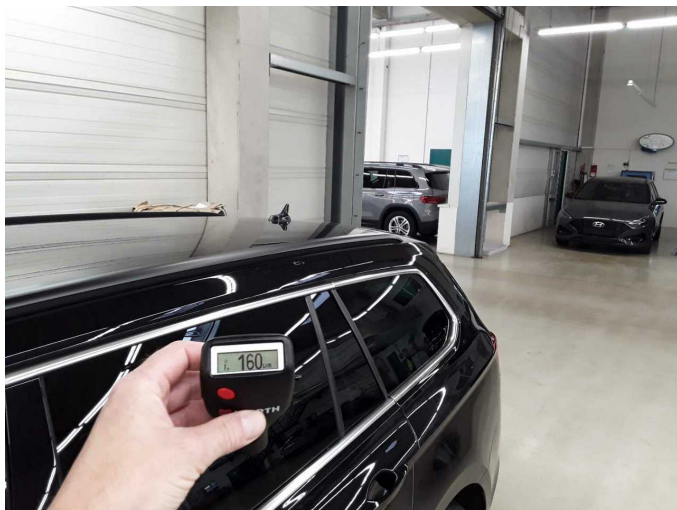
1 Roof rail - left side, Side panel - rear left side, Door - rear left side, Professionally carried out

Repainting 1: Roof rail - left side, Side panel - rear left side, Door - rear left side

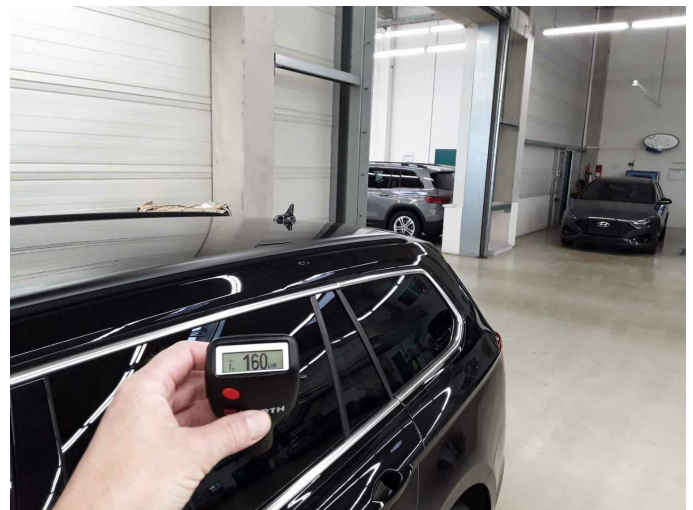
Roof rail - left side: 160 μm

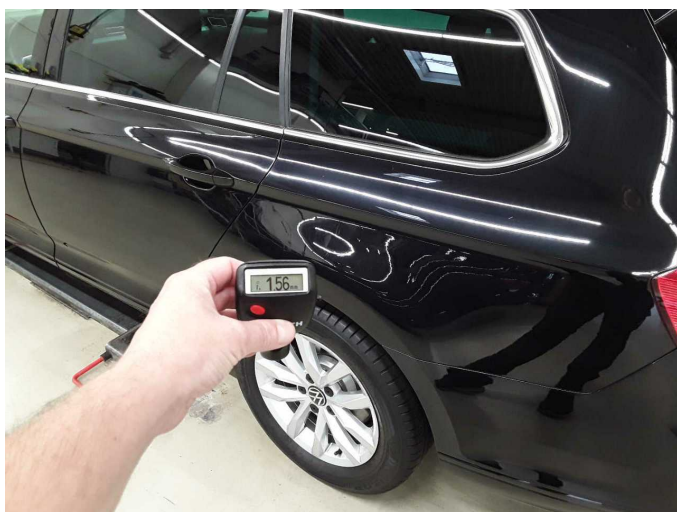
Side panel - rear left side: 1,560 μm

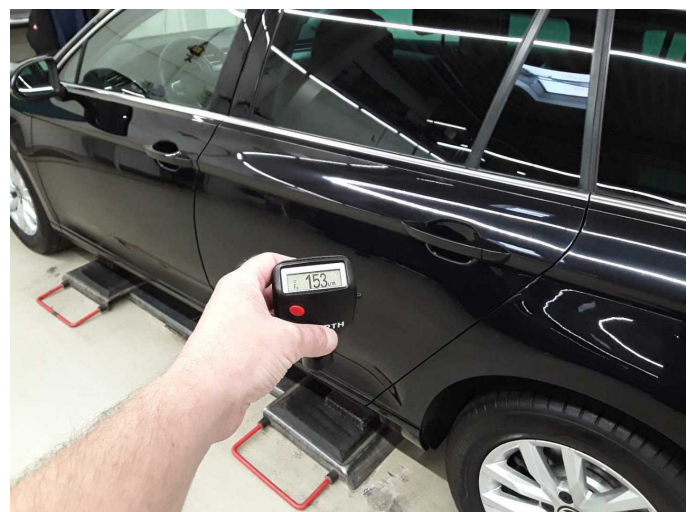
Door - rear left side: 153 μm
