Expertise

Protocol number: 41218959
Order No. / Reference: 25112026
Inspection date: 25 Aug 2025

Manufacturer: Volkswagen

Model: Passat Variant 2.0 TDI SCR DSG Business

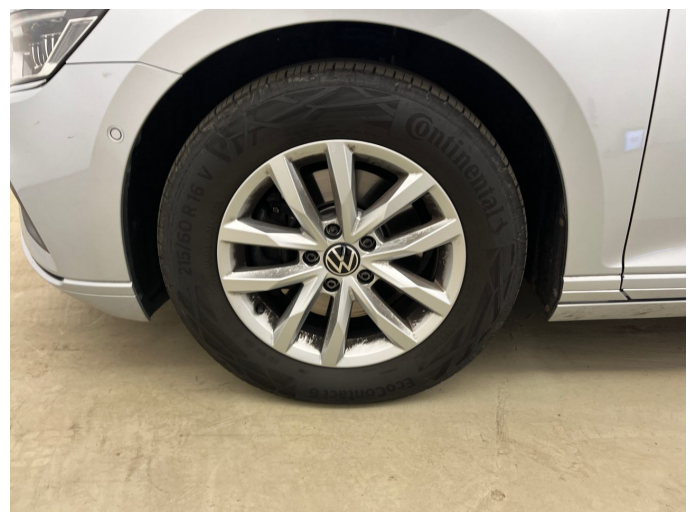
Figure 12: Mounted tyres

| # | Tyre size | Type of tyre | Manufacturer | Tread depth |
|---|---|---|---|---|
| 1) | 215/60 R16 95V | Summer tyres on Light alloy | Continental | 3mm / 3mm |

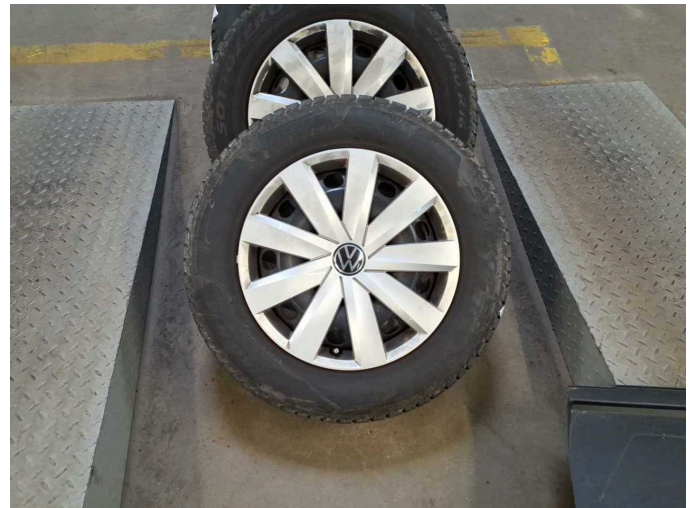
Figure 16: Additional tyres

| # | Tyre size | Type of tyre | Manufacturer | Tread depth |
|---|---|--|---|---|
| 1) | 215/60 R16 95H | Winter tyres on Steel rim with wheel cover | Pirelli | 2mm / 2mm |

| No. | Component group | Description |
|---|---|--|
| 5 | 2nd wheel set | 2 tyres - Does not meet the leasing specifications - Replace |

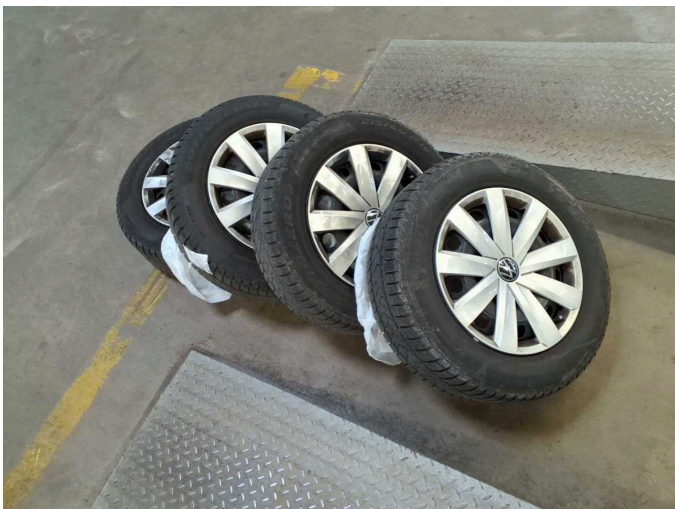
Figure 17: Additional tyres

| # | Tyre size | Type of tyre | Manufacturer | Tread depth |
|---|---|--|---|---|
| 2) | 215/60 R16 95H | Winter tyres on Steel rim with wheel cover | Pirelli | 5mm / 5mm |

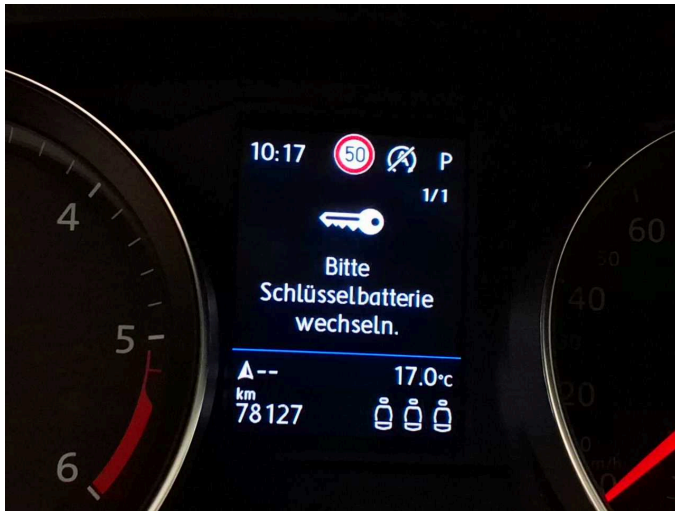
Damage 2: Equipment: Vehicle key (Batterie) - Empty - Replace

| No. | Component group | Description |
|---|---|--|
| 2 | Equipment | Vehicle key (Batterie) - Empty - Replace |

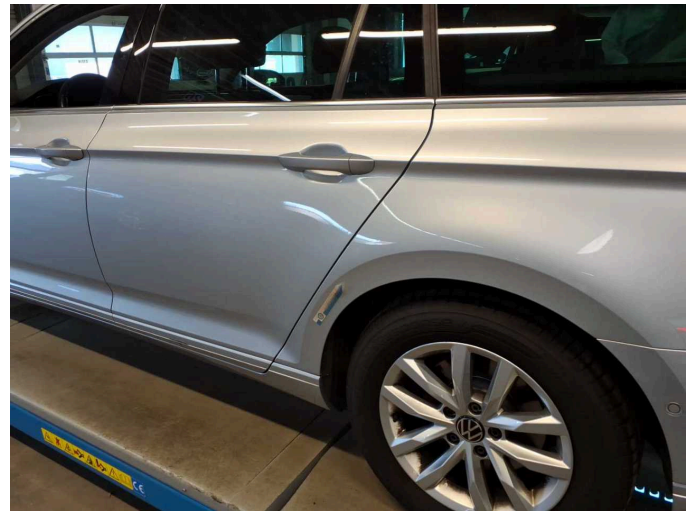
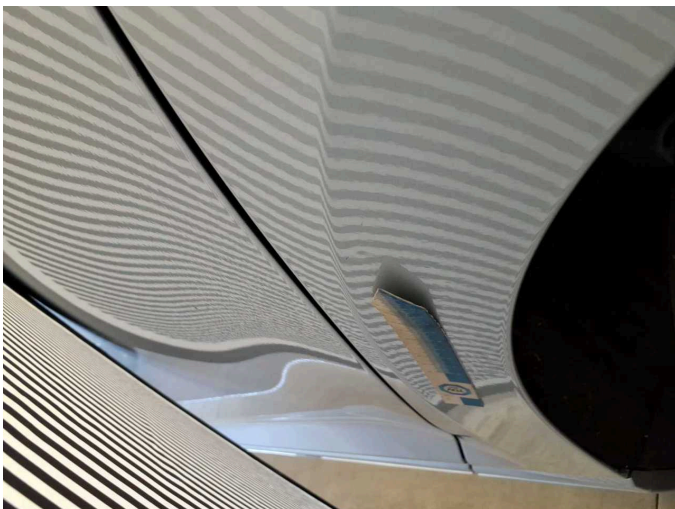
Damage 3: Side panel - rear left side: Side panel - dent(s) - Smooth repair work

| No. | Component group | Description |
|---|---|--|
| 3 | Side panel - rear left side | Side panel - dent(s) - Smooth repair work |

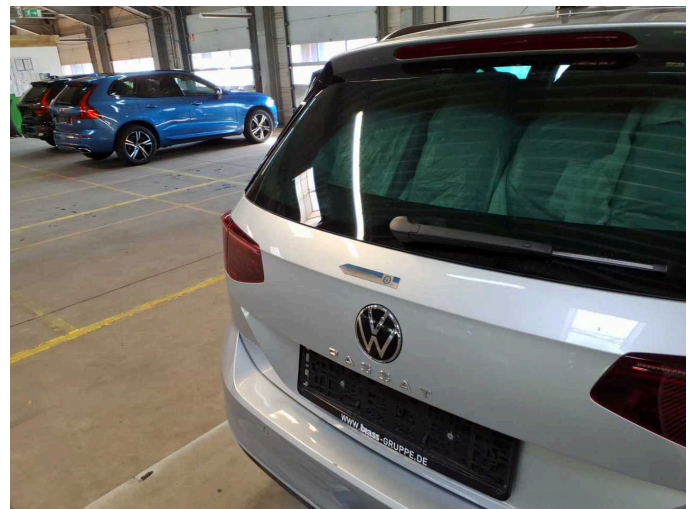
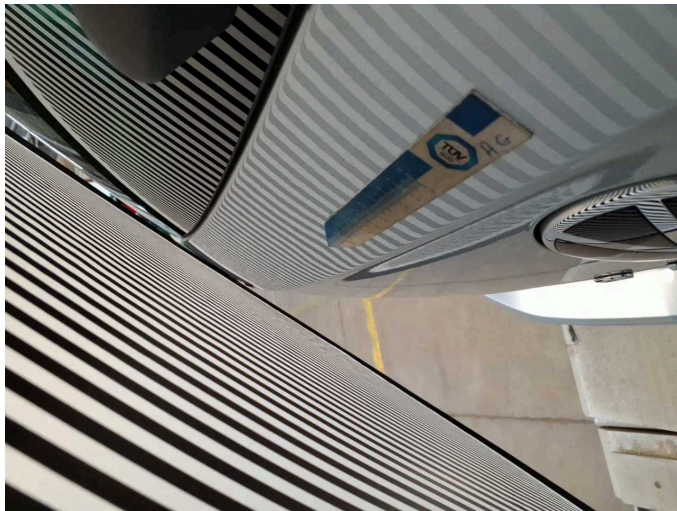
Damage 4: Boot lid / rear door: Boot lid - dent(s) - Smooth repair work

| No. | Component group | Description |
|---|---|--|
| 4 | Boot lid / rear door | Boot lid - dent(s) - Smooth repair work |

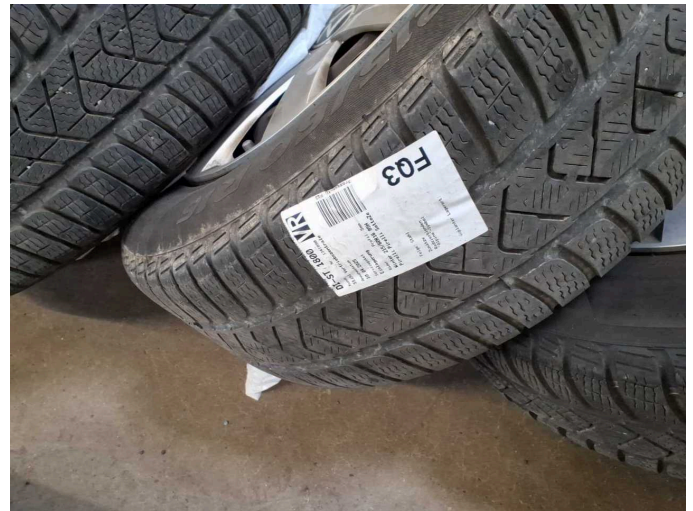
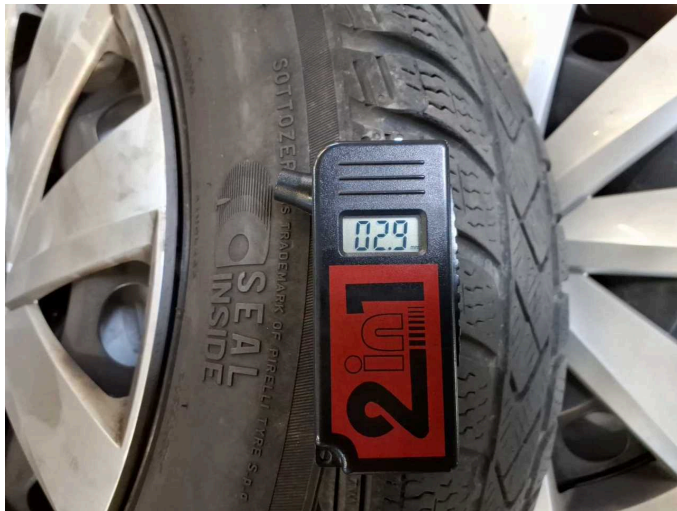
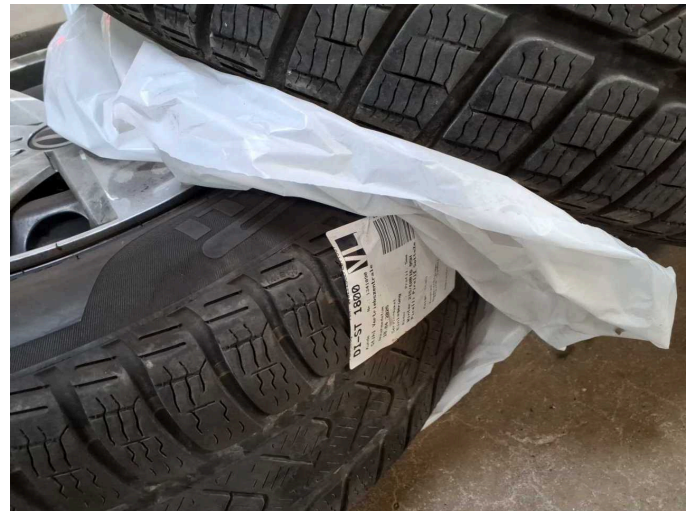
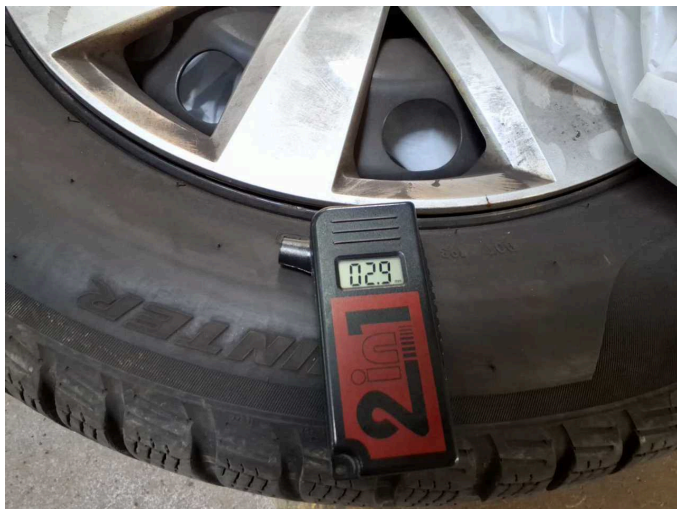
Damage 5: 2nd wheel set: 2 tyres - Does not meet the leasing specifications - Replace

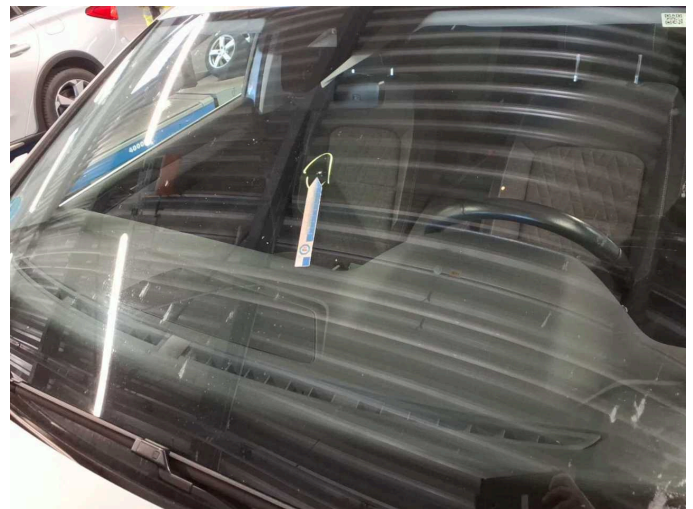
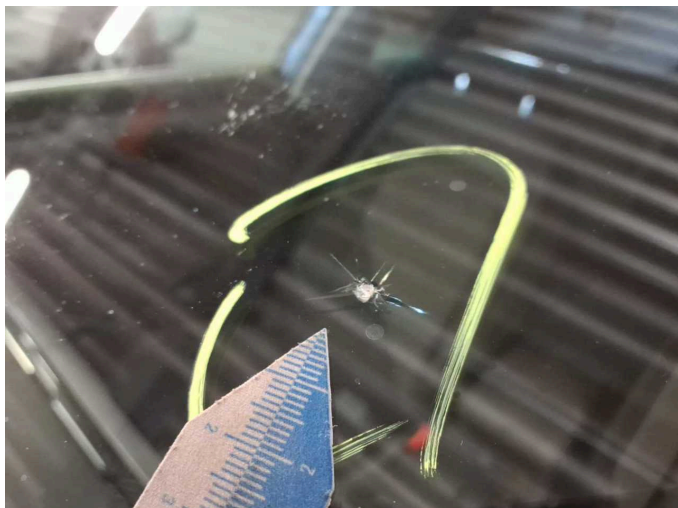
Damage 6: Vehicle glazing: Windscreen (Rissbildung) - Stone chips - Replace

| No. | Component group | Description |
|---|---|--|
| 6 | Vehicle glazing | Windscreen (Rissbildung) - Stone chips - Replace |
