# VOLKSWAGEN Polo V

## Polo 1.4

### Inspection Report Summary

| Customer | BCA Online | Report Number | P20250902072926 |

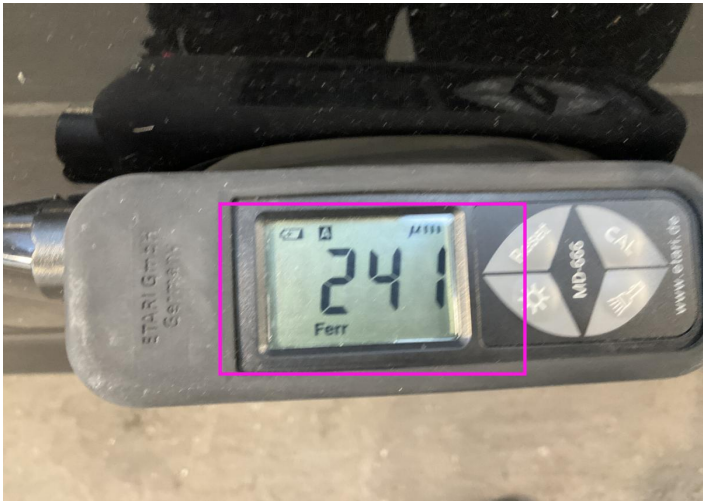
| Component | | Damage | Comments |
|---|---|---|---|
| 1 | Fender / Back Right | Paint / Poor Previous Repair | |

1. Fender / Back Right  
Paint / Poor Previous Repair -

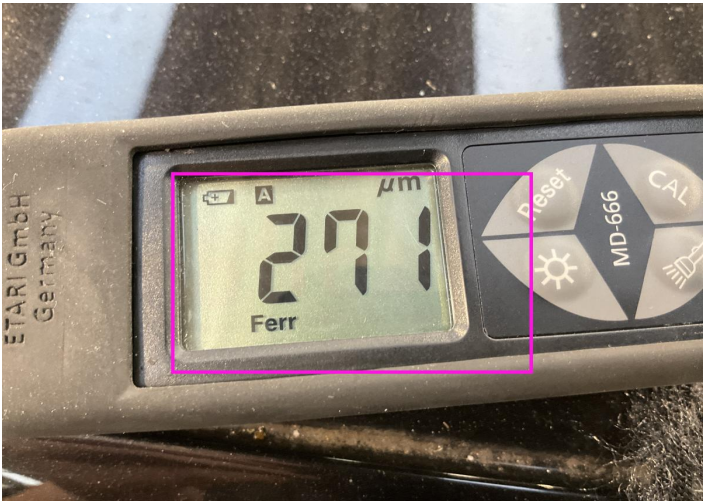
| Component | | Damage | Comments |
|---|---|---|---|
| 2 | Door / Front Right | Paint / Poor Previous Repair | |

2. Door / Front Right  
Paint / Poor Previous Repair -

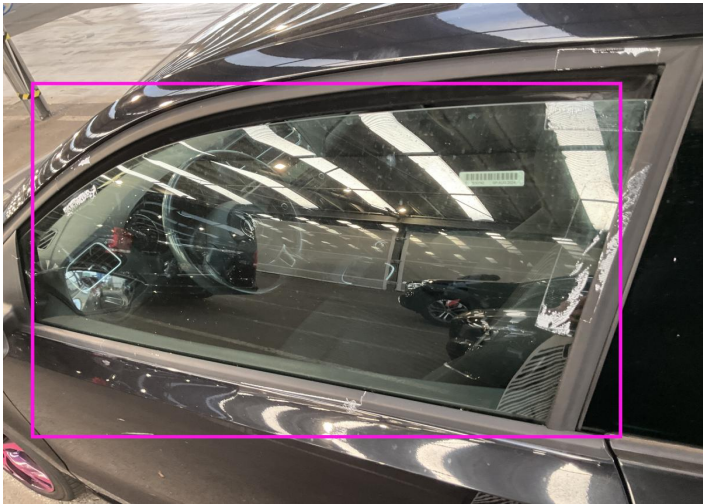
| Component | | Damage | Comments |
|---|---|---|---|
| 3 | Side Window / Front Left | Bodywork / Breakage | |

3. Side Window / Front Left  
Bodywork / Breakage -

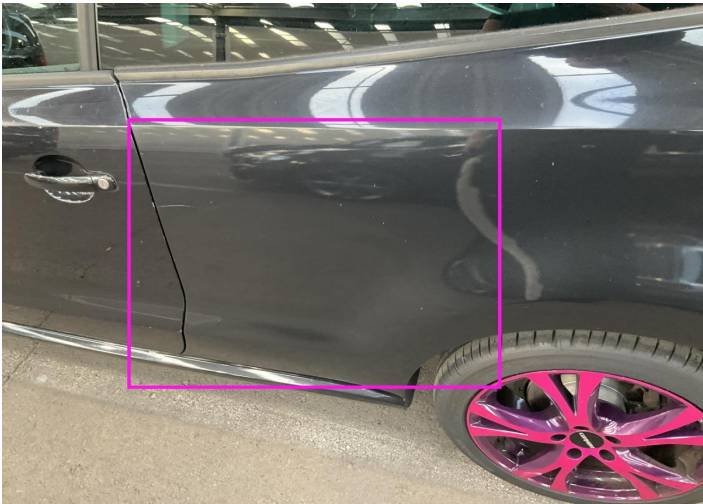
| Component | | Damage | Comments |
|---|---|---|---|
| 4 | Fender / Back Left | Paint / Scratch / Scuff | |

4. Fender / Back Left  
Paint / Scratch / Scuff -

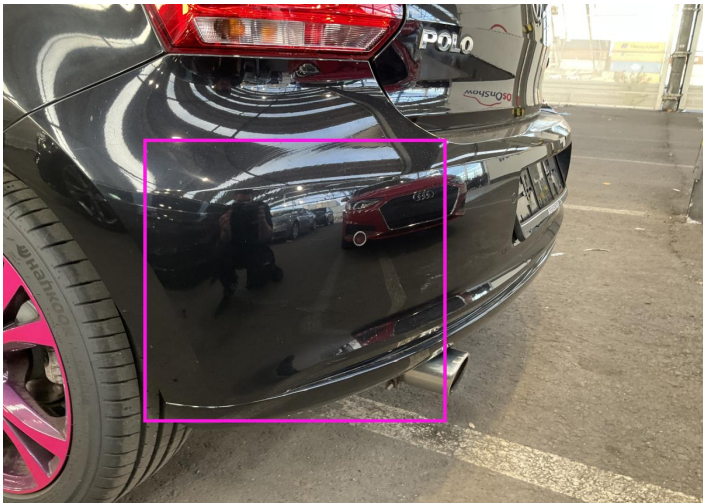
| Component | | Damage | Comments |
|---|---|---|---|
| 5 | Bumper / Back | Bodywork / Breakage | |

5. Bumper / Back  
Bodywork / Breakage -

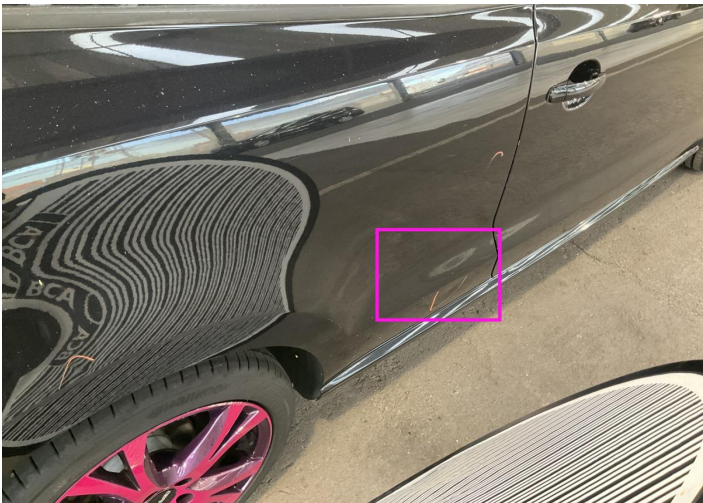
| Component | | Damage | Comments |
|---|---|---|---|
| 6 | Fender / Back Right | Bodywork / Dent / Dent | |

6. Fender / Back Right  
Bodywork / Dent / Dent -

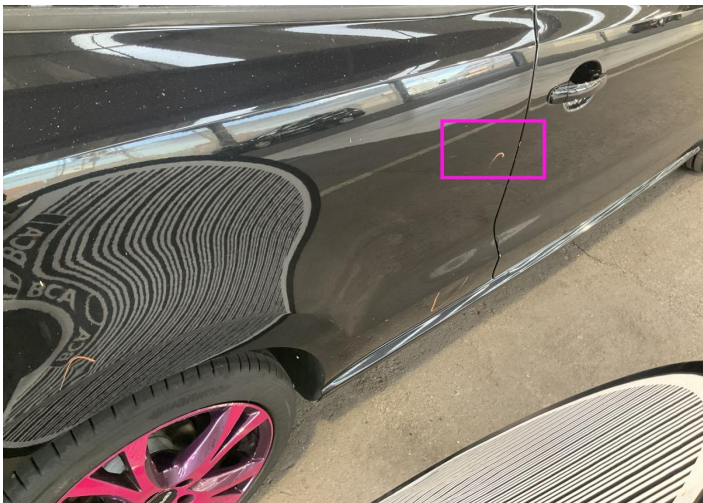
| Component | | Damage | Comments |
|---|---|---|---|
| 7 | Fender / Back Right | Bodywork / Dent / Dent | |

7. Fender / Back Right  
Bodywork / Dent / Dent -

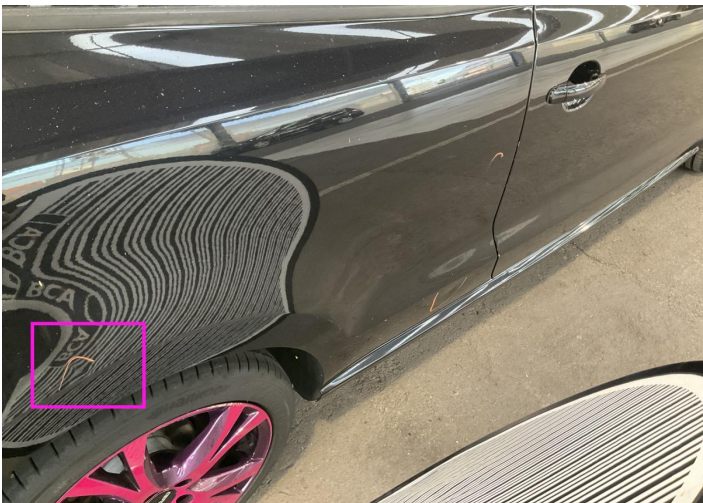
| Component | | Damage | Comments |
|---|---|---|---|
| 8 | Fender / Back Right | Bodywork / Dent / Dent | |

8. Fender / Back Right  
Bodywork / Dent / Dent -

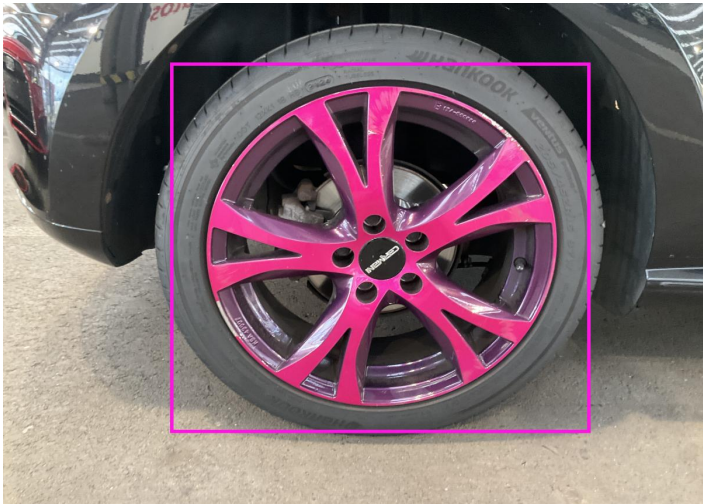
| Component | | Damage | Comments |
|---|---|---|---|
| 9 | Rim / Back Right | Out of Bodywork / Scratch | |

9. Rim / Back Right  
Out of Bodywork / Scratch -

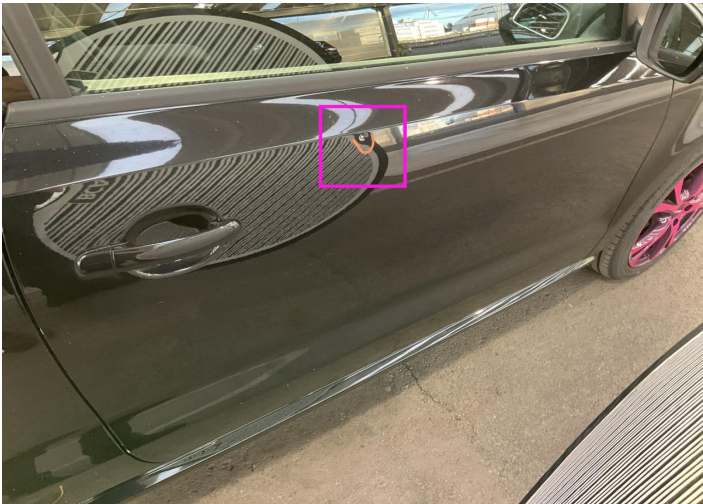
| Component | | Damage | Comments |
|---|---|---|---|
| 10 | Door / Front Right | Bodywork / Dent / Dent | |

10. Door / Front Right  
Bodywork / Dent / Dent -

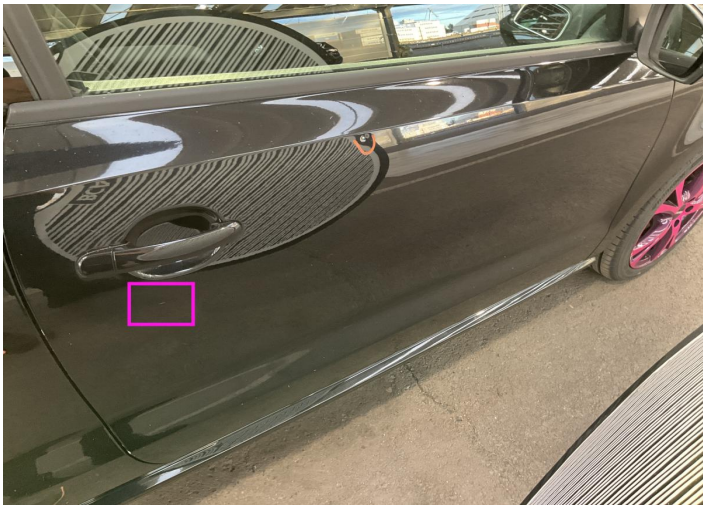
| Component | | Damage | Comments |
|---|---|---|---|
| 11 | Door / Front Right | Paint / Scratch / Scuff | |

11. Door / Front Right  
Paint / Scratch / Scuff -

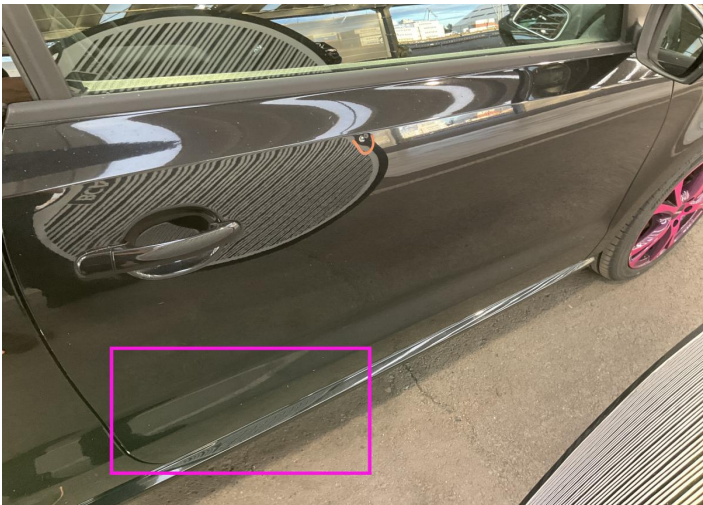
| Component | | Damage | Comments |
|---|---|---|---|
| 12 | Door / Front Right | Paint / Scratch / Scuff | |

12. Door / Front Right  
Paint / Scratch / Scuff -

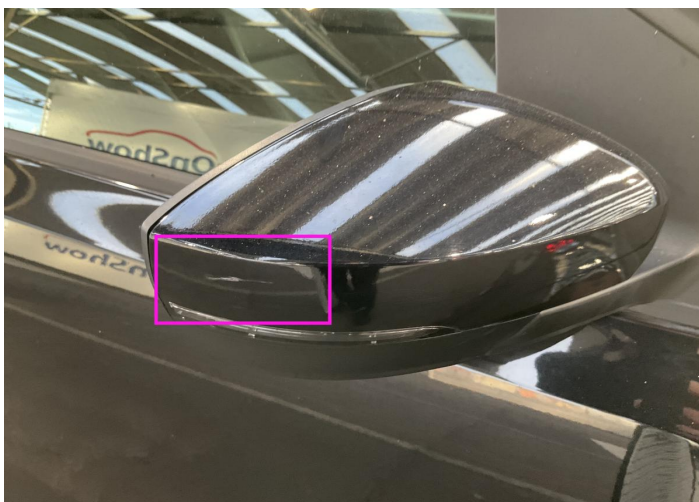
| 13 | Mirror Repeater / Right | Glass Break / Scratch / Scratch |

13. Mirror Repeater / Right  
Glass Break / Scratch / Scratch -

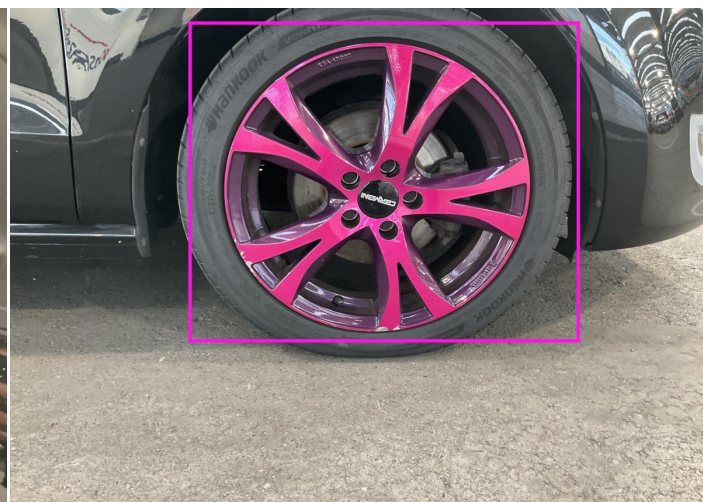
| 14 | Rim / Front Right | Out of Bodywork / Scratch |

14. Rim / Front Right  
Out of Bodywork / Scratch -

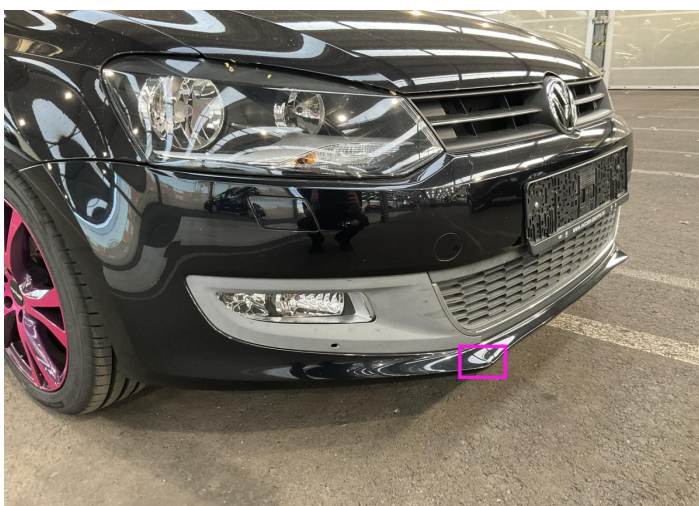
| 15 | Bumper / Front | Bodywork / Dent / Dent |

15. Bumper / Front  
Bodywork / Dent / Dent -

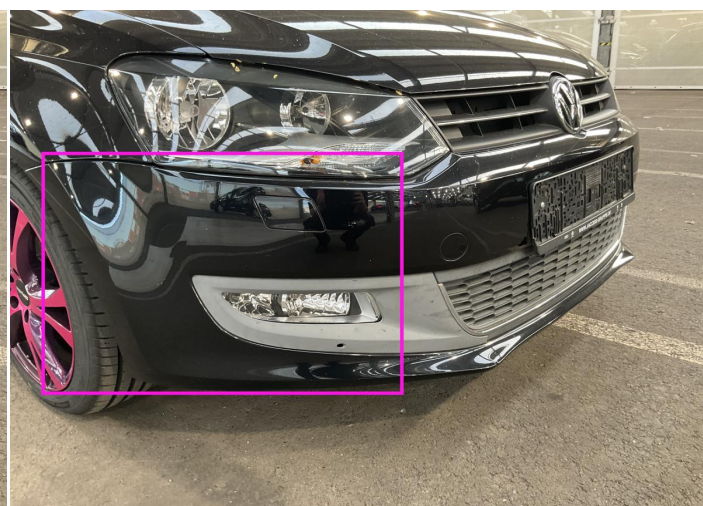
| 16 | Bumper / Front | Paint / Scratch / Scuff |

16. Bumper / Front  
Paint / Scratch / Scuff -

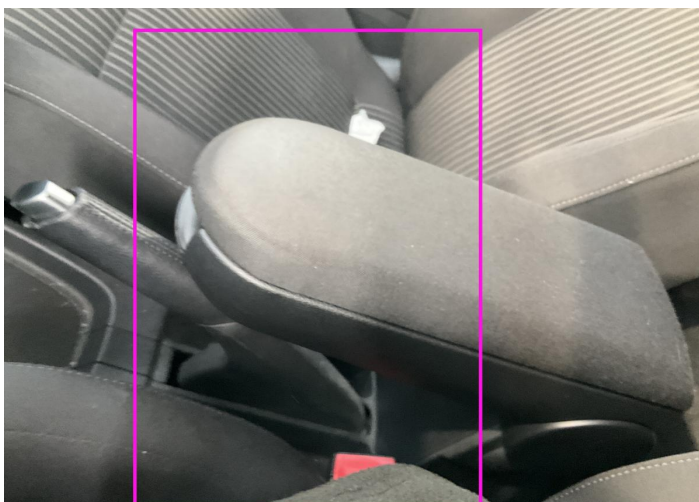
| 17 | Center Console | Interior / Broken |

17. Center Console  
Interior / Broken -
