Expertise

Protocol number: 40012509
Order No. / Reference: 24773595
Inspection date: 3 Jun 2025

Manufacturer: Volvo

Model: XC90 B5 D AWD Geartronic RDesign

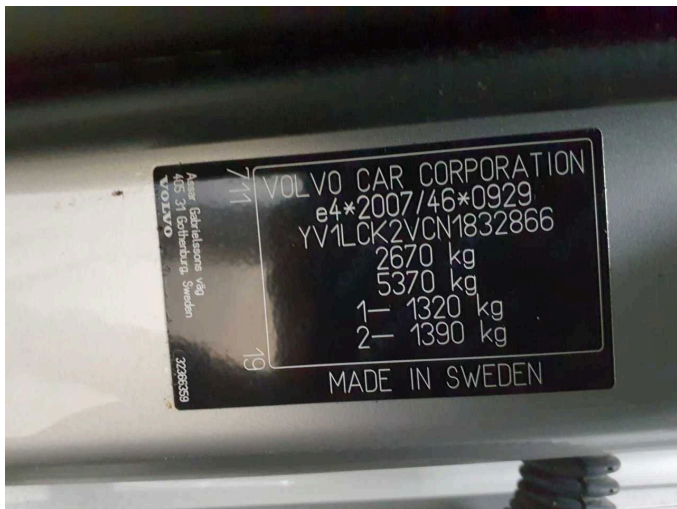
| VIN comparison | The vehicle identification number (VIN) was read and the undersigned verified that it matched the documents submitted during the inspection. |

Figure 11: VIN

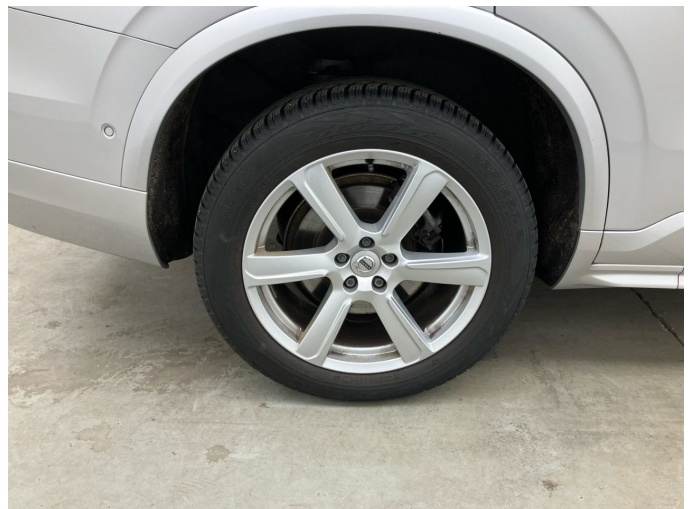
| # | Tyre size | Type of tyre | Manufacturer | Tread depth |
|---|---|---|---|---|
| 1) | 235/55 R19 105V | Winter tyres on Light alloy | Nokian | 6mm / 6mm |
| 2) | 235/55 R19 105V | Winter tyres on Light alloy | Nokian | 6mm / 6mm |

Figure 12: Mounted tyres

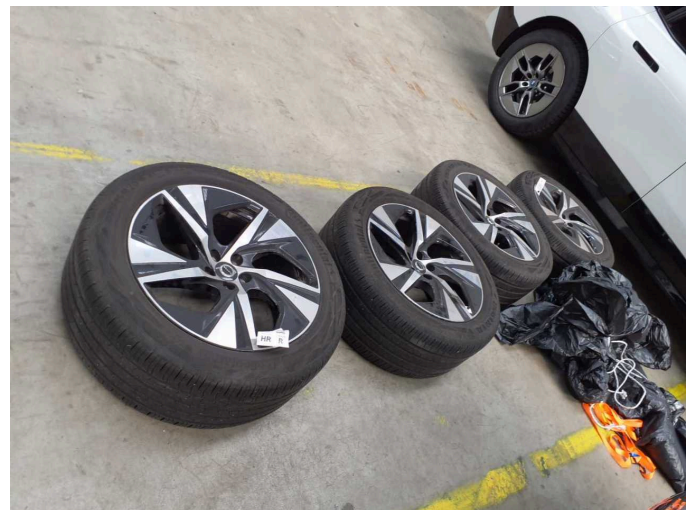
| # | Tyre size | Type of tyre | Manufacturer | Tread depth |
|---|---|---|---|---|
| 1) | 275/45 R20 110V | Summer tyres on Light alloy | Continental | 5mm / 5mm |
| 2) | 275/45 R20 110V | Summer tyres on Light alloy | Continental | 6mm / 6mm |

Figure 16: Additional tyres

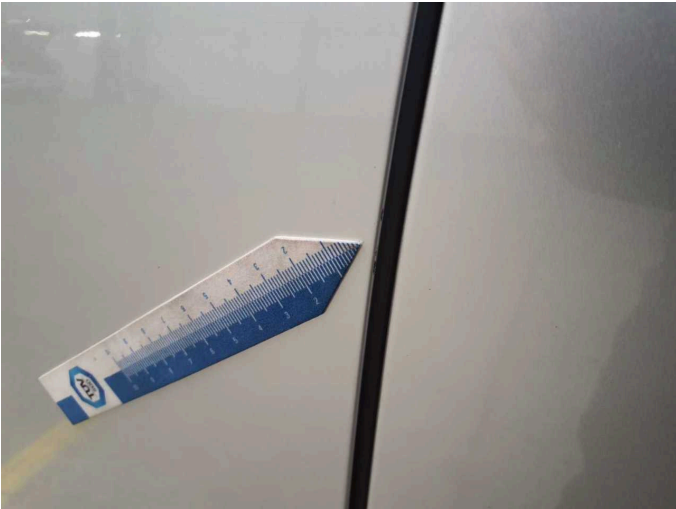
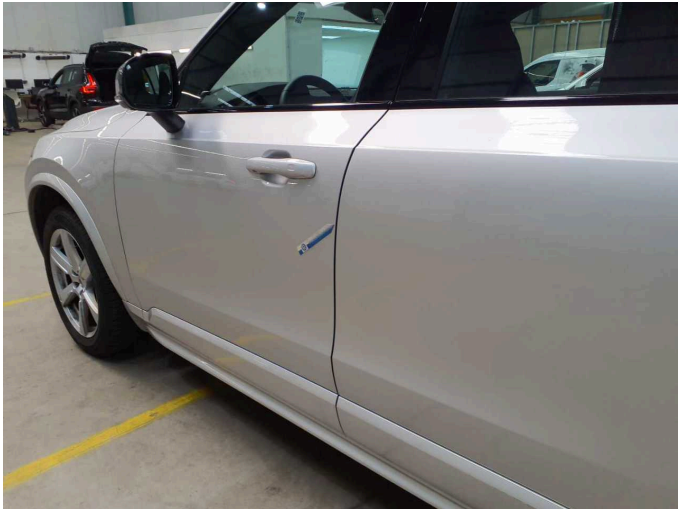
| No. | Component group | Description |
|---|---|---|
| 2 | Door - front left side | Door edge - Scratch(es) - Smart repair |

Damage 2: Door - front left side: Door edge - Scratch(es) - Smart repair

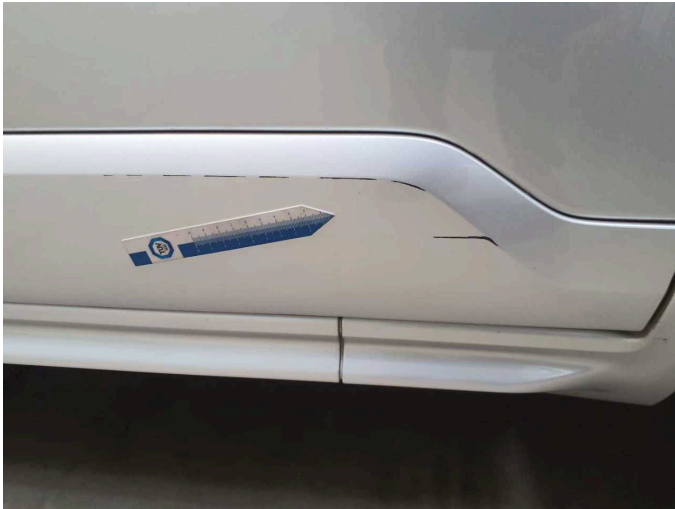
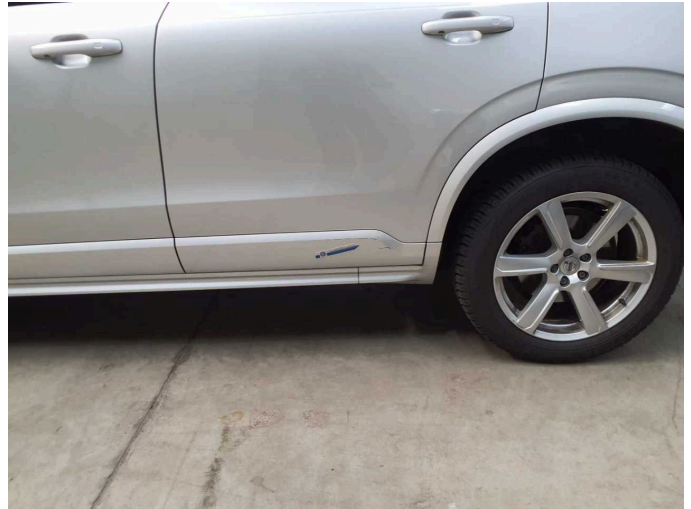
| No. | Component group | Description |
|---|---|---|
| 3 | Door - rear left side | Door (Zierleiste) - Scratch(es) - Smart repair |

Damage 3: Door - rear left side: Door (Zierleiste) - Scratch(es) - Smart repair

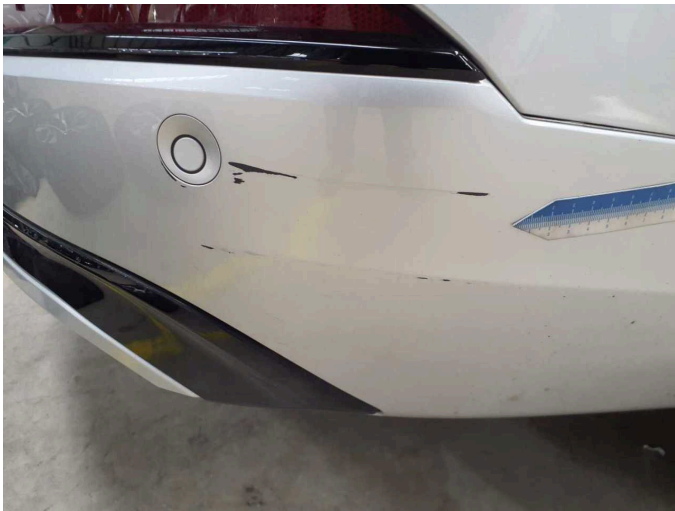
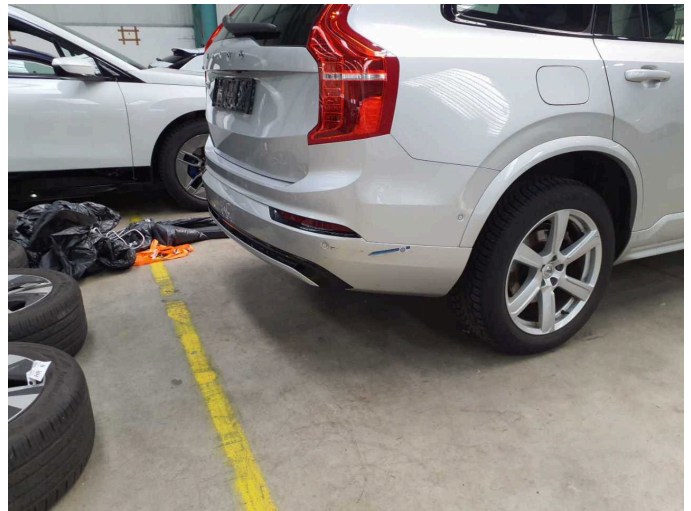
| No. | Component group | Description |
|---|---|---|
| 4 | Rear bumper | Rear bumper - Scratch(es) - Paint |

Damage 4: Rear bumper: Rear bumper - Scratch(es) - Paint
