Expertise

Protocol number: 41492148  
Order No. / Reference: 25171008  
Inspection date: 11 Sept 2025

Manufacturer: Volvo  
VIN: YV1LFH5V9R1160832

Model: XC90 T8 AWD Recharge Ultimate Dark

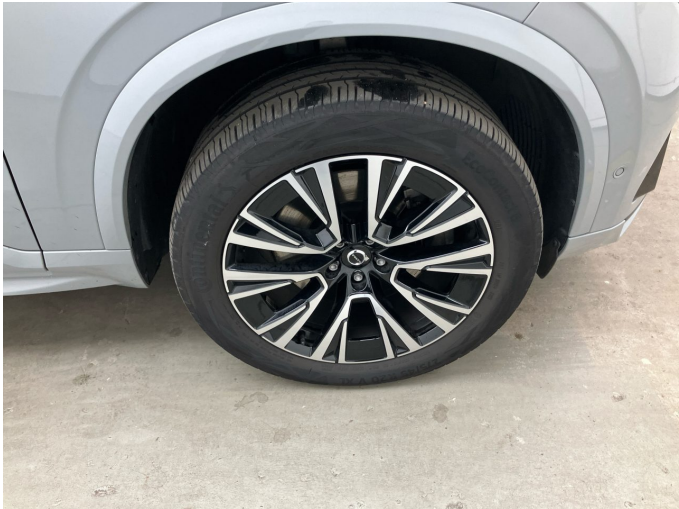
Figure 12: Mounted tyres

Tyres				
Mounted tyres				
#	Tyre size	Type of tyre	Manufacturer	Tread depth
1)	275/45 R20 110V	Summer tyres on Light alloy	Continental	4mm / 4mm
2)	275/45 R20 110V	Summer tyres on Light alloy	Continental	5mm / 5mm

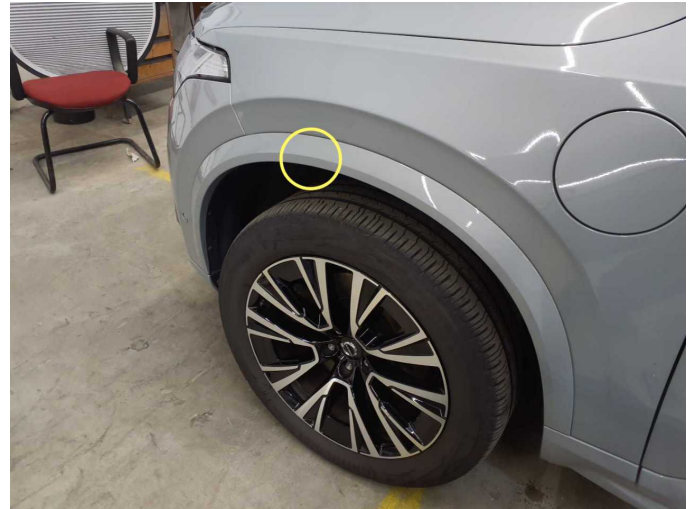
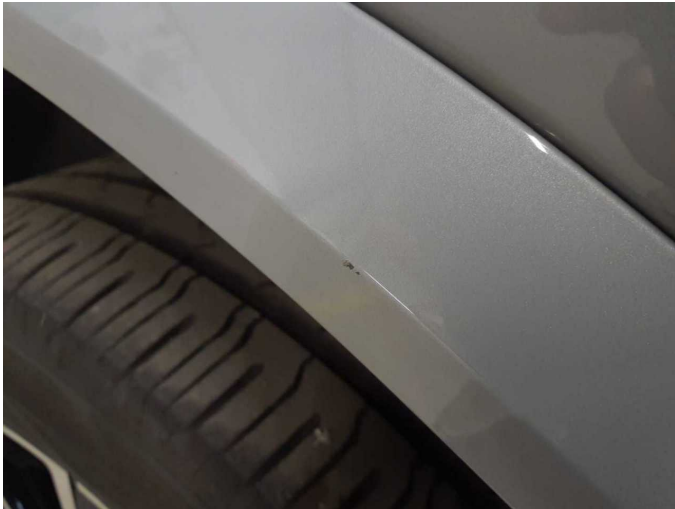
No.	Component group	Description
1	Mudguard - left side	Wheel well extension - Scratch(es) - Smart repair
2	Side panel - rear right side	Side panel - dent(s) - Smooth repair work

**Damage 1:** Mudguard - left side: Wheel well extension - Scratch(es) - Smart repair

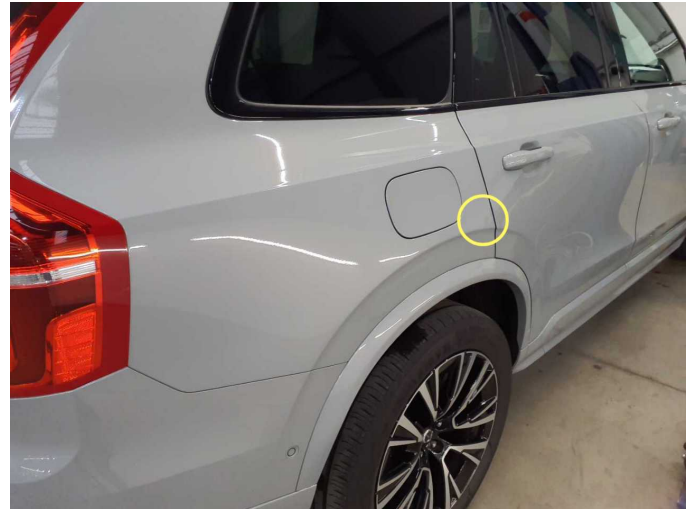
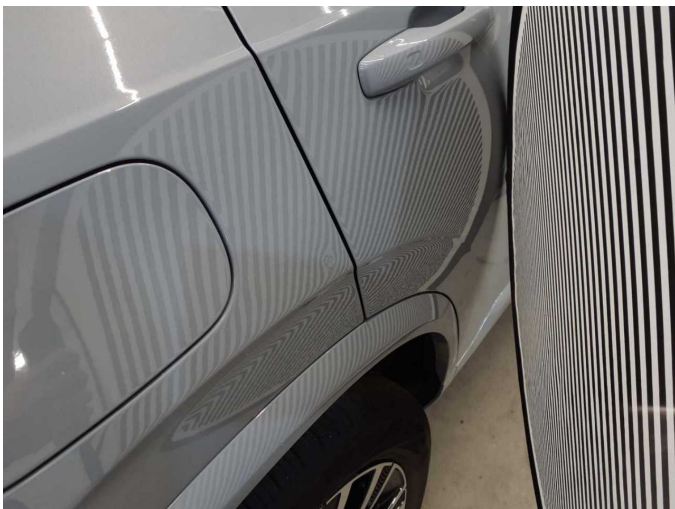
**Damage 2:** Side panel - rear right side: Side panel - dent(s) - Smooth repair work
