Expertise

Protocol number: 41338081  
Order No. / Reference: 25142029  
Inspection date: 1 Sept 2025

Manufacturer: Volvo	Model: XC90 T8 AWD Recharge Geartronic RDesign Edition
VIN: YV1LFH5VDN1856335

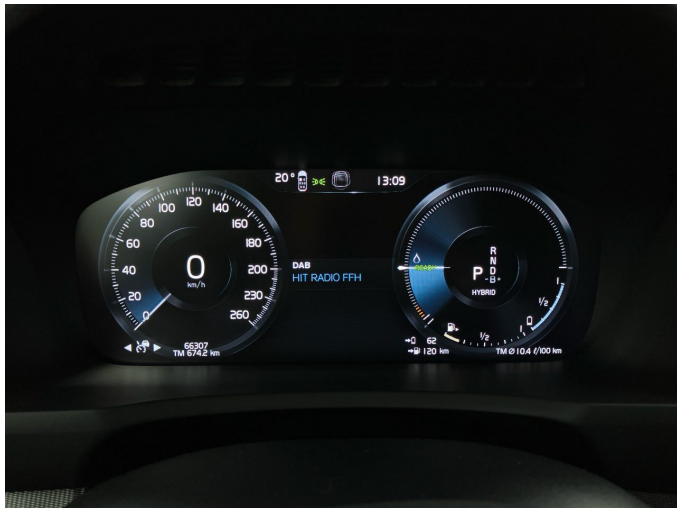
Figure 7: Instrument cluster

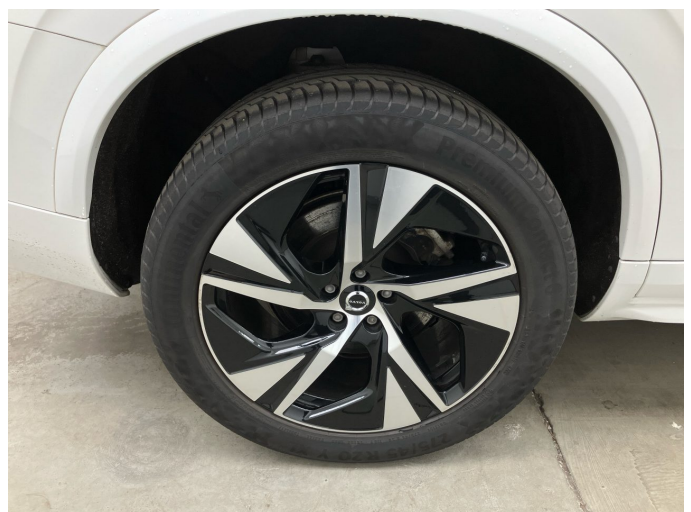
#	Tyre size	Type of tyre	Manufacturer	Tread depth
1)	275/45 R20 110V	Summer tyres on Light alloy	Continental	5mm / 5mm
2)	275/45 R20 110V	Summer tyres on Light alloy	Continental	5mm / 5mm

Figure 12: Mounted tyres

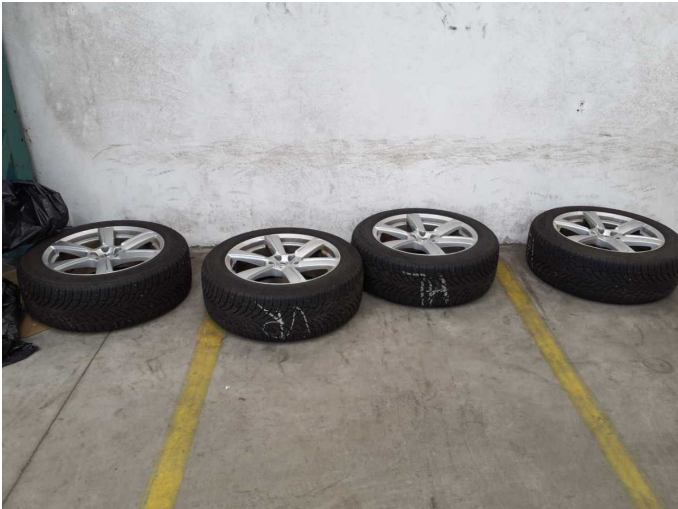
#	Tyre size	Type of tyre	Manufacturer	Tread depth
1)	235/55 R19 105V	Winter tyres on Light alloy	Nokian	5mm / 5mm
2)	235/55 R19 105V	Winter tyres on Light alloy	Nokian	5mm / 5mm

Figure 16: Additional tyres

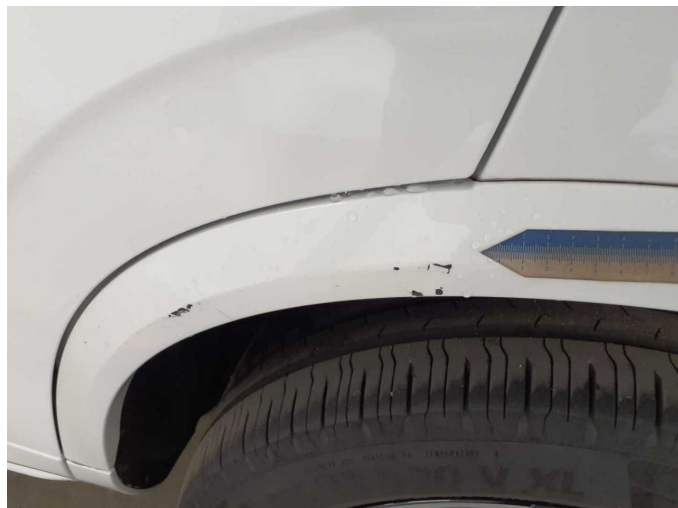
**Damage 1:** Side panel - rear left side: Wheel well extension - Scratch(es)  
- Smart repair

No.	Component group	Description
1	Side panel - rear left side	Wheel well extension - Scratch(es) - Smart repair

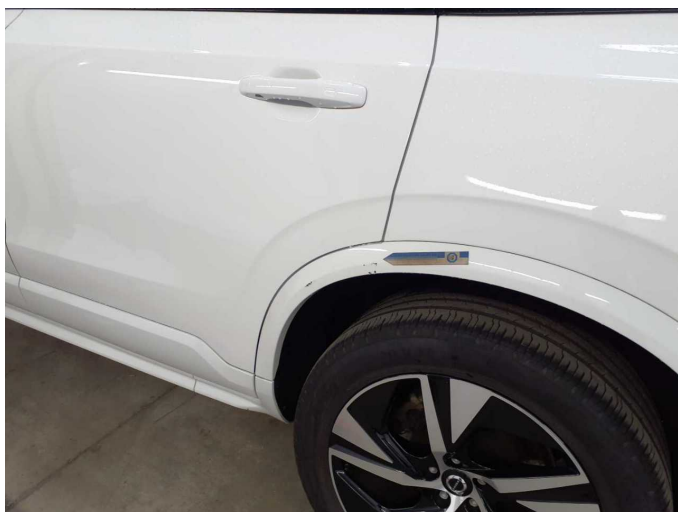
**Damage 1:** Side panel - rear left side: Wheel well extension - Scratch(es)  
- Smart repair
