Expertise

Protocol number: 41485118  
Order No. / Reference: 25116066  
Inspection date: 4 Sept 2025

Manufacturer: Volvo	Model: XC60 B4 D AWD Geartronic Momentum Pro
VIN: YV1UZZK5VCN1077192

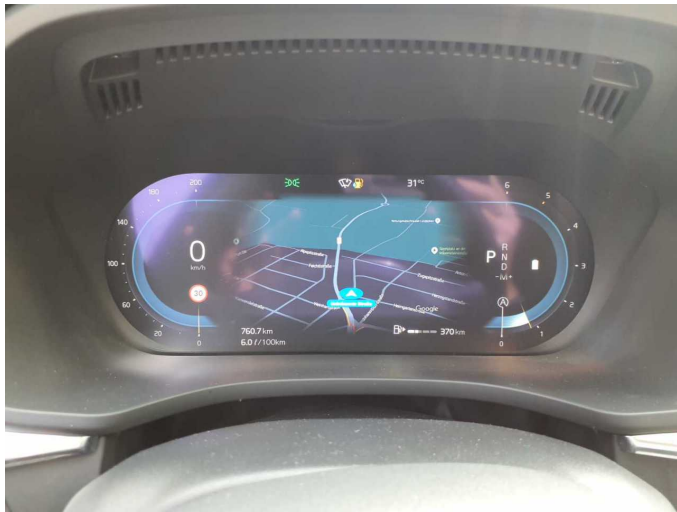
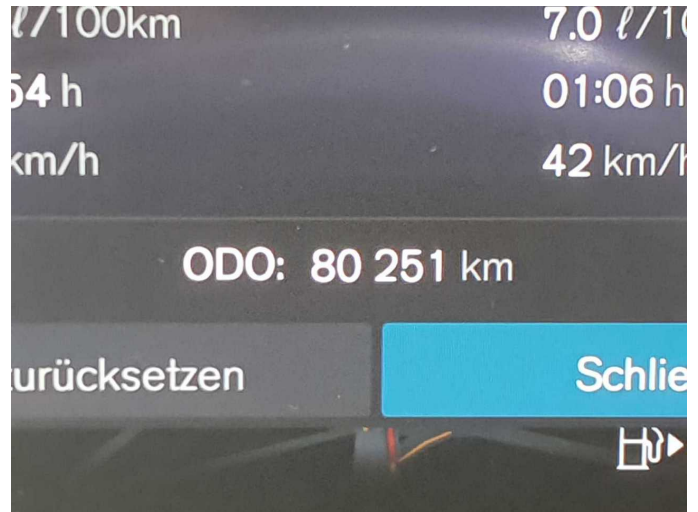
Vehicle details	
Manufacturer / Type / Model / Equipment	
Volvo XC60 B4 D AWD Geartronic Momentum Pro	
Vehicle Identification number	YV1UZZK5VCN1077192
Mileage (Read)	80,251 km
First registration	17 Aug 2022
Number of holders	1
Next periodical technical inspection	08/2025
(Taken from ZBI)	
Power / Engine displacement	145 kw / 1,969 ccm
Fuel type / Cylinder	Hybrid Diesel / E / 4
Gearbox / Number of gears	Automatic / 8
Type of drive	All-wheel drive
Type of vehicle	SUV
Colour / colour code	BLACK SOLID (STONE)
Doors / Seats	5 / 5
Upholstery type	Leather
Colour of upholstery	Black
Re/Import	no
Driving readiness	Roadworthy

Figure 7: Instrument cluster

Figure 8: Instrument cluster

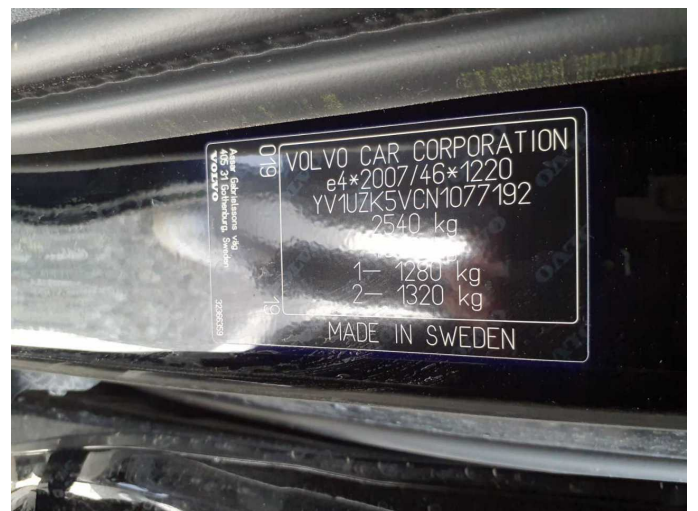
Figure 12: VIN

Documents submitted	At the time of the inspection, the registration certificate Part 1 (certificate) was available, but the registration certificate Part 2 (letter) was not. (Copy)
VIN comparison	The vehicle identification number (VIN) was read from the vehicle and its conformity with the submitted documents was verified during the inspection by the undersigned.
Inspection	A proper visual inspection of the paintwork and bodywork was only possible to a limited extent due to insufficient lighting conditions/wetness or dirt. No lifting equipment or pit was available to inspect the vehicle. Therefore, inspection of the vehicle's underside was only possible to a limited extent.
Test drive	No test drive/maneuvering was carried out during the inspection of the vehicle.
Engine function test	An engine test run was performed.
Driving readiness	The vehicle was drivable at the time of inspection.

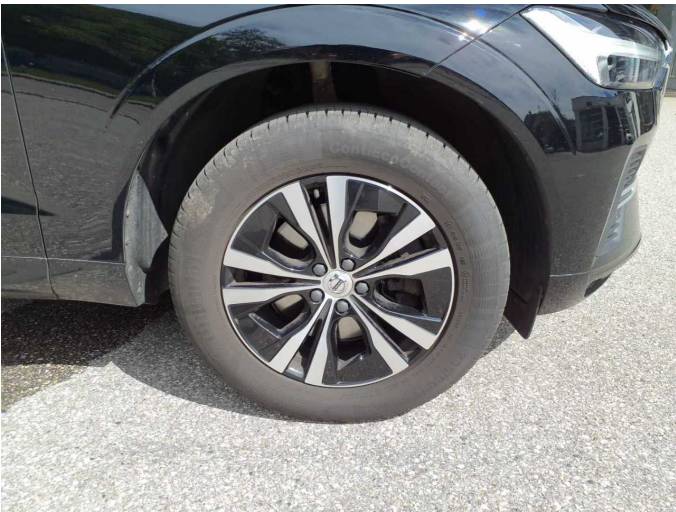
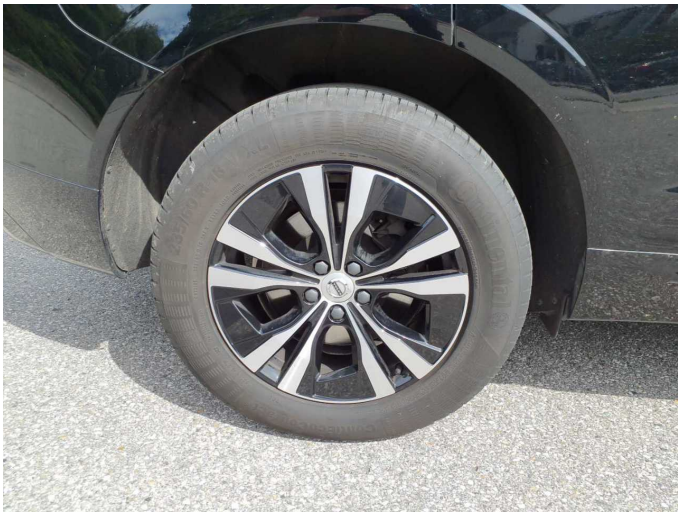
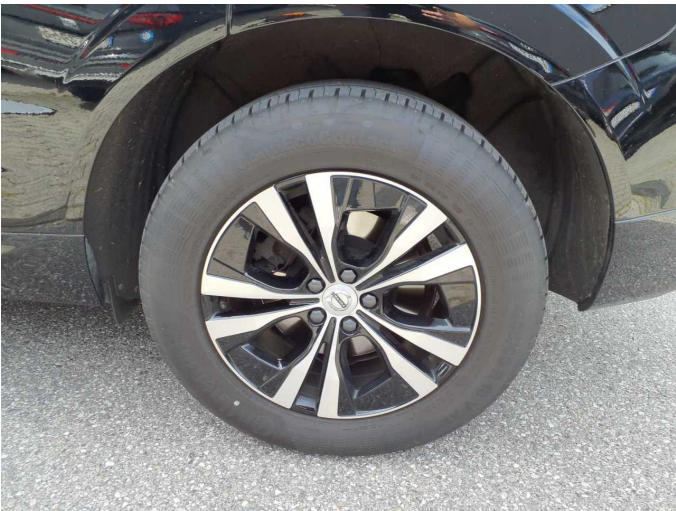
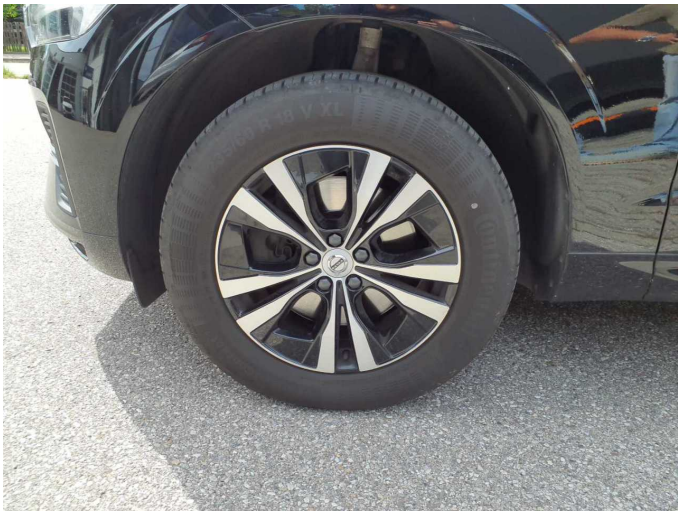
#	Tyre size	Type of tyre	Manufacturer	Tread depth
1)	235/60 R18 107V	Summer tyres on Light alloy	Continental	6mm / 6mm
2)	235/60 R18 107V	Summer tyres on Light alloy	Continental	6mm / 6mm

Figure 13: Mounted tyres

Figure 14: Mounted tyres

Figure 15: Mounted tyres

Figure 16: Mounted tyres

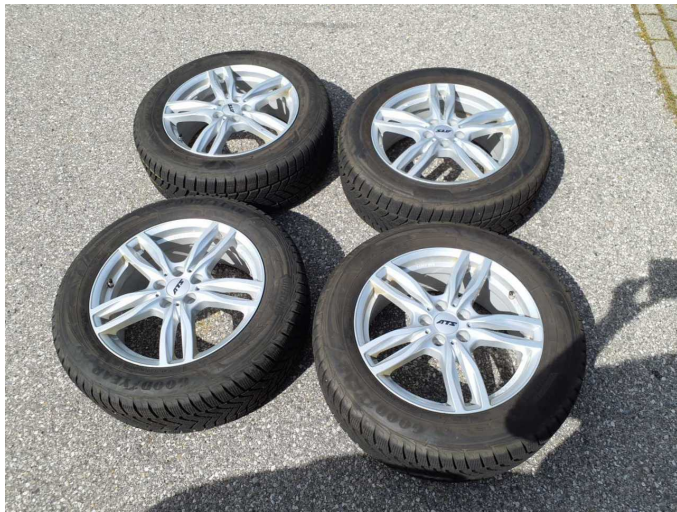
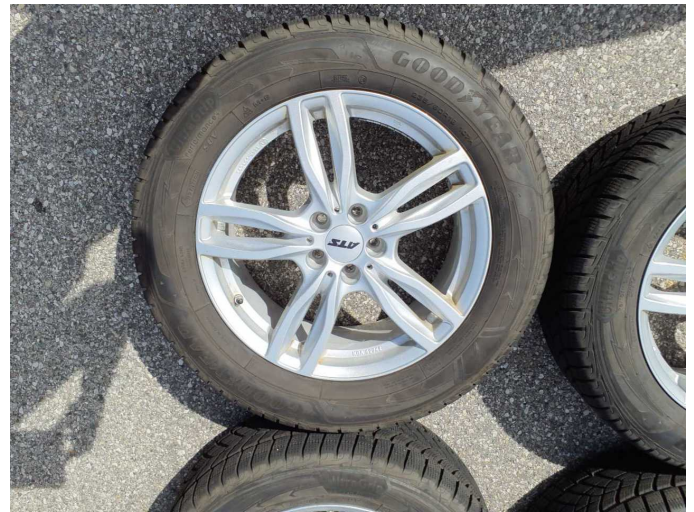
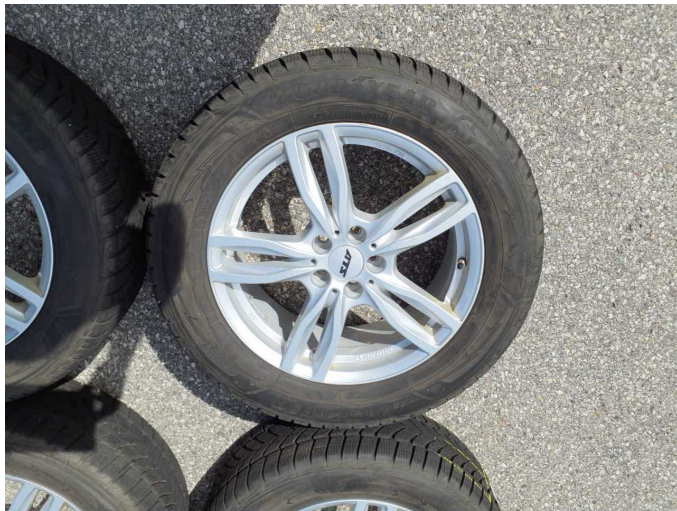
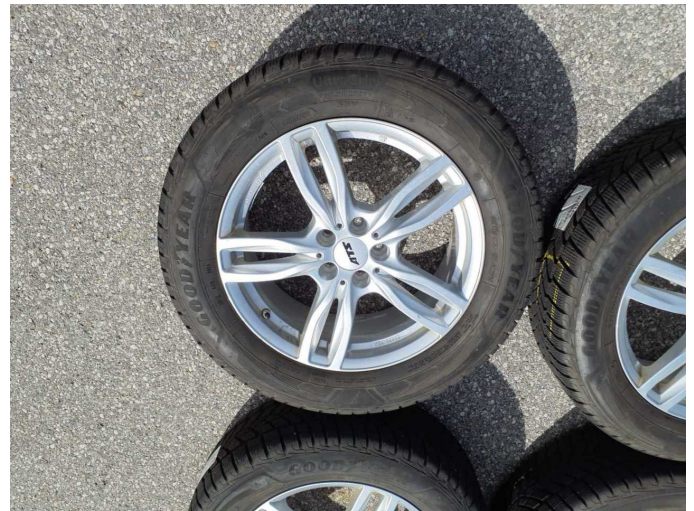
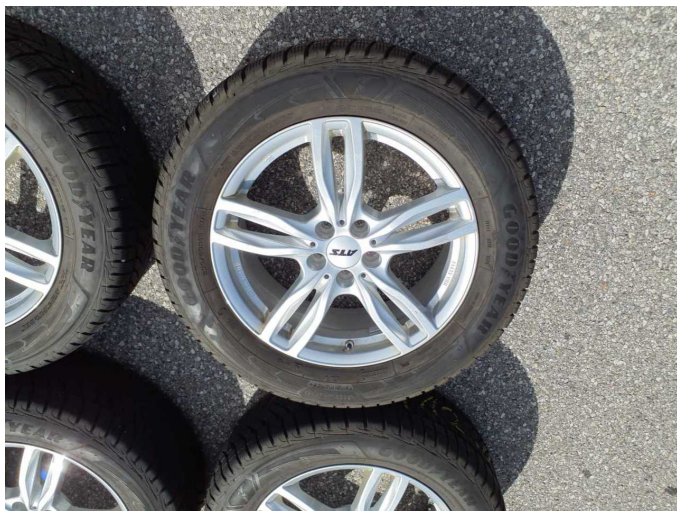
#	Tyre size	Type of tyre	Manufacturer	Tread depth
1)	235/60 R18 107H	Winter tyres on Light alloy	Goodyear	6mm / 6mm
2)	235/60 R18 107H	Winter tyres on Light alloy	Goodyear	6mm / 6mm

Figure 19: Additional tyres

Figure 20: Additional tyres

Figure 21: Additional tyres

Figure 22: Additional tyres

Figure 23: Additional tyres

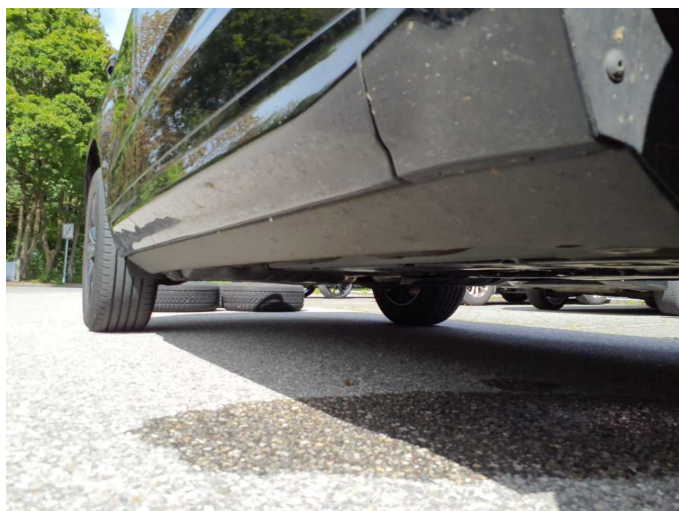
Roof	130 µm	Roof rail - left side	130 µm
Roof rail - right side	120 µm	Mudguard - left side	120 µm
Mudguard - right side	120 µm	Bonnet	120 µm
Sill - left side	60 µm	Sill - right side	70 µm
Side panel - rear left side	120 µm	Side panel - rear right side	130 µm
Door - rear left side	130 µm	Door - rear right side	120 µm
Door - front left side	130 µm	Door - front right side	130 µm

**Figure 35:** Sill

**Figure 36:** Sill
