Expertise

Protocol number: 41138438
Order No. / Reference: 25025657
Inspection date: 11 Aug 2025

Manufacturer: Volvo	Model: XC60 B4 D Geartronic Inscription
VIN: YV1UZZK5VDN1982982

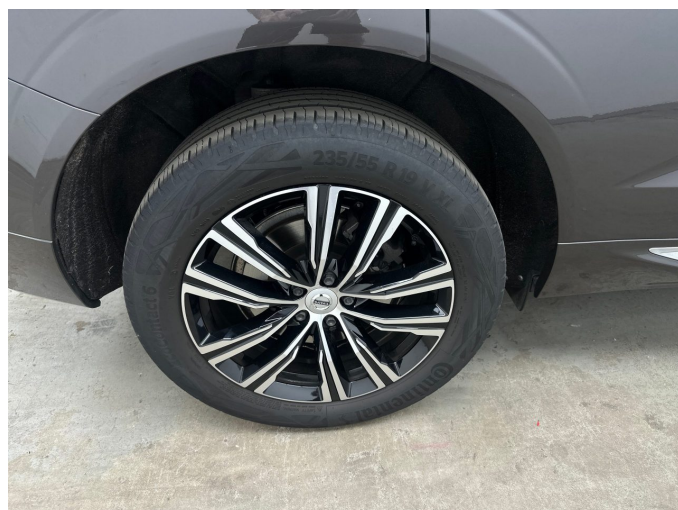
Figure 12: Mounted tyres

#	Tyre size	Type of tyre	Manufacturer	Tread depth
1)	235/55 R19 105V	Summer tyres on Light alloy	Continental	2mm / 2mm
2)	235/55 R19 105V	Summer tyres on Light alloy	Continental	4mm / 4mm

Sommerreifen haben 2,4mm.

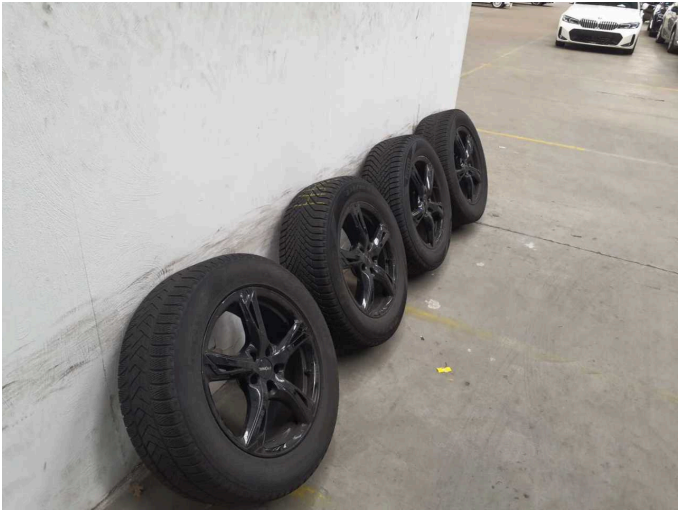
Figure 16: Additional tyres

#	Tyre size	Type of tyre	Manufacturer	Tread depth
1)	235/60 R16 107H	Winter tyres on Light alloy	Pirelli	5mm / 5mm
2)	235/60 R16 107H	Winter tyres on Light alloy	Pirelli	6mm / 6mm

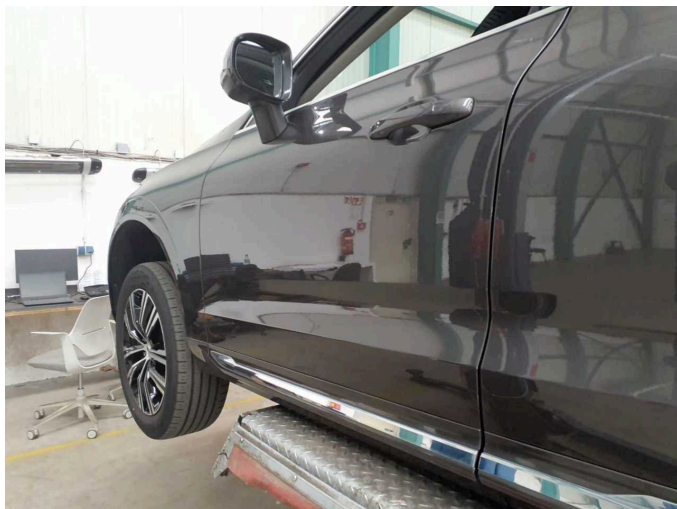
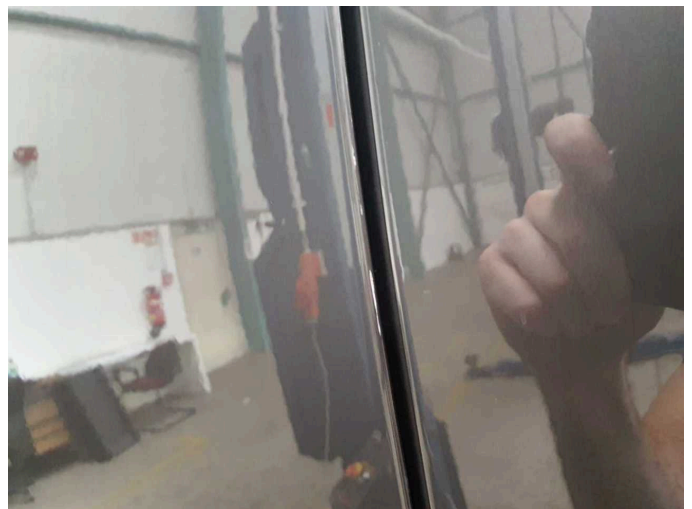
Damage 1: Door - front left side: Door edge - Scratch(es) - Smart repair

No.	Component group	Description
1	Door - front left side	Door edge - Scratch(es) - Smart repair
2	Wheel / tyres	Alloy rim - front left side - Scratch(es) - Loss in value
3	Vehicle glazing	Windscreen - Stone chips - repair according to calculation

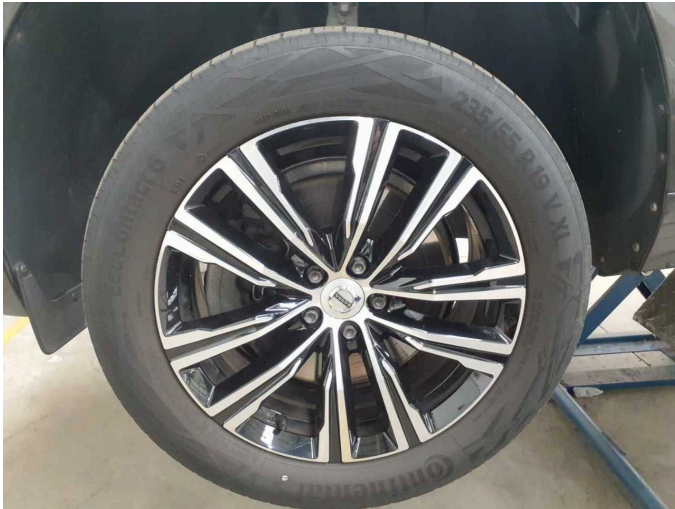
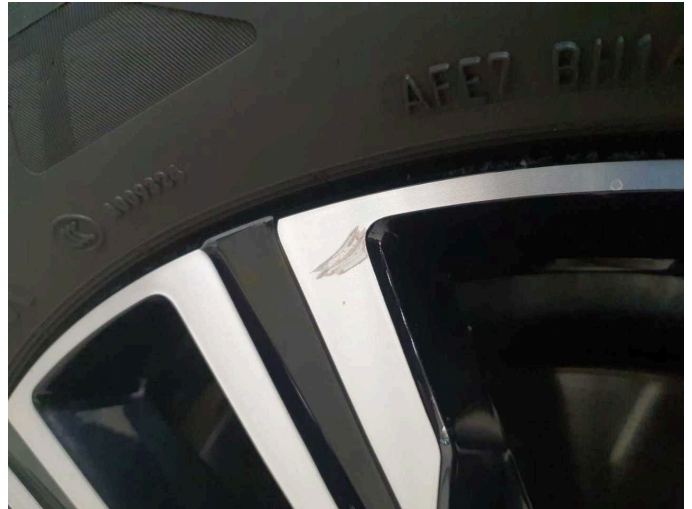
Damage 2: Wheel / tyres: Alloy rim - front left side - Scratch(es) - Loss in value

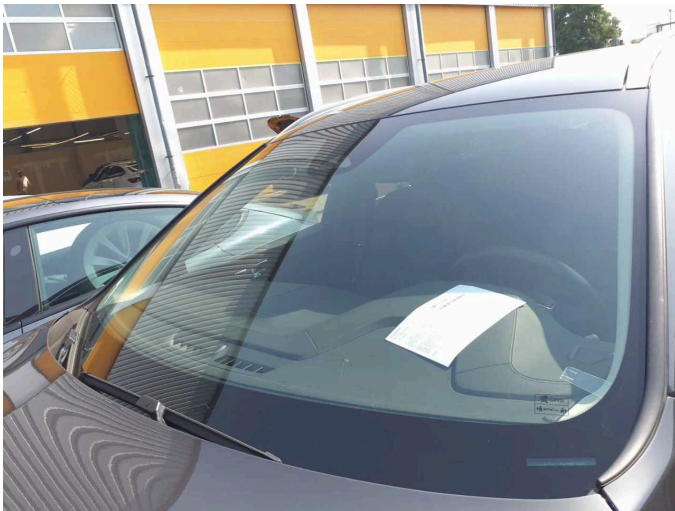
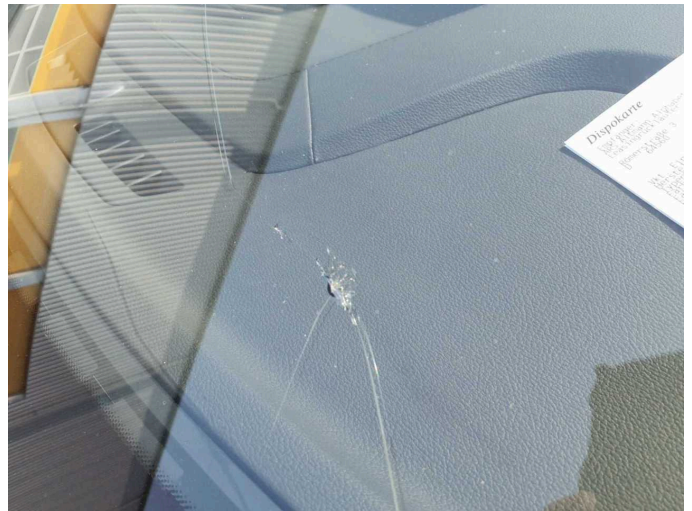
Damage 3: Vehicle glazing: Windscreen - Stone chips - repair according to calculation
