Expertise

Protocol number: 41220811
Order No. / Reference: 25071717
Inspection date: 22 Aug 2025

| Manufacturer: Volvo | Model: V60 D3 Momentum Pro |

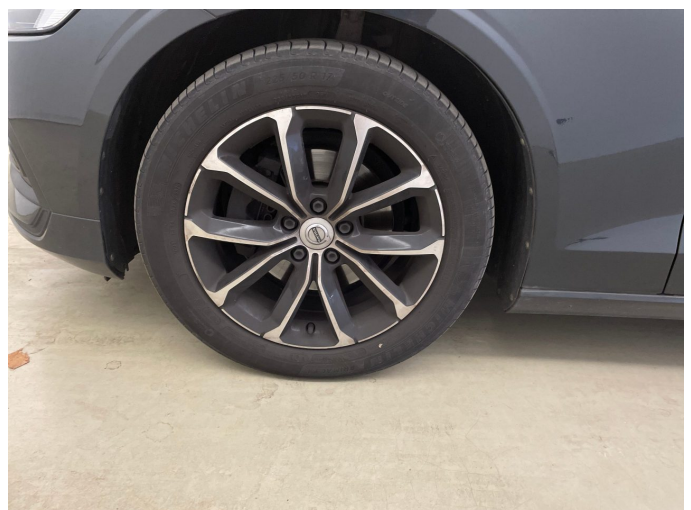
| # | Tyre size | Type of tyre | Manufacturer | Tread depth |
|---|---|---|---|---|
| 1) | 225/50 R17 98V | Summer tyres on Light alloy | Michelin | 5mm / 5mm |
| 2) | 225/50 R17 98V | Summer tyres on Light alloy | Michelin | 5mm / 5mm |

Figure 12: Mounted tyres

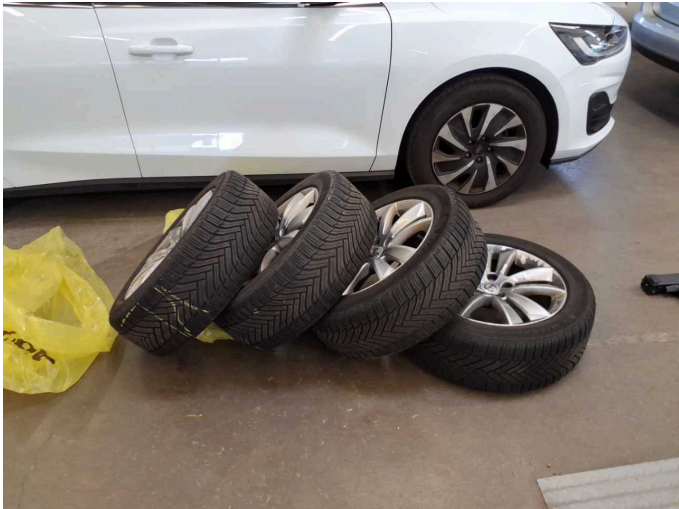
| # | Tyre size | Type of tyre | Manufacturer | Tread depth |
|---|---|---|---|---|
| 1) | 225/50 R17 98V | Winter tyres on Light alloy | Michelin | 6mm / 6mm |
| 2) | 225/50 R17 98V | Winter tyres on Light alloy | Michelin | 6mm / 6mm |

Figure 16: Additional tyres

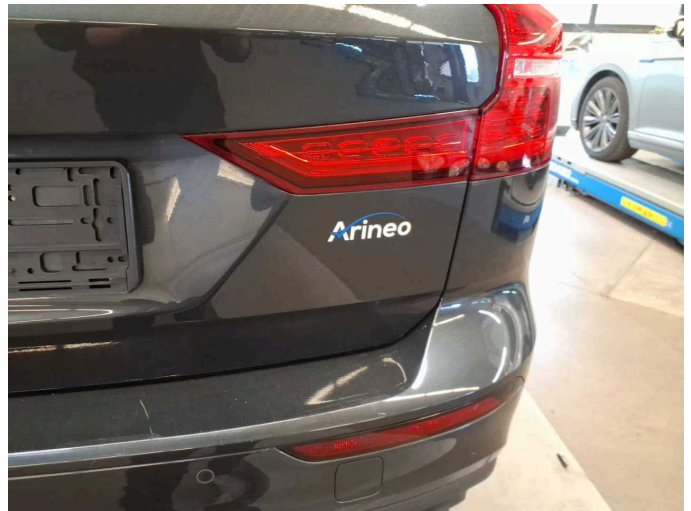
| No. | Component group | Description |
|---|---|--|
| 1 | Boot lid / rear door | Boot lid - Glued / labelled - De-glue / neutralise |

Damage 1: Boot lid / rear door: Boot lid - Glued / labelled - De-glue / neutralise

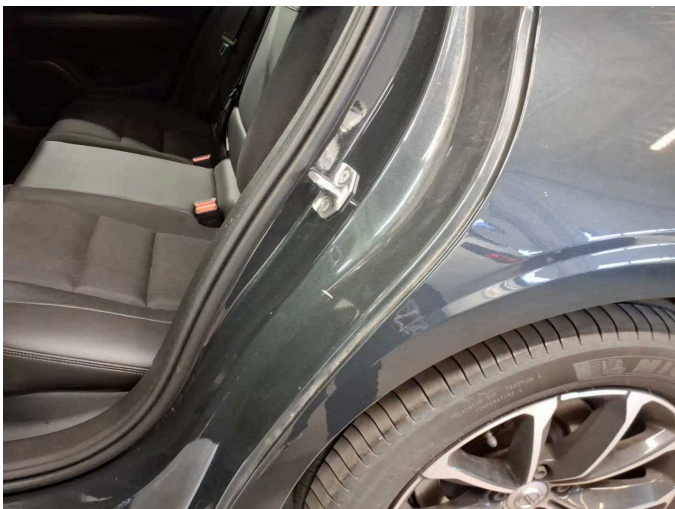
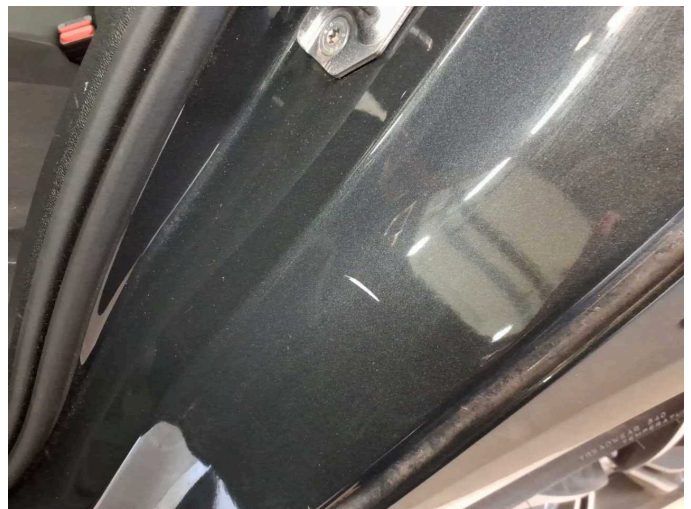
| No. | Component group | Description |
|---|---|--|
| 2 | Side panel - rear left side | Sill - Scratch(es) - Smart repair |

Damage 2: Side panel - rear left side: Sill - Scratch(es) - Smart repair

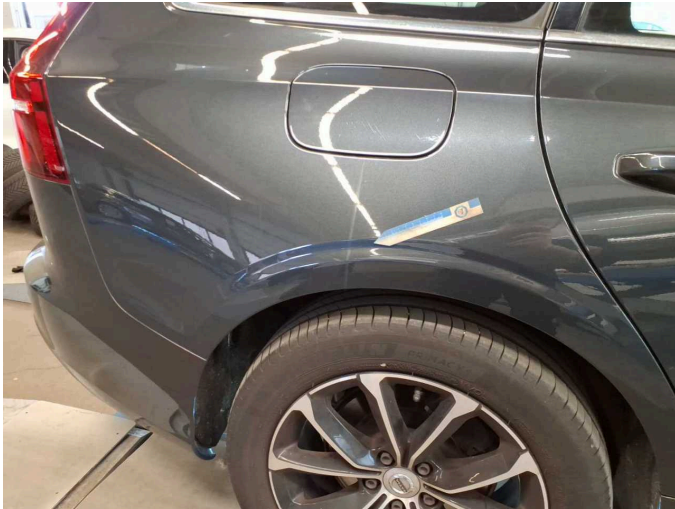
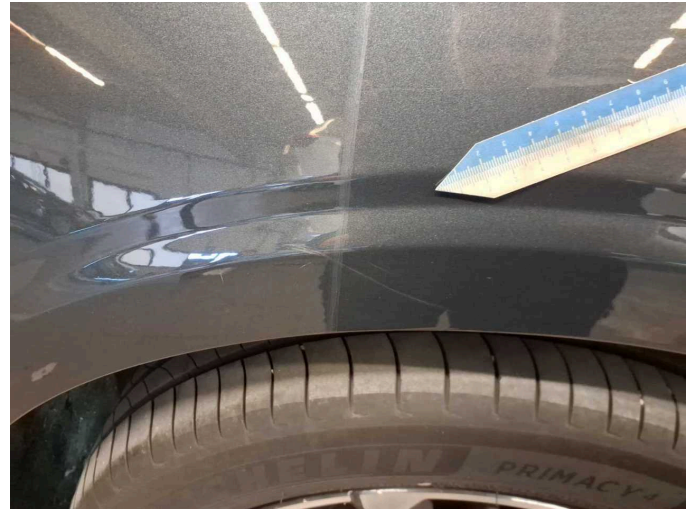
| No. | Component group | Description |
|---|---|--|
| 3 | Side panel - rear right side | Side panel - Scratch(es) - Smart repair |

Damage 3: Side panel - rear right side: Side panel - Scratch(es) - Smart repair

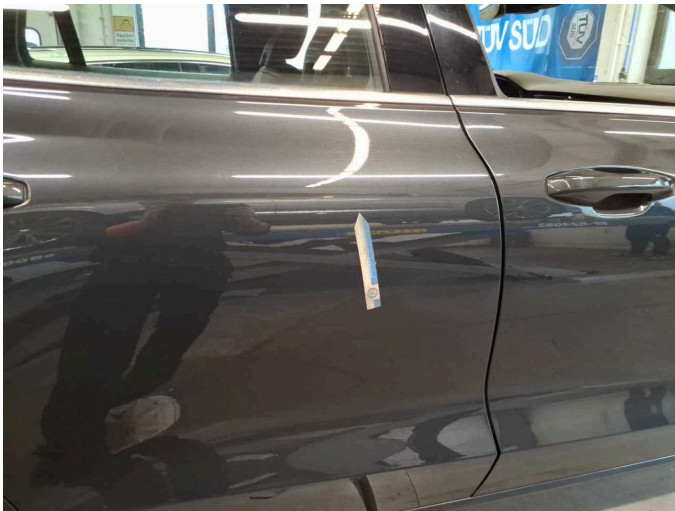
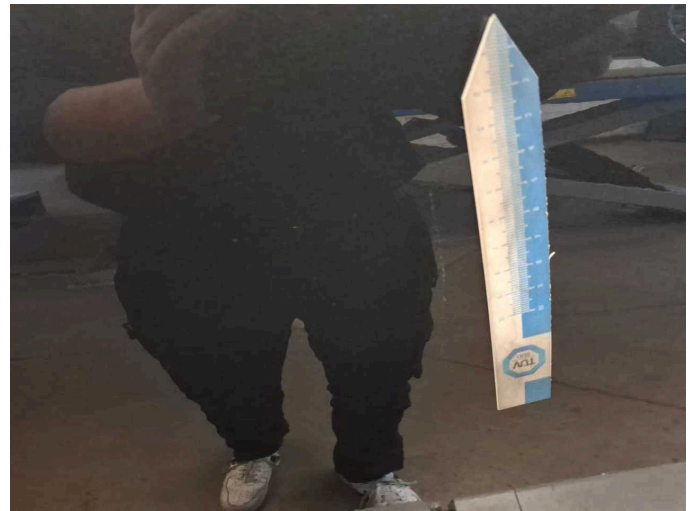
| No. | Component group | Description |
|---|---|--|
| 4 | Door - rear right side | Door - Scratch(es) - Smart repair |

Damage 4: Door - rear right side: Door - Scratch(es) - Smart repair

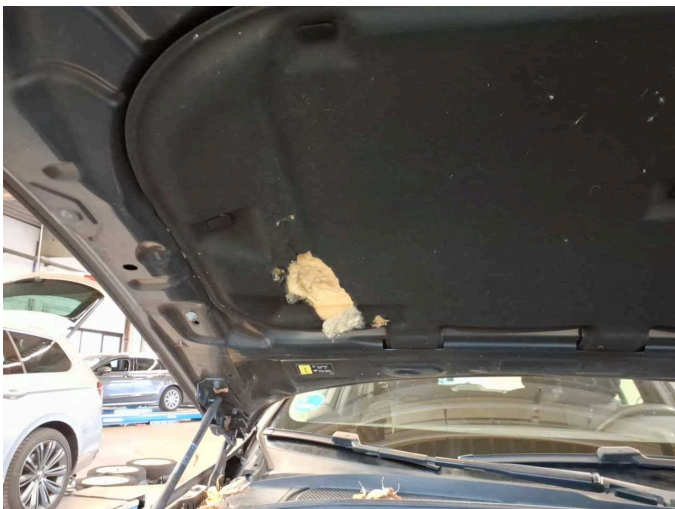
| No. | Component group | Description |
|---|---|--|
| 5 | Bonnet | Insulation lining - Damage caused by marten / rodent - Replace |

Damage 5: Bonnet: Insulation lining - Damage caused by marten / rodent - Replace

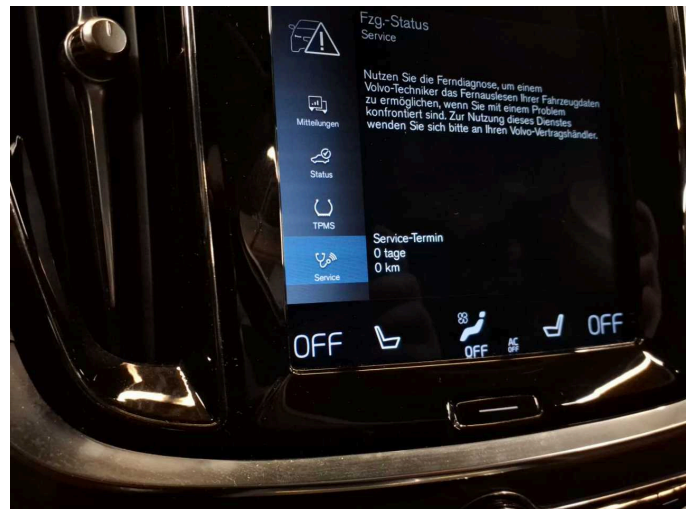
| No. | Component group | Description |
|---|---|--|
| 6 | Misc. | Inspection / maintenance - Due - Perform |

Damage 6: Misc.: Inspection / maintenance - Due - Perform

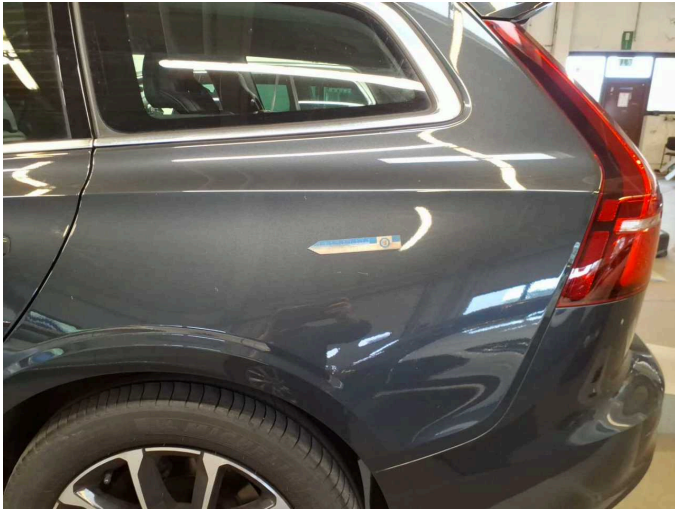
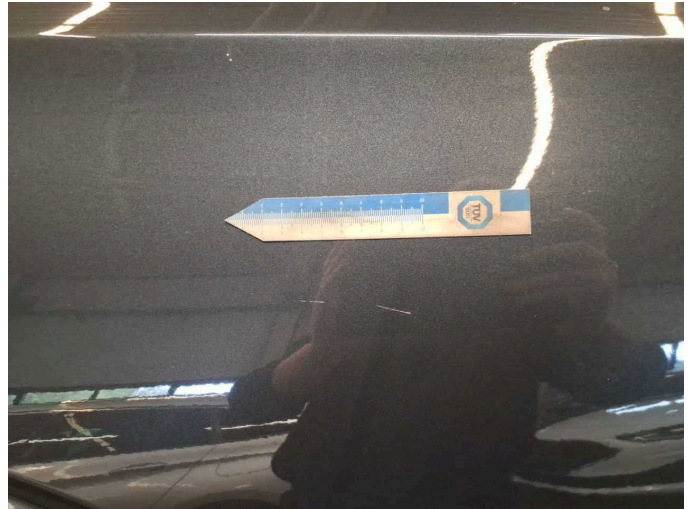
| No. | Component group | Description |
|---|---|--|
| 7 | Side panel - rear left side | Side panel - Scratch(es) - Paint |

Damage 7: Side panel - rear left side: Side panel - Scratch(es) - Paint

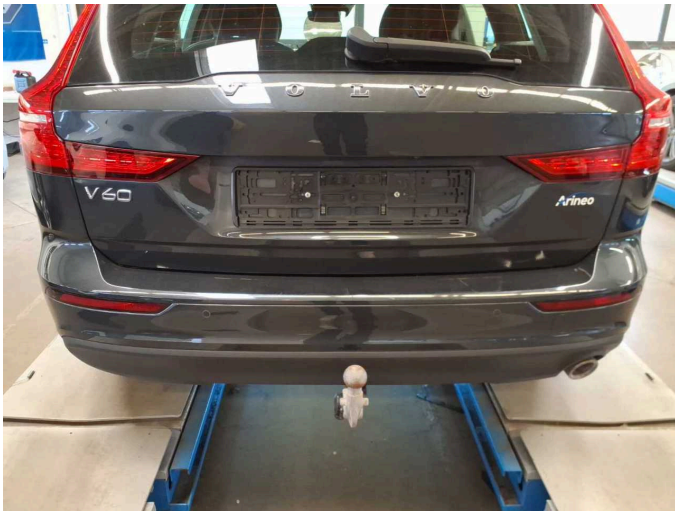
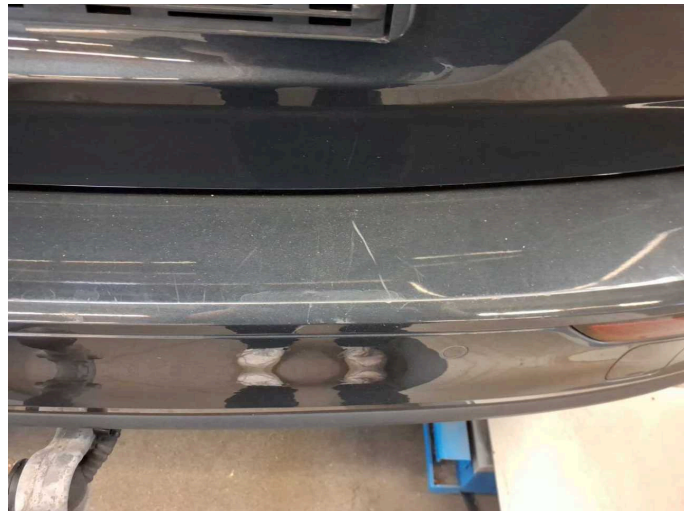
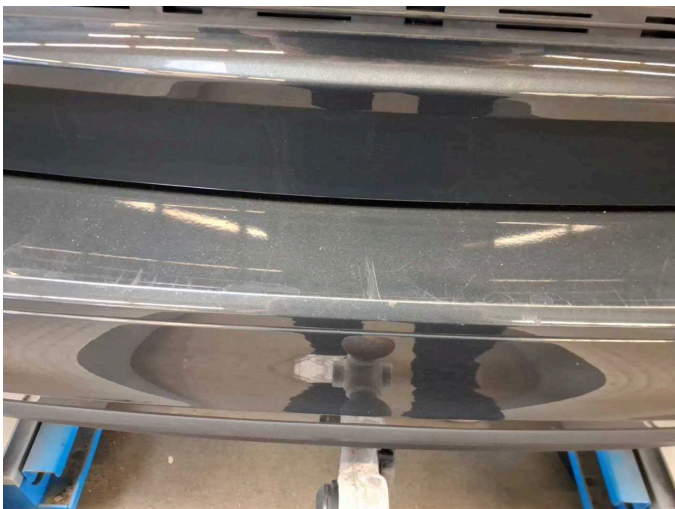
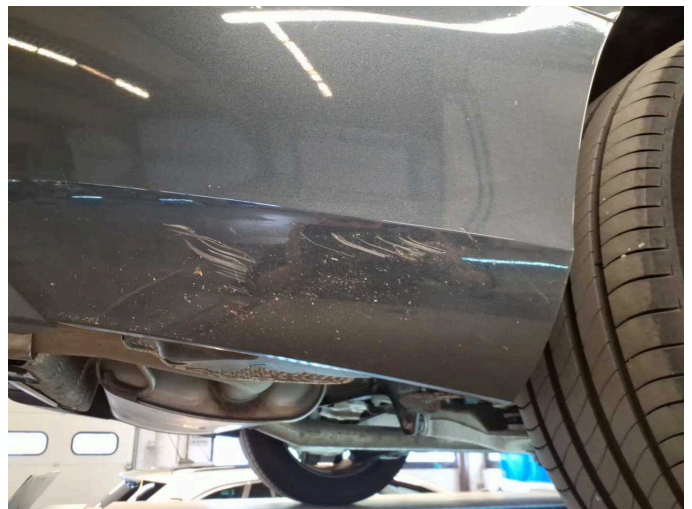
| No. | Component group | Description |
|---|---|--|
| 8 | Rear bumper | Rear bumper - Scratch(es) - Paint |

Damage 8: Rear bumper: Rear bumper - Scratch(es) - Paint

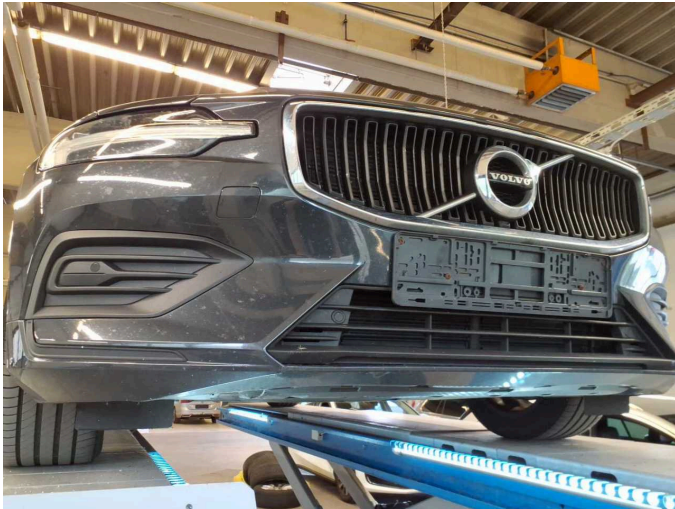
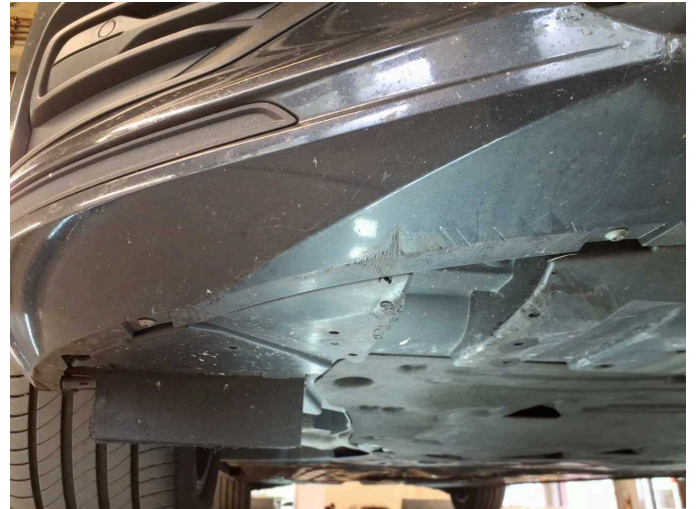
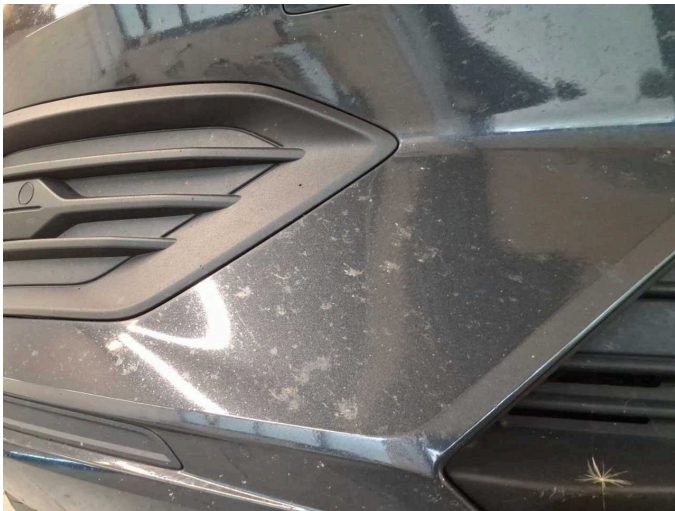
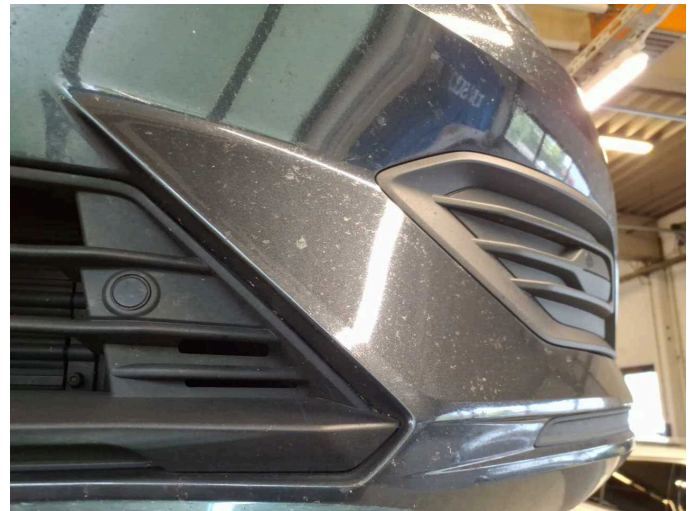
| No. | Component group | Description |
|---|---|--|
| 9 | Front bumper | Front bumper (+ Kratzer) - Stone chips - Paint |

Damage 9: Front bumper: Front bumper (+ Kratzer) - Stone chips - Paint

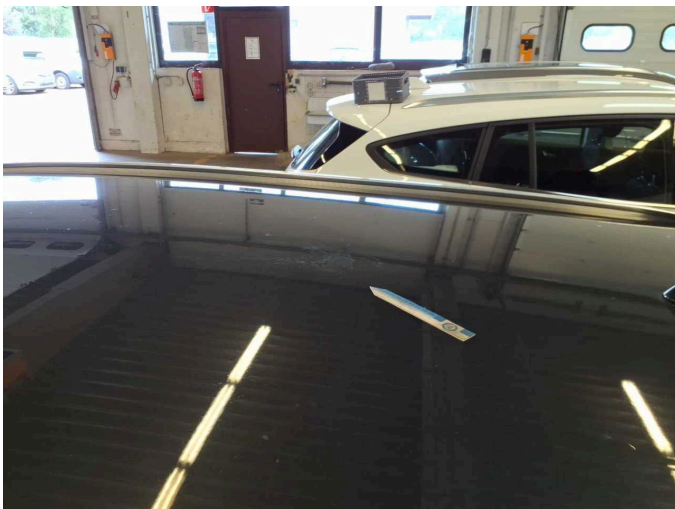
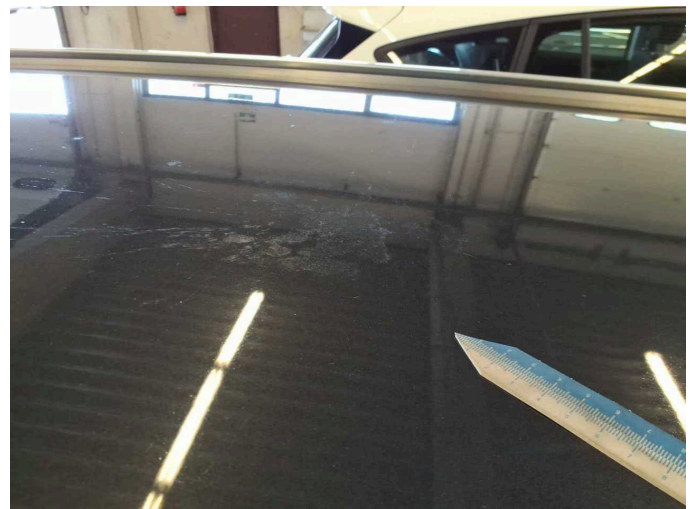
| No. | Component group | Description |
|---|---|--|
| 10 | Roof | Roof (Vogelkotverätzung) - Paint defect - Paint |

Damage 10: Roof: Roof (Vogelkotverätzung) - Paint defect - Paint
