JEEP Cherokee

Cherokee 2.0 Multijet Active Drive I Automatik

VIN NO 1C4PJMDYXFW622890

Inspection Report Summary

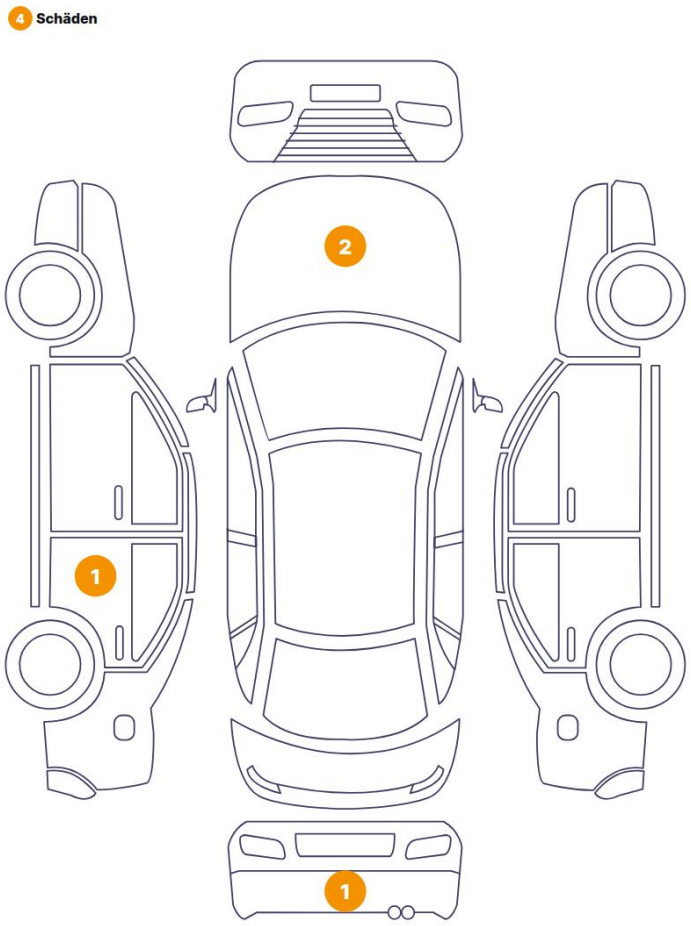
Component	Damage	Comments
1	Hood	Bodywork / Breakage / Crack	
2	Hood	Paint / Corrosion	
3	Door / Back Left	Paint / Scratch / Scuff	
4	Bumper / Back	Paint / Scratch / Scuff

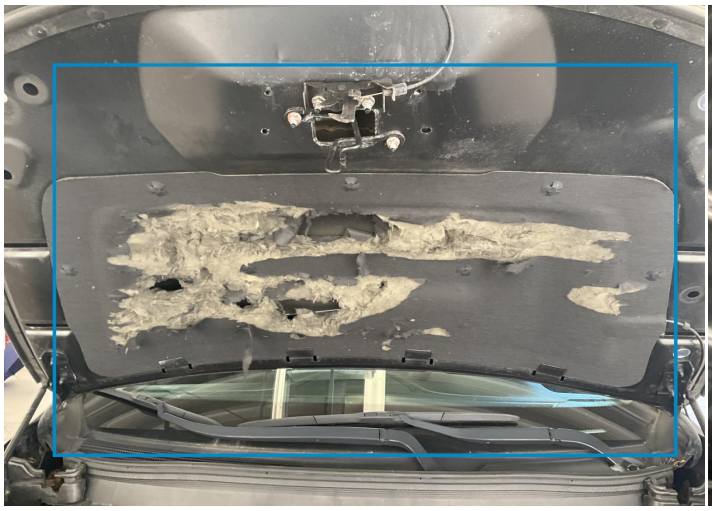
1. Hood
Bodywork / Breakage / Crack -

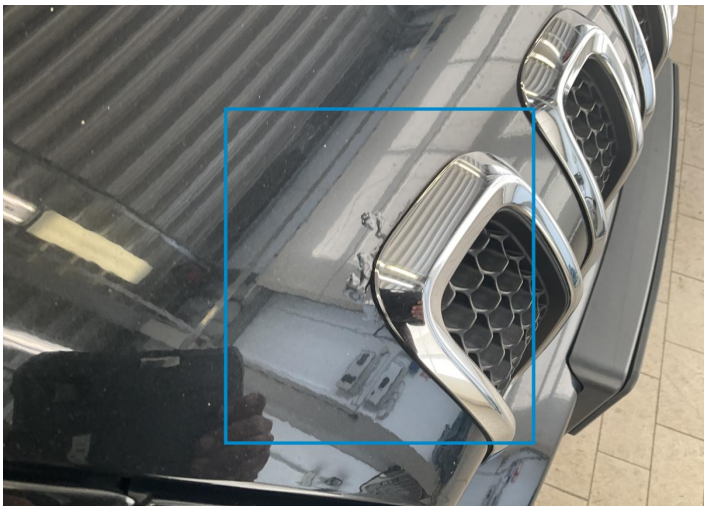
2. Hood
Paint / Corrosion -

3. Door / Back Left
Paint / Scratch / Scuff -

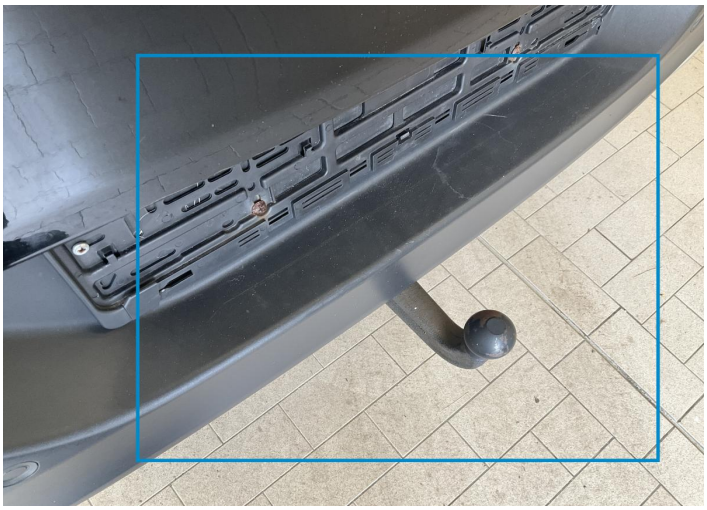
4. Bumper / Back
Paint / Scratch / Scuff -
