CHEVROLET Corvette
Corvette Z06 Cabriolet 5.5 V8 3LZ

VIN NO 1G1Y92D30R5602706

Inspection Report Summary

Customer	BCA Online	Report Number	P20250912094955
Inspection Date / Place	2025-09-12 / BCA Neuss	Cosmetic Grade	1

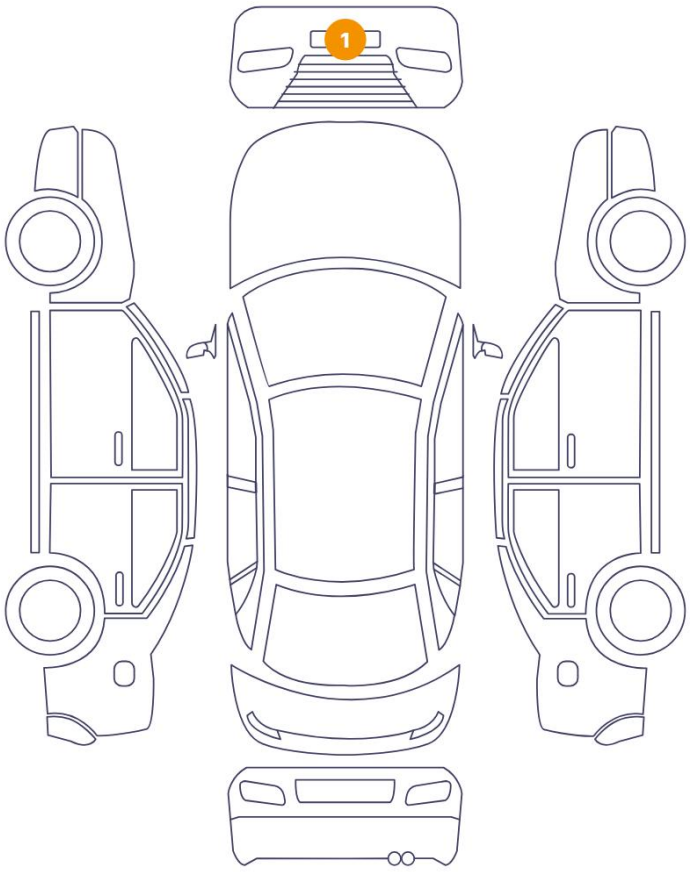
1 Schäden

Component	Damage	Comments
1	Bumper / Front	Paint / Scratch / Scuff

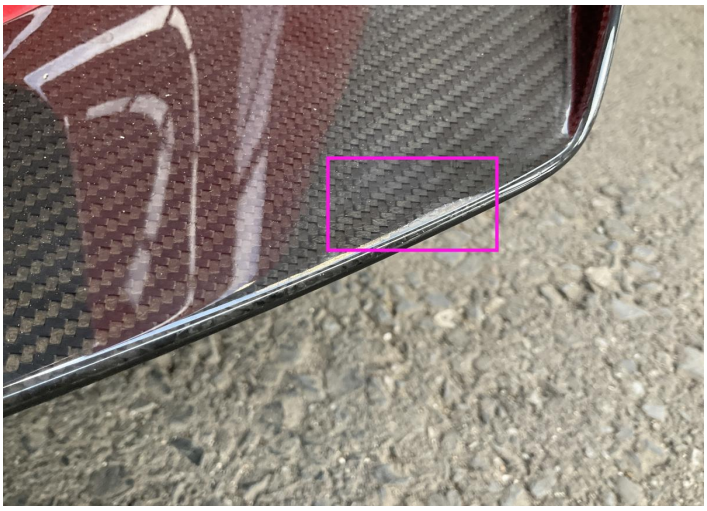
1. Bumper / Front
Paint / Scratch / Scuff -
