CHEVROLET Corvette

Corvette Stingray Cabriolet 3LT 6.2 V8 Automatik

Inspection Report Summary

Customer	BCA Online	Report Number	P20250917142152
Inspection Date / Place	2025-09-17 / BCA Neuss	Cosmetic Grade	1

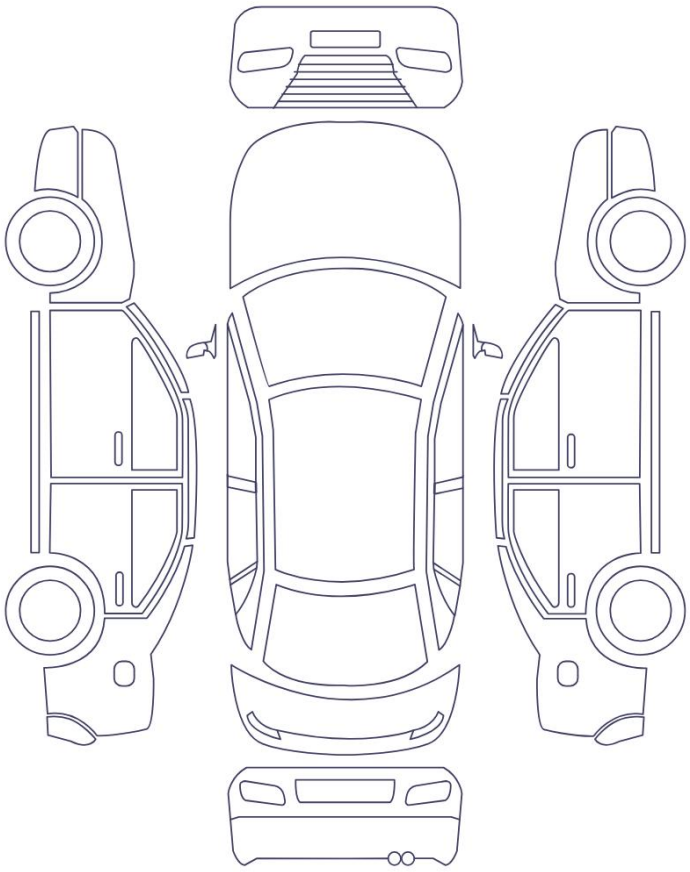
0 Schäden

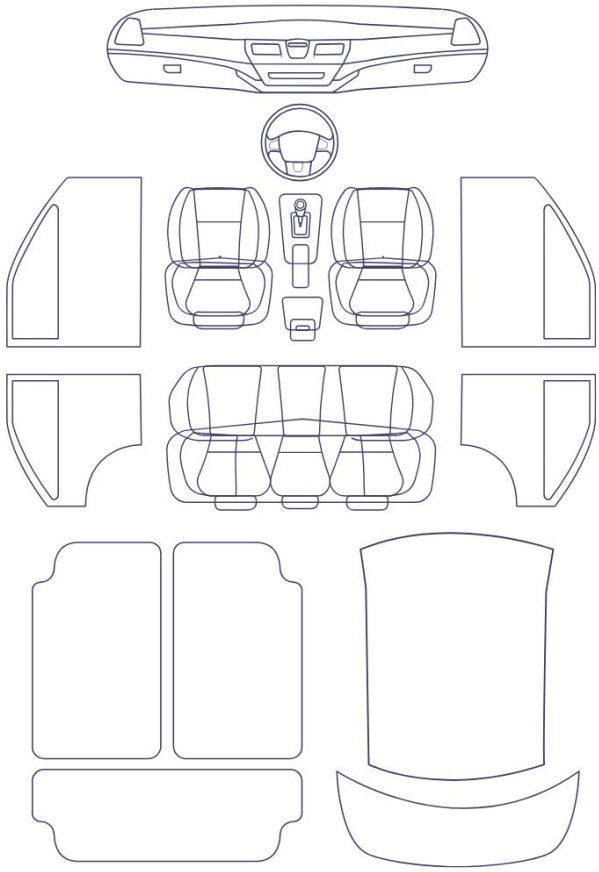
0 Schäden
