MITSUBISHI Outlander
Outlander 2.0 4WD Plug-In Hybrid

VIN NO JMBXDGG2WEZ012528

Inspection Report Summary

Customer	BCA Online	Report Number	P20250915132442
Inspection Date / Place	2025-09-15 / BCA Berlin	Cosmetic Grade	3

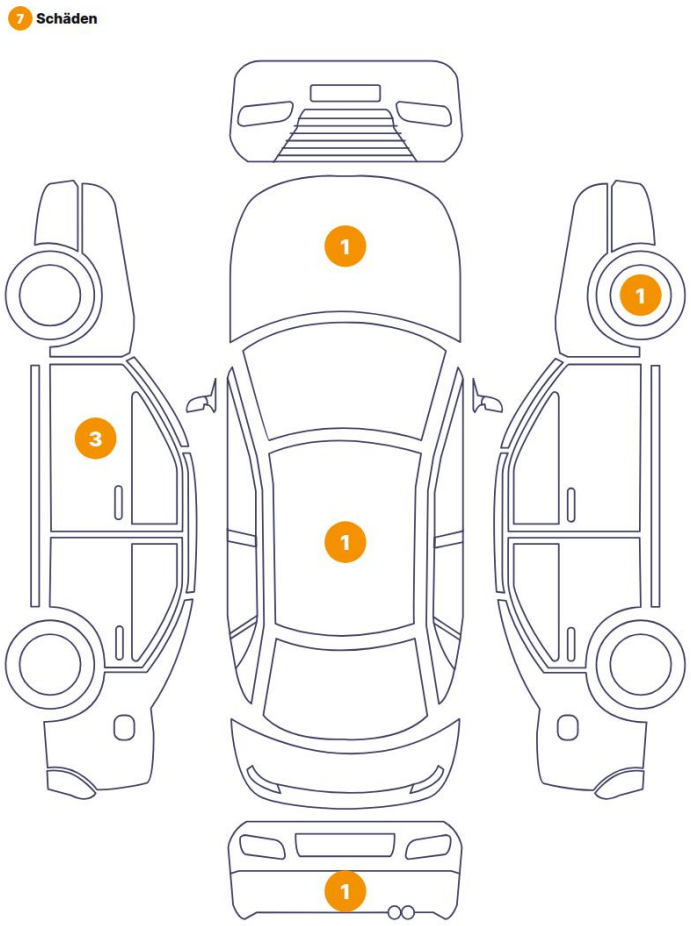
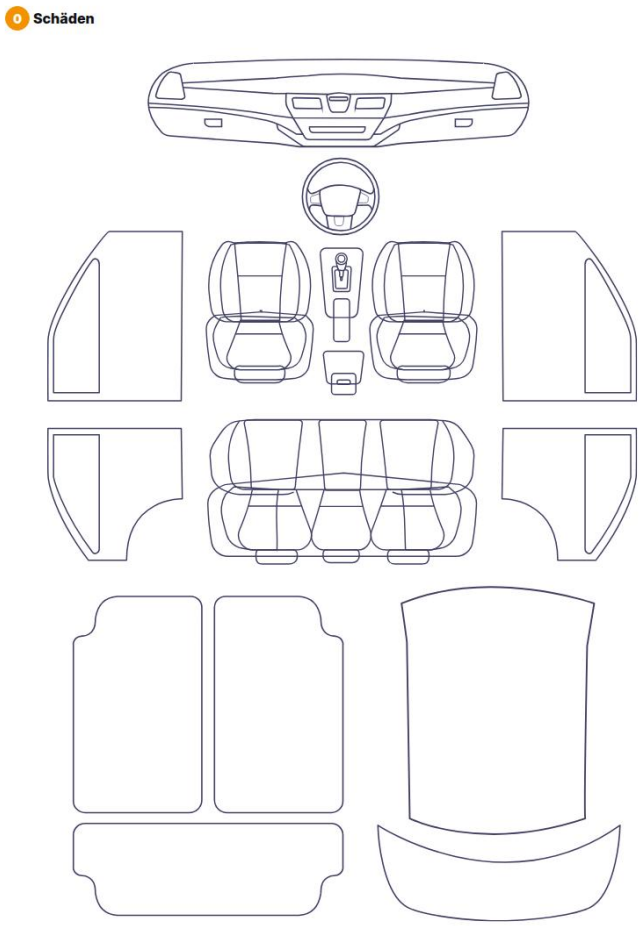
Cosmetic Damage

Component	Damage	Comments
1	Rim / Front Right	Out of Bodywork / Scratch	
2	Mirror / Front Left	Bodywork / Breakage / Crack	
3	Door / Front Left	Bodywork / Dent / Dent	
4	Bumper / Back	Paint / Scratch / Scuff	
5	Roof	Bodywork / Dent / Dent	
6	Hood	Bodywork / Dent / Dent	
7	Door / Front Left	Bodywork / Dent / Dent

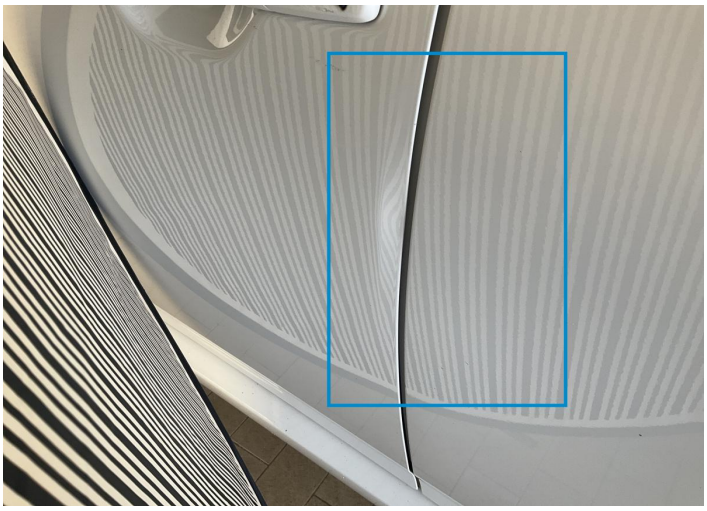
5. Roof
Bodywork / Dent / Dent -

6. Hood
Bodywork / Dent / Dent -

7. Door / Front Left
Bodywork / Dent / Dent -
