MAZDA CX-3

CX-3 SKYACTIV-G 120 FWD

Inspection Report Summary

Customer	BCA Online	Report Number	P20250917133205
Inspection Date / Place	2025-09-17 / ARS Altmann AG Riedstadt	Cosmetic Grade	3

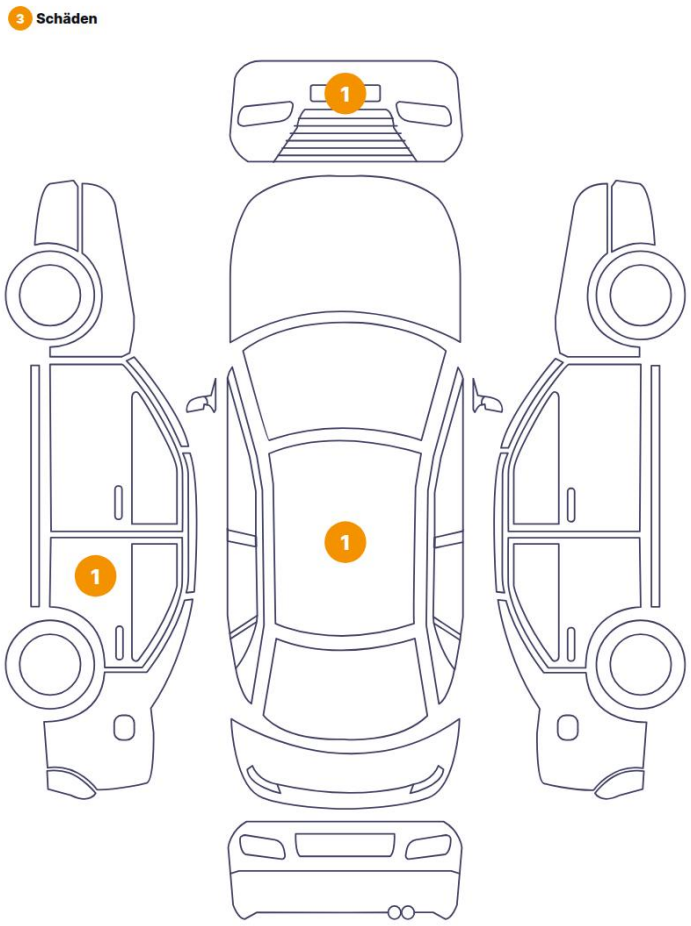
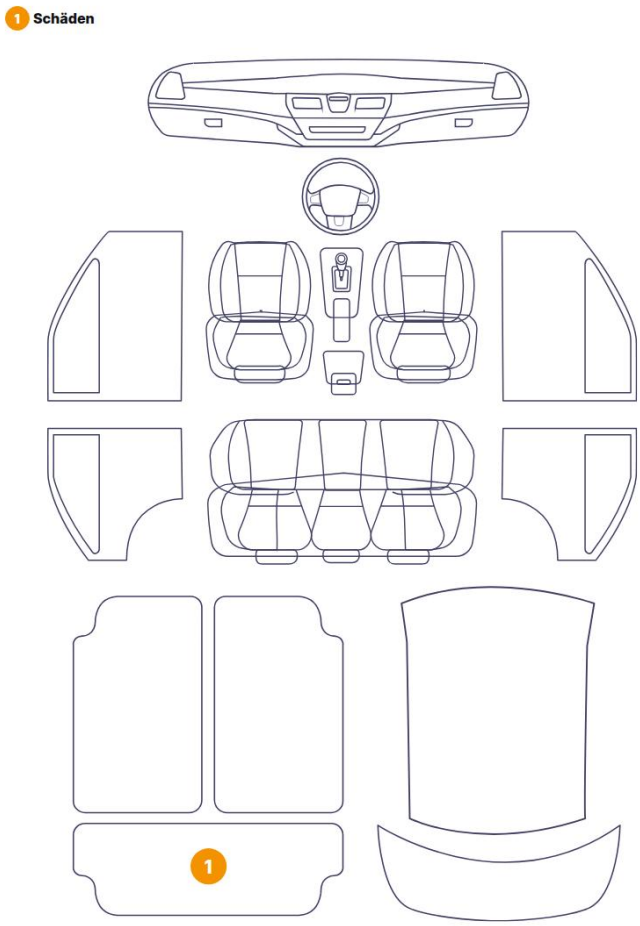
Cosmetic Damage

Component	Damage	Comments
1	Bumper / Front	Paint / Scratch / Scuff	
2	Door / Back Left	Bodywork / Dent / Dent	
3	Luggage Space Cover / Back	Interior / Dysfunctional	
4	Roof	Bodywork / Dent / Hail Area
