HYUNDAI i20

i20 1.2

VIN NO NLHBA51BAFZ342596

Inspection Report Summary

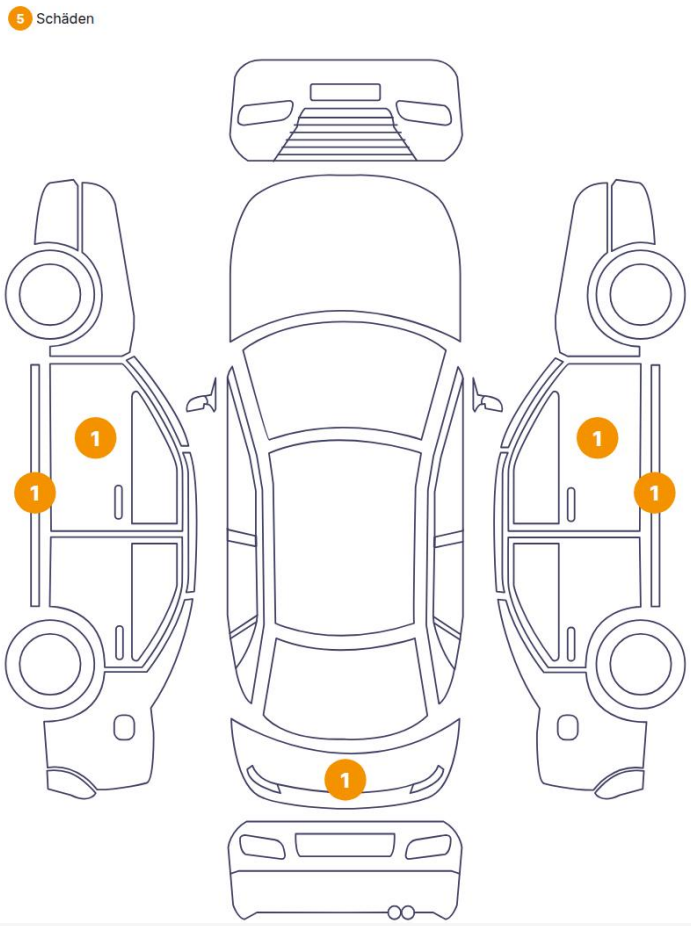
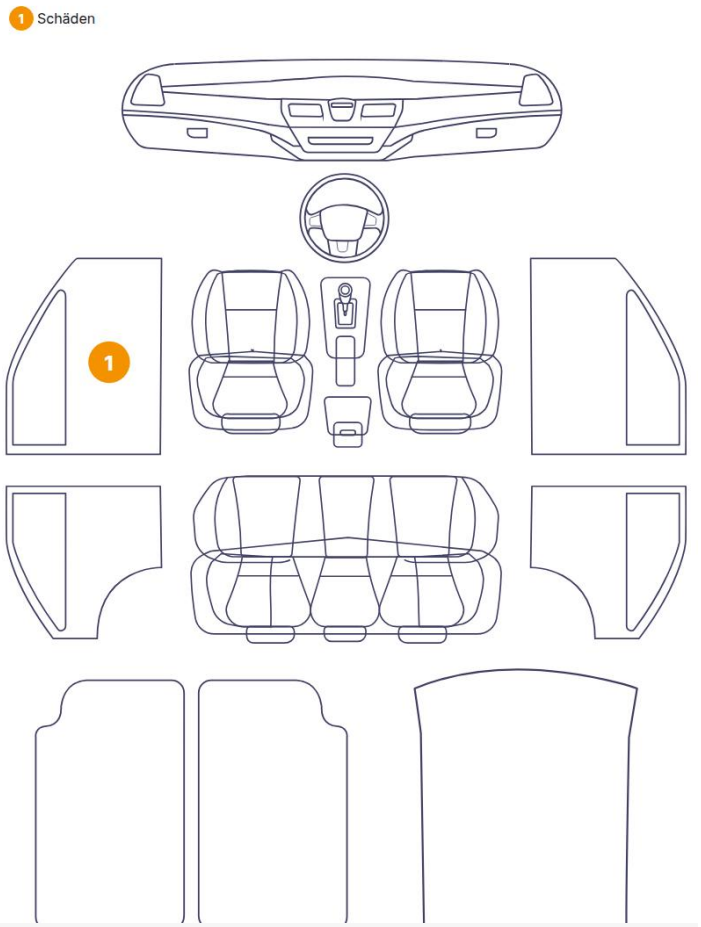
Cosmetic Damage

Component	Damage	Comments
1	Mirror / Front Left	Paint / Scratch / Scuff	
2	Rocker Panel / Center Left	Paint / Scratch / Line	
3	Panel Filling / Front Left	Interior / Scraped	
4	Tailgate	Paint / Corrosion	
5	Mirror / Front Right	Paint / Scratch / Scuff	
6	Rocker Panel / Center Right	Paint / Scratch / Line

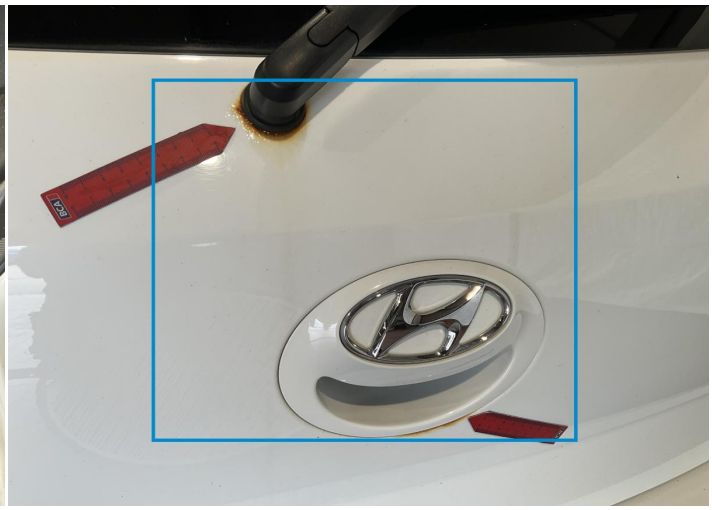
1. Mirror / Front Left
Paint / Scratch / Scuff -

2. Rocker Panel / Center Left
Paint / Scratch / Line -

3. Panel Filling / Front Left
Interior / Scraped -

4. Tailgate
Paint / Corrosion -

5. Mirror / Front Right
Paint / Scratch / Scuff -

6. Rocker Panel / Center Right
Paint / Scratch / Line -
