SKODA Kodiaq
Kodiaq 2.0 TDI DSG

VIN NO TMBJJ7PS2ST043127

Inspection Report Summary

Customer	BCA Online	Report Number	P20250926143202
Inspection Date / Place	2025-09-26 / BCA Neuss	Cosmetic Grade	2

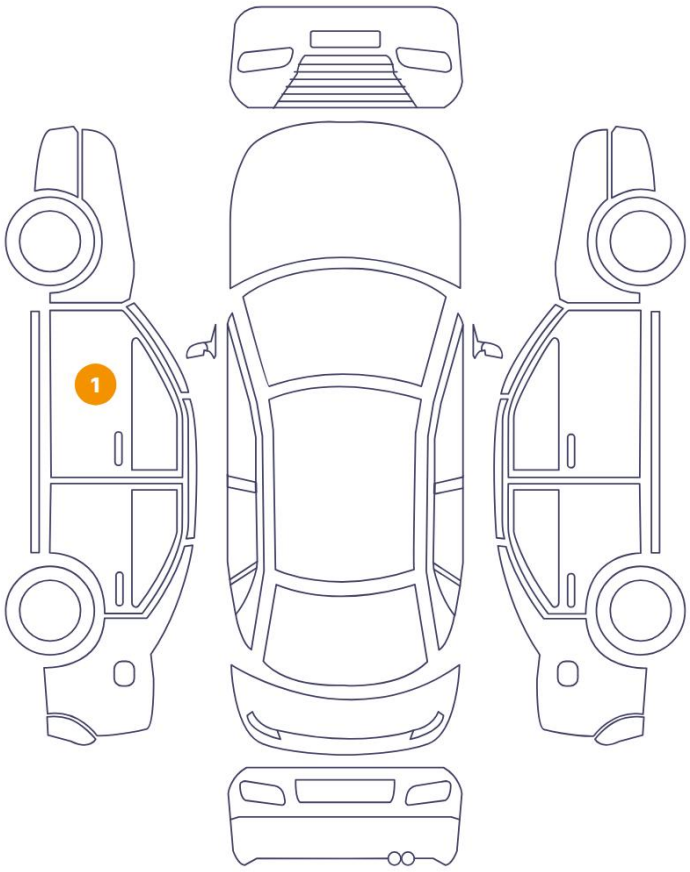
1 Schäden

Component	Damage	Comments
1	Door / Front Left	Paint / Poor Previous Repair

1. Door / Front Left
Paint / Poor Previous Repair -
