HYUNDAI ix35

VIN NO U5YZT81BABL027388

Inspection Report Summary

Customer	BCA Online	Report Number	P20251002090517
Inspection Date / Place	2025-10-02 / BCA Oberndorf	Cosmetic Grade	2

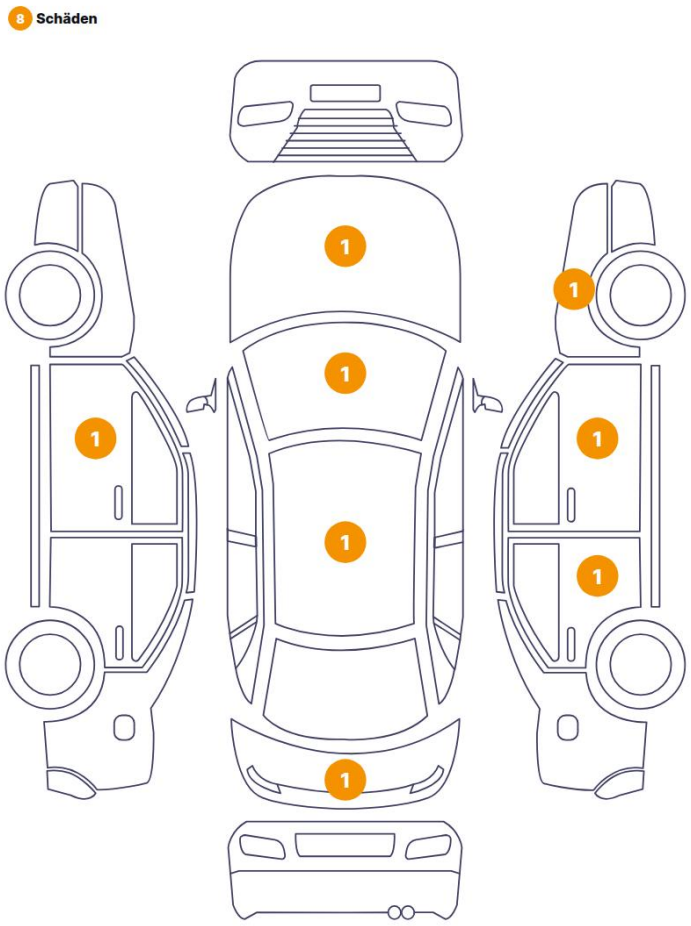
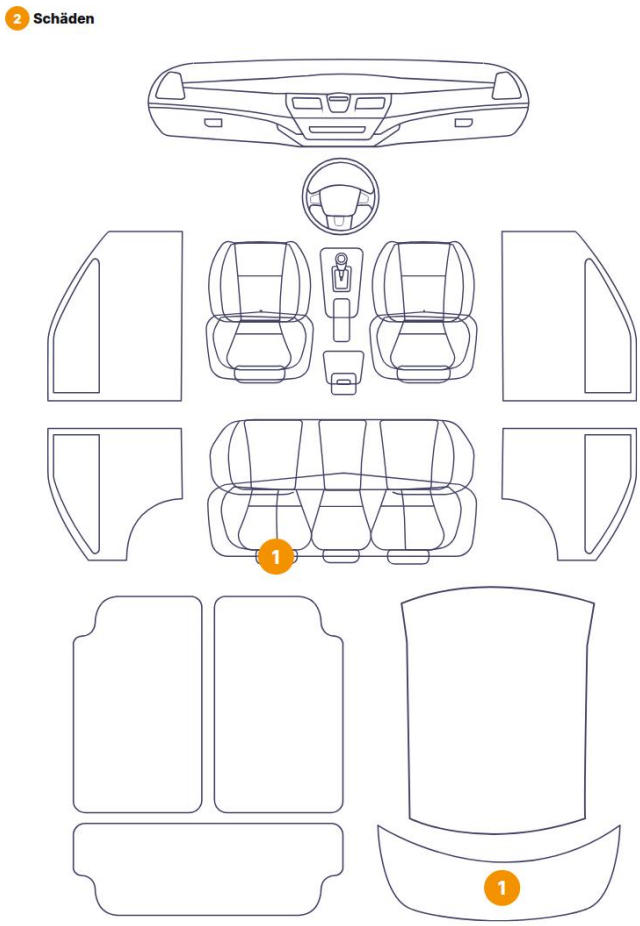
Cosmetic Damage

Component	Damage	Comments
1	Seat / Back Left	Interior / Ripped	
2	Tailgate Upholstery / Back	Interior / Scratched	
3	Door / Front Left	Bodywork / Dent / Dent	
4	Windshield / Front	Glass Break / Impact	
5	Door / Front Right	Paint / Poor Previous Repair	
6	Door / Back Right	Paint / Poor Previous Repair	
7	Tailgate	Paint / Poor Previous Repair	
8	Antenna Rod	Out of Bodywork / Breakage	
9	Hood	Bodywork / Dent / Dent	
10	Wing Stick / Front Right	Paint / Poor Previous Repair

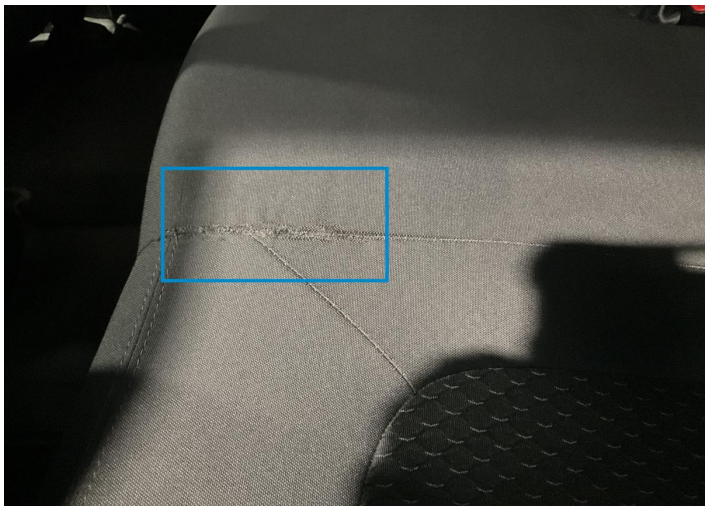
1. Seat / Back Left
Interior / Ripped -

2. Tailgate Upholstery / Back
Interior / Scratched -

3. Door / Front Left
Bodywork / Dent / Dent -

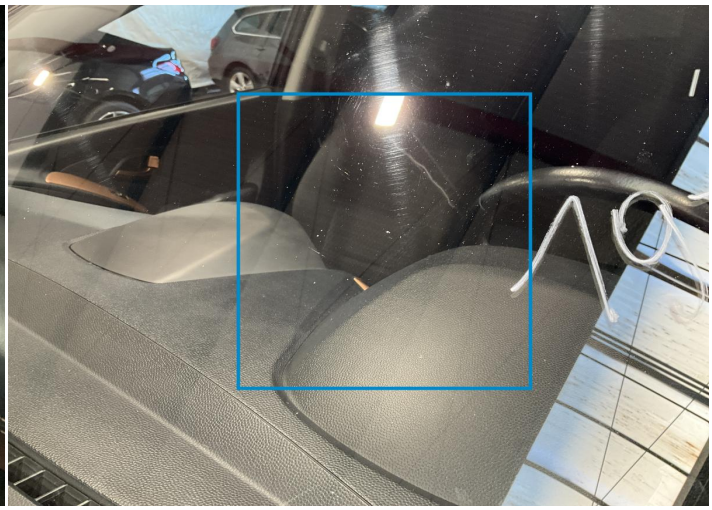
4. Windshield / Front
Glass Break / Impact -

5. Door / Front Right
Paint / Poor Previous Repair -

6. Door / Back Right
Paint / Poor Previous Repair -

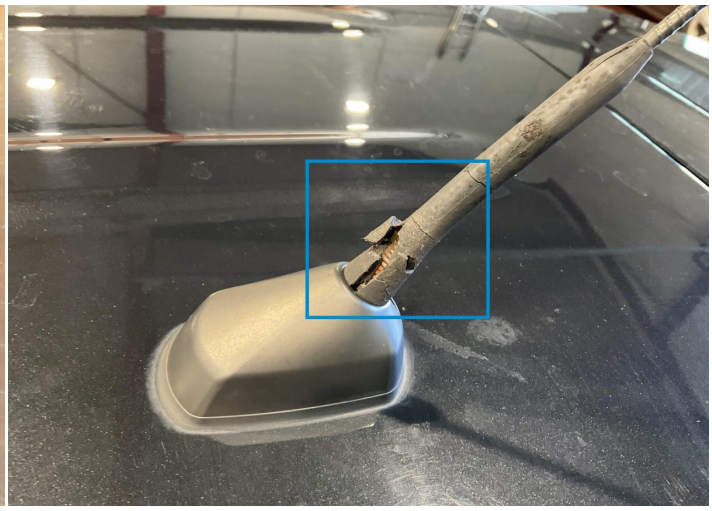
7. Tailgate
Paint / Poor Previous Repair -

8. Antenna Rod
Out of Bodywork / Breakage -

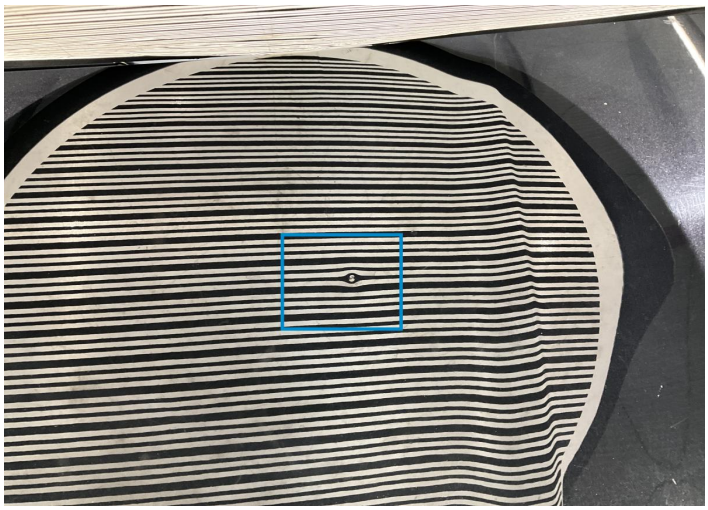
9. Hood
Bodywork / Dent / Dent -

10. Wing Stick / Front Right
Paint / Poor Previous Repair -
