CITROEN C3

VIN NO VF7FCHFXC28850168

Inspection Report Summary

Customer	BCA Online	Report Number	P20250915110710
Inspection Date / Place	2025-09-15 / Dürkop Goslar	Cosmetic Grade	5

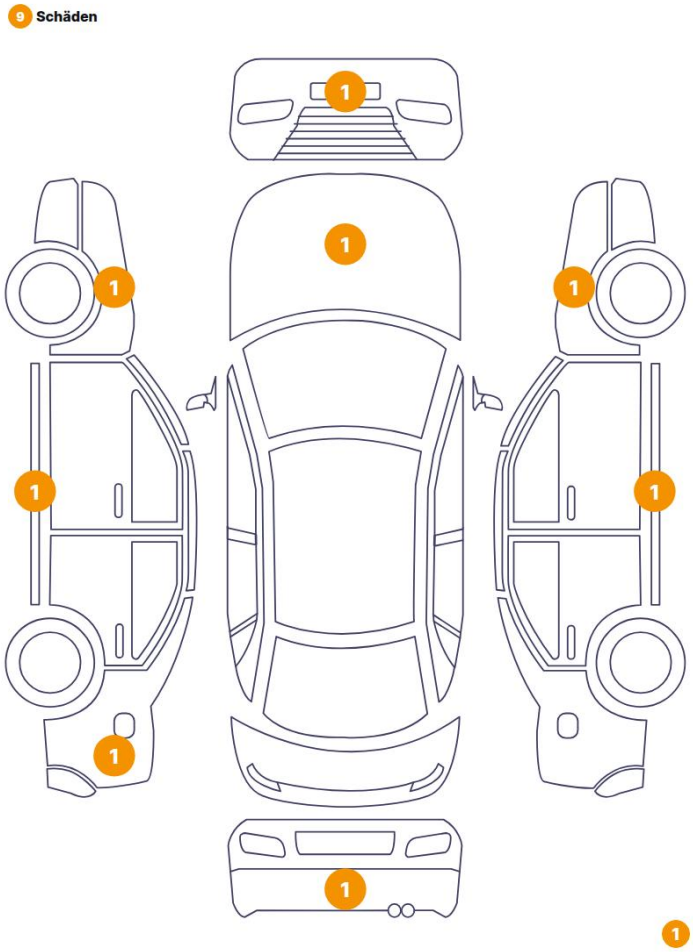
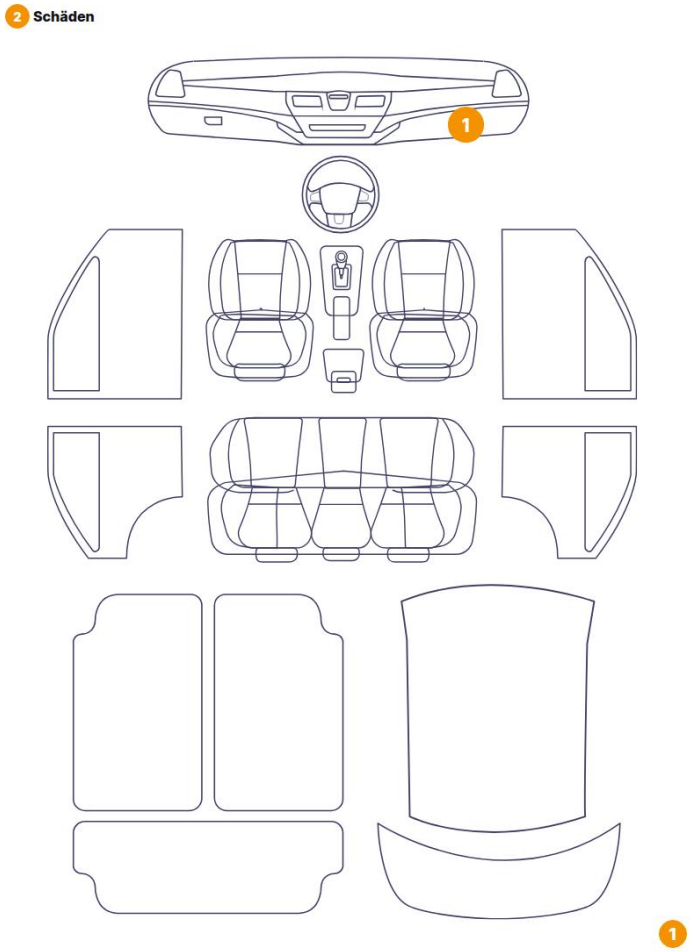
Cosmetic Damage

Component	Damage	Comments
1	Hood	Bodywork / Dent / Dent	
2	Bumper / Front	Bodywork / Breakage	
3	Other	Bodywork / Breakage	
4	Fender / Front Left	Paint / Corrosion	
5	Rocker Panel / Center Left	Paint / Corrosion	
6	Fender / Back Left	Paint / Corrosion	
7	Bumper / Back	Bodywork / Breakage	
8	Rocker Panel / Center Right	Paint / Corrosion	
9	Fender / Front Right	Paint / Corrosion	
10	Dashboard / Front	Interior / Dirty	
11	Other	Interior / Dirty

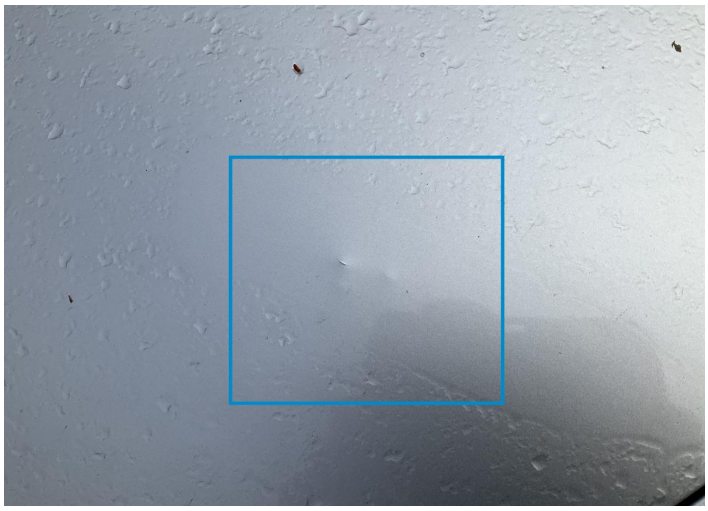
1. Hood
Bodywork / Dent / Dent -

2. Bumper / Front
Bodywork / Breakage -

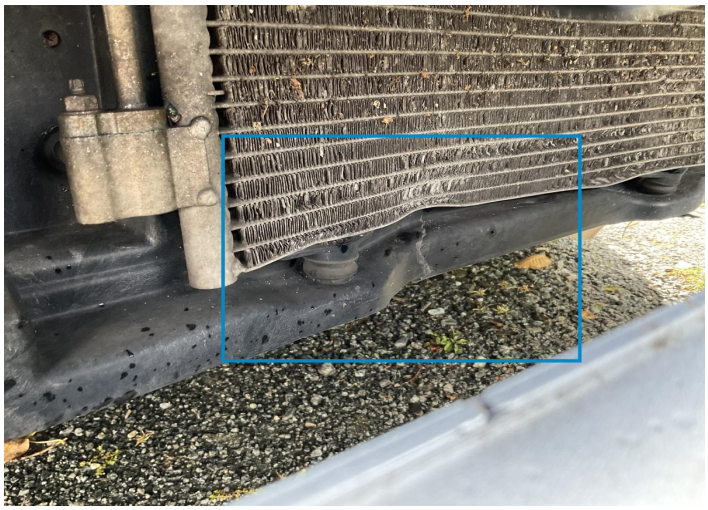
3.
Bodywork / Breakage -

4. Fender / Front Left
Paint / Corrosion -

5. Rocker Panel / Center Left
Paint / Corrosion -

6. Fender / Back Left
Paint / Corrosion -

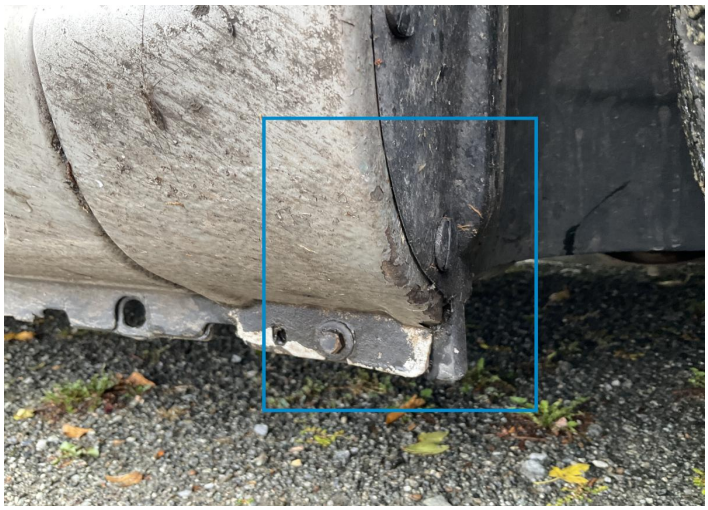
7. Bumper / Back
Bodywork / Breakage -

8. Rocker Panel / Center Right
Paint / Corrosion -

9. Fender / Front Right
Paint / Corrosion -

10. Dashboard / Front
Interior / Dirty -

11.
Interior / Dirty -
