CUPRA Leon
Leon 2.0 TSI DSG

VIN NO VSSZZZKLZNR062543

Inspection Report Summary

Customer	BCA Online	Report Number	P20250909130343
Inspection Date / Place	2025-09-09 / BCA Heidenheim	Cosmetic Grade	2

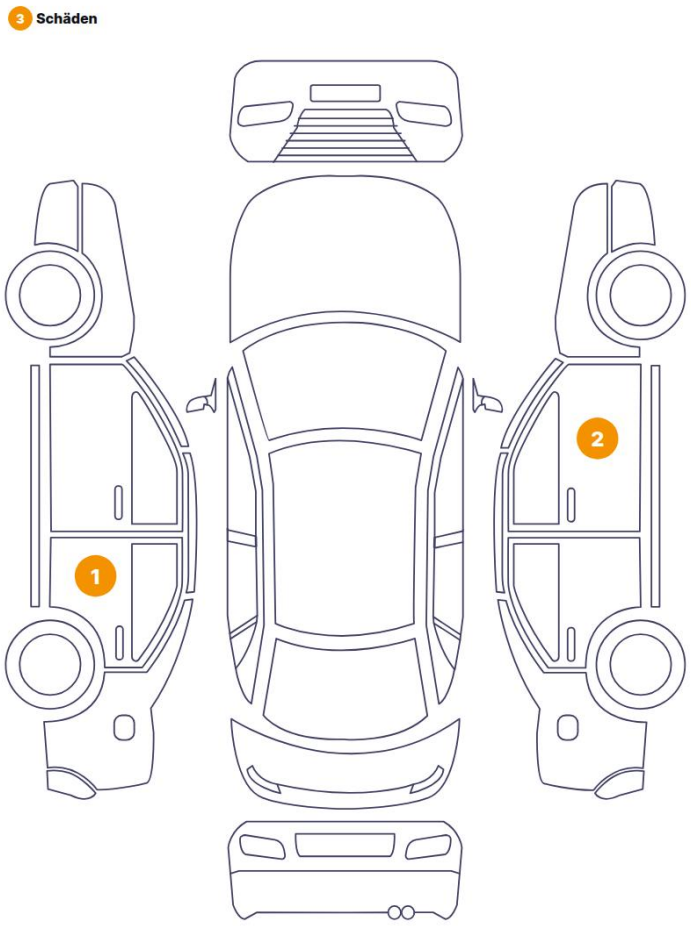
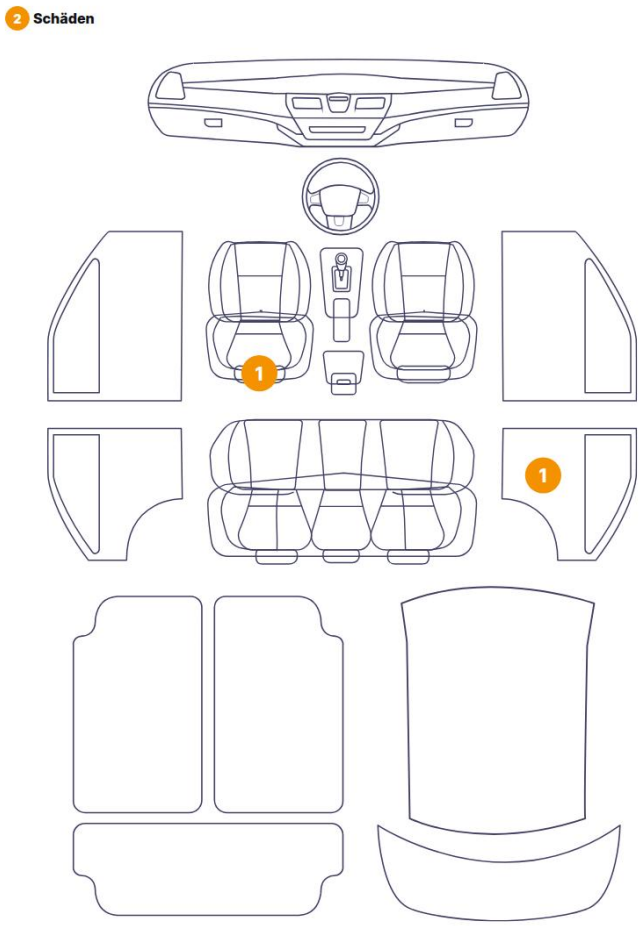
Cosmetic Damage

Component	Damage	Comments
1	Seat / Front Left	Interior / Scratched	
2	Panel Filling / Back Right	Interior / Scratched	
3	Door / Front Right	Paint / Scratch / Scuff	
4	Door Handle / Front Right	Paint / Scratch / Scuff	
5	Door / Back Left	Paint / Scratch / Scuff

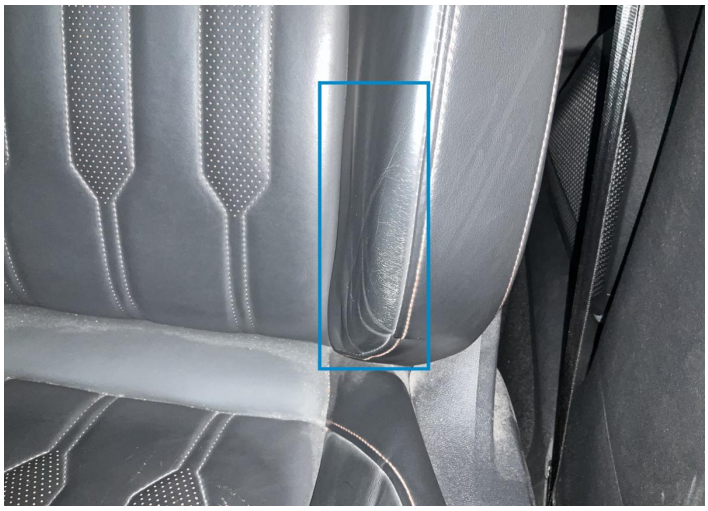
1. Seat / Front Left
Interior / Scratched -

2. Panel Filling / Back Right
Interior / Scratched -

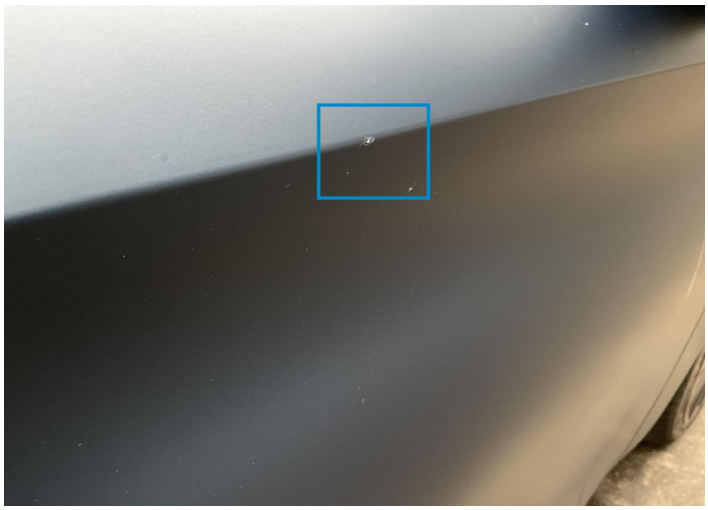
3. Door / Front Right
Paint / Scratch / Scuff -

4. Door Handle / Front Right
Paint / Scratch / Scuff -

5. Door / Back Left
Paint / Scratch / Scuff -
