OPEL Corsa

Corsa 1.2 Direct Injection Turbo Start/Stop

Inspection Report Summary

Customer	BCA Online	Report Number	P20250826141310
Inspection Date / Place	2025-08-26 / ARS Altmann AG Riedstadt	Cosmetic Grade	1

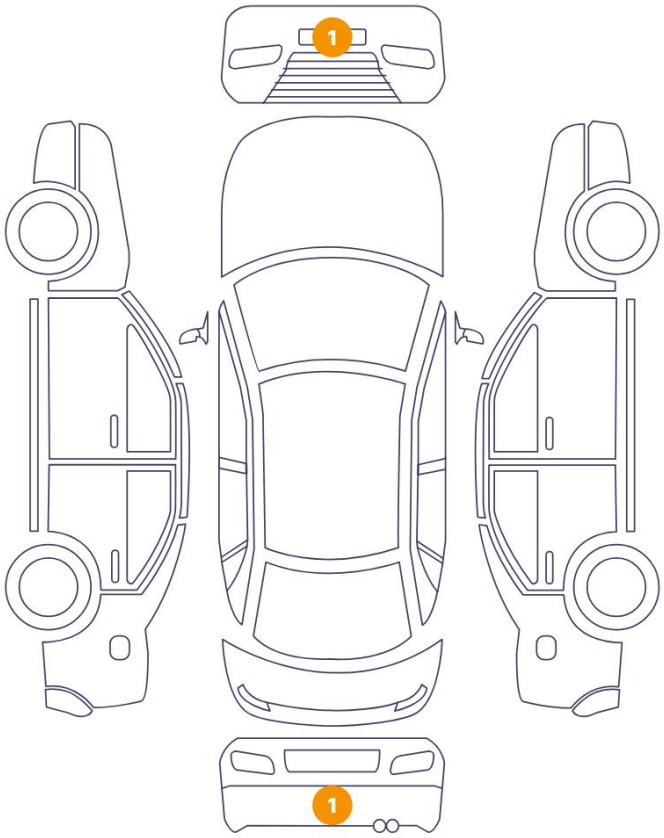
2 Schäden

Component	Damage	Comments
1	Bumper / Front	Paint / Stone Chip	
2	Bumper / Back	Paint / Stone Chip

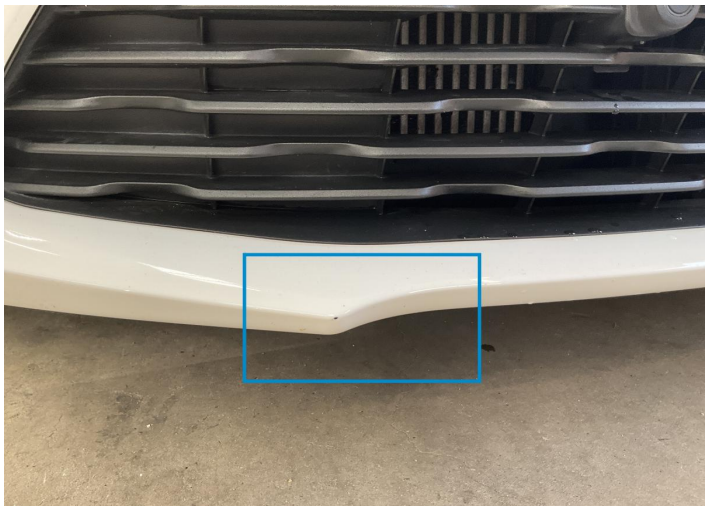
1. Bumper / Front
Paint / Stone Chip -

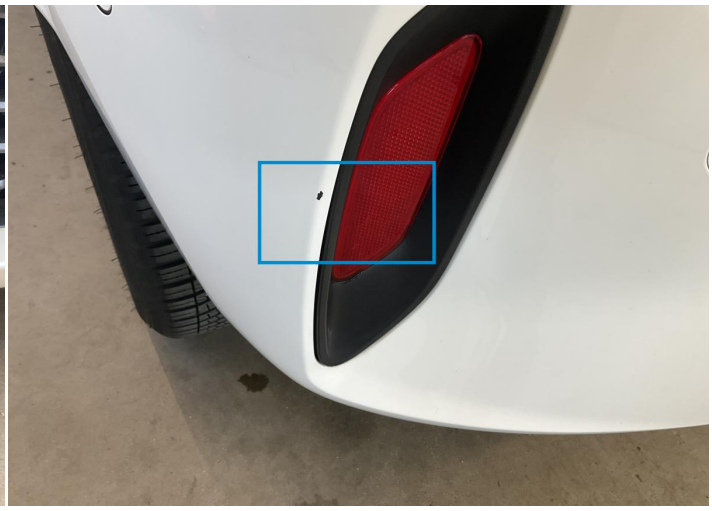
2. Bumper / Back
Paint / Stone Chip -
