OPEL Corsa
Corsa 1.4 16V

VIN NO W0L0SDL08B6097271

Inspection Report Summary

Customer	BCA Online	Report Number	P20250812090050
Inspection Date / Place	2025-08-12 / BCA Berlin	Cosmetic Grade	5

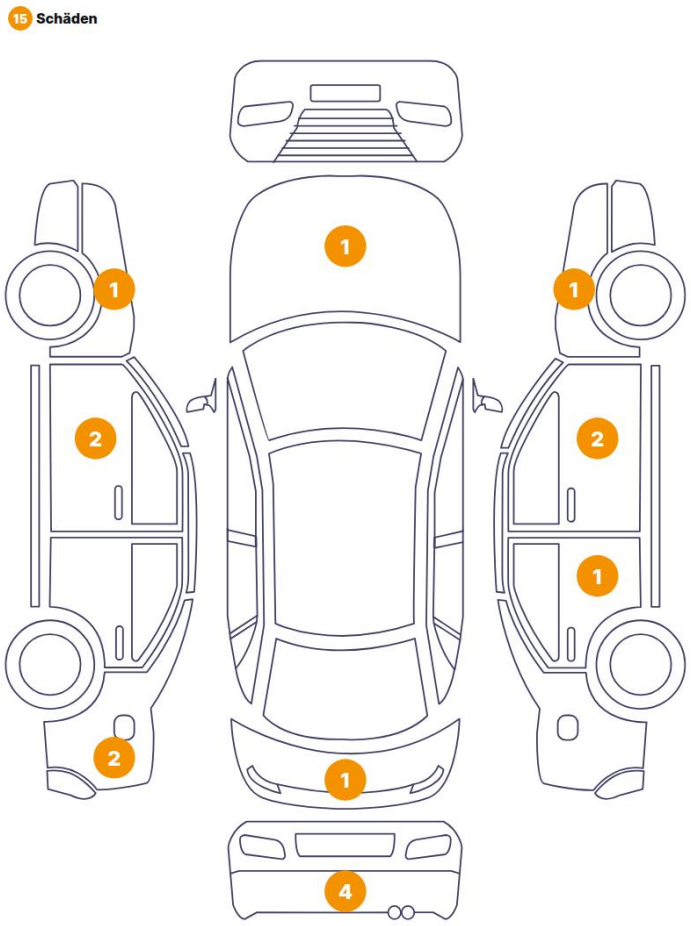
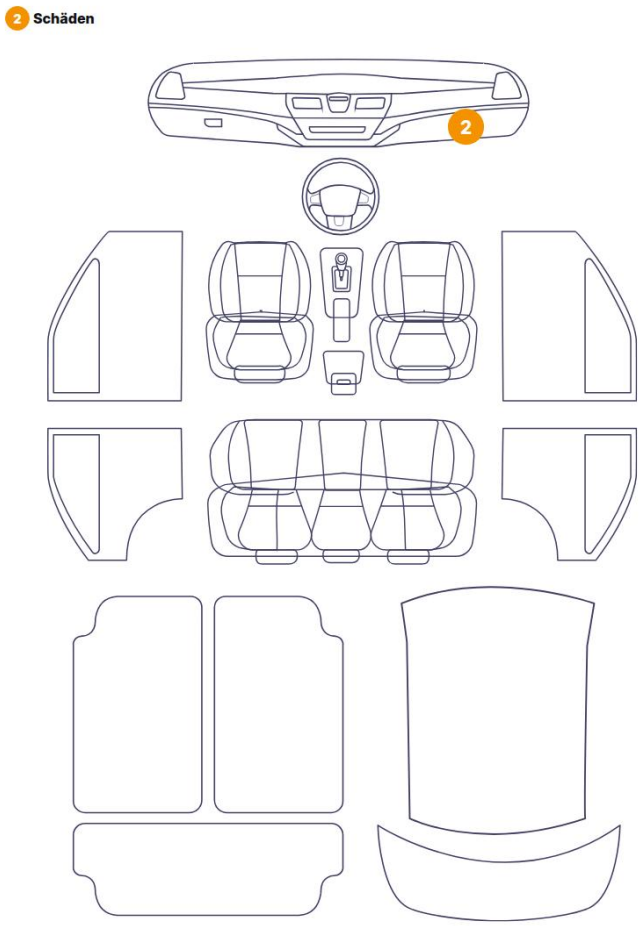
Component	Damage	Comments
1	Fender / Front Left	Paint / Scratch / Scuff	
2	Mirror Shell / Front Left	Paint / Scratch / Scuff	
3	Door / Front Left	Paint / Scratch / Scuff	
4	Side Panel / Back Left	Paint / Scratch / Scuff	
5	Side Panel / Back Left	Paint / Scratch / Scuff	
6	Bumper / Back	Bodywork / Breakage	
7	Bumper / Back	Paint / Scratch / Scuff	
8	Bumper / Back	Paint / Scratch / Scuff	
9	Tailgate light	Paint / Scratch / Scuff	
10	Bumper / Back	Paint / Scratch / Scuff	
11	Door / Back Right	Paint / Scratch / Scuff	
12	Door / Front Right	Paint / Scratch / Scuff

13	Door / Front Right	Bodywork / Dent / Dent
14	Fender / Front Right	Paint / Scratch / Scuff
15	Hood	Bodywork / Dent / Dent
16	Center Console	Interior / Dirty
17	Center Console	Interior / Dirty

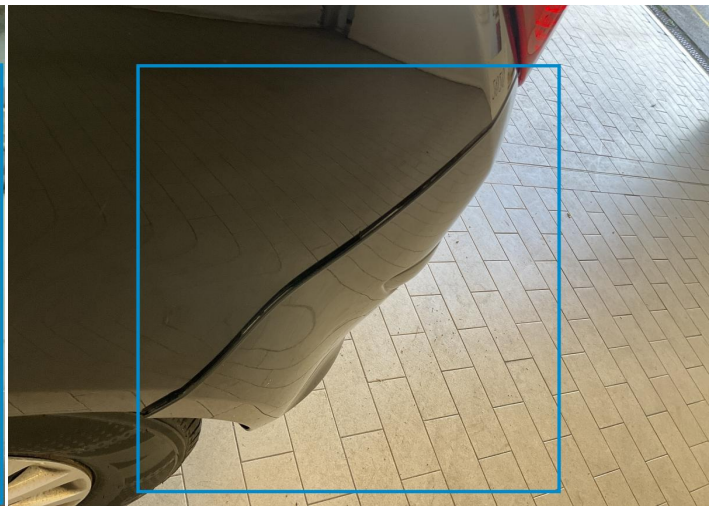
1. Fender / Front Left
Paint / Scratch / Scuff -

2. Mirror Shell / Front Left
Paint / Scratch / Scuff -

3. Door / Front Left
Paint / Scratch / Scuff -

4. Side Panel / Back Left
Paint / Scratch / Scuff -

5. Side Panel / Back Left
Paint / Scratch / Scuff -

6. Bumper / Back
Bodywork / Breakage -

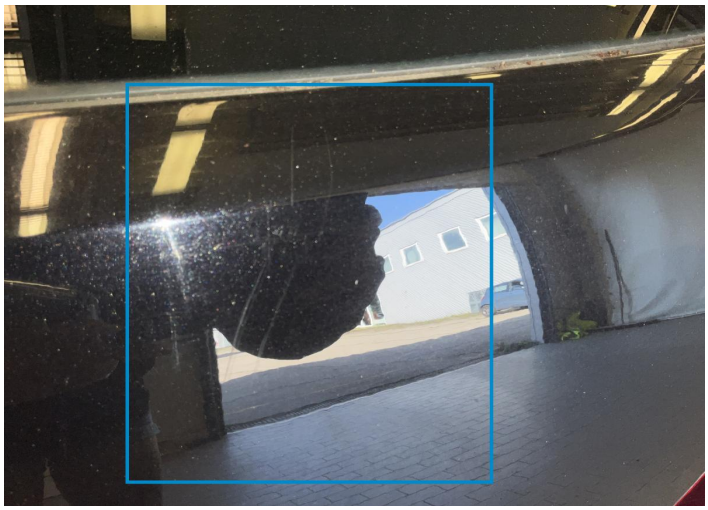
7. Bumper / Back
Paint / Scratch / Scuff -

8. Bumper / Back
Paint / Scratch / Scuff -

9. Tailgate light
Paint / Scratch / Scuff -

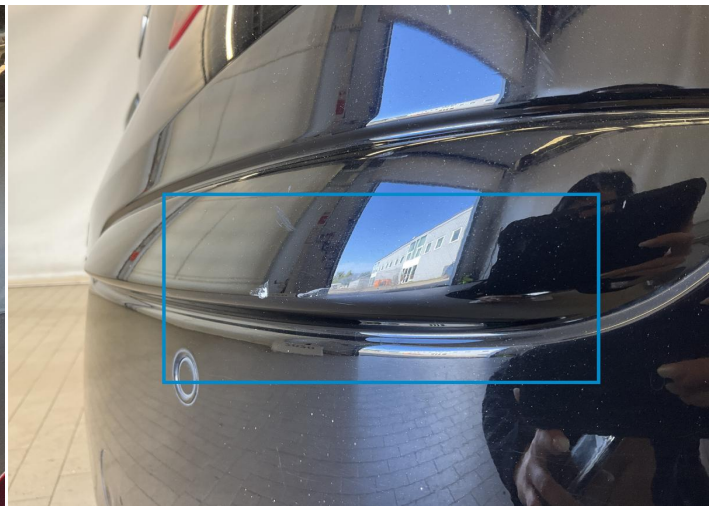
10. Bumper / Back
Paint / Scratch / Scuff -

11. Door / Back Right
Paint / Scratch / Scuff -

12. Door / Front Right
Paint / Scratch / Scuff -

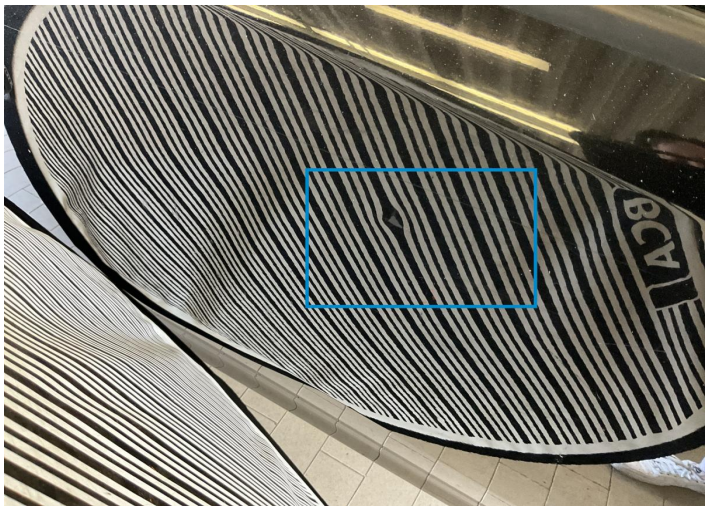
13. Door / Front Right
Bodywork / Dent / Dent -

14. Fender / Front Right
Paint / Scratch / Scuff -

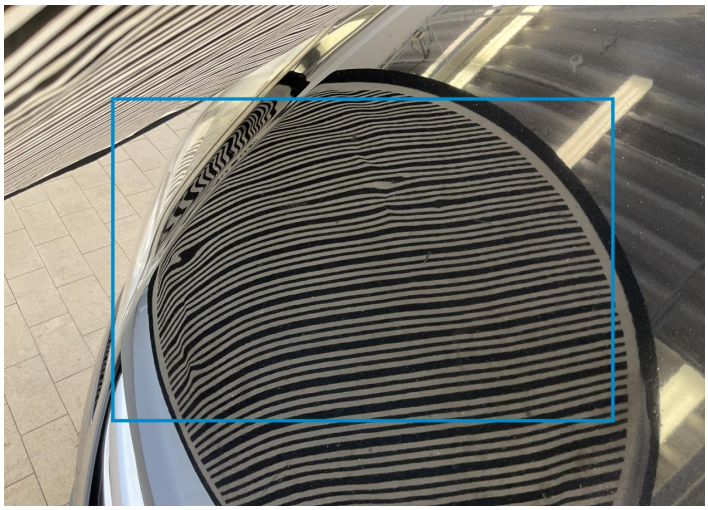
15. Hood
Bodywork / Dent / Dent -

16. Center Console
Interior / Dirty -

17. Center Console
Interior / Dirty -
