OPEL Corsa
Corsa 1.2

VIN NO W0L0XEP68G4131657

Inspection Report Summary

Customer	BCA Online	Report Number	P20250822123359
Inspection Date / Place	2025-08-22 / Dürkop Berlin-Prenzlauer Berg	Cosmetic Grade	3

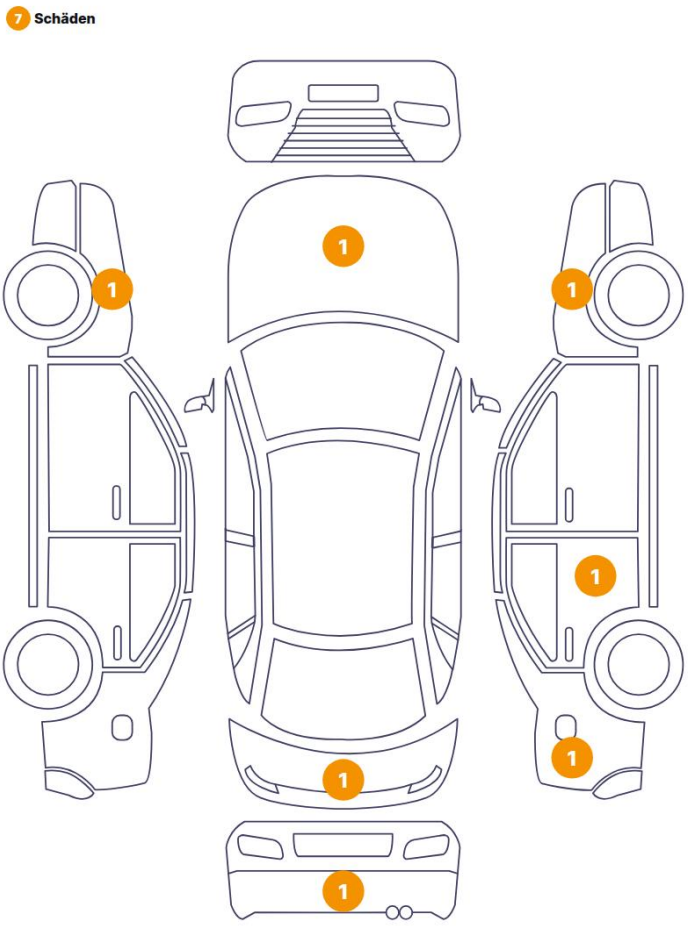
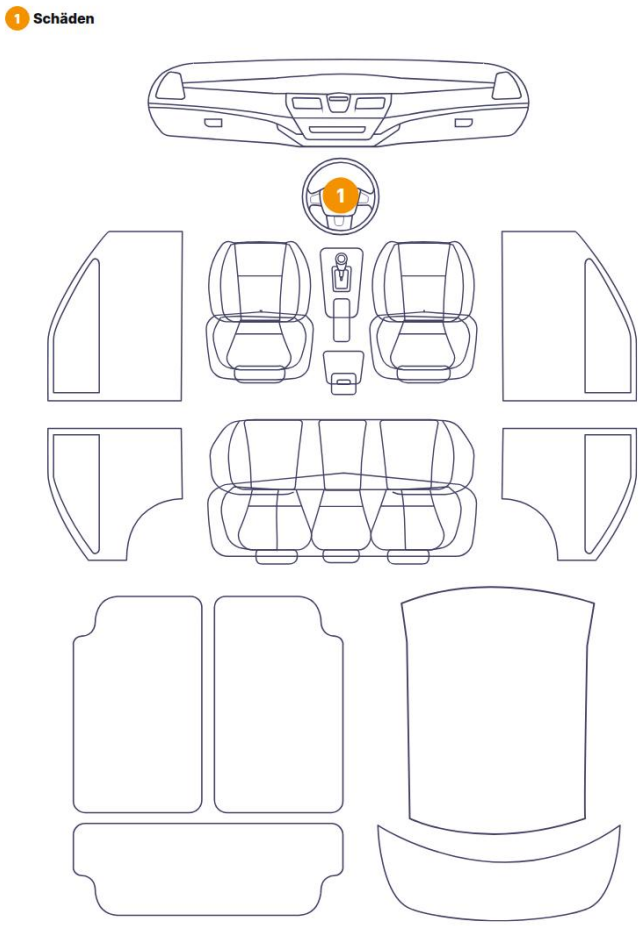
Cosmetic Damage

Component	Damage	Comments
1	Bumper / Back	Paint / Scratch / Scuff	
2	Side Panel / Back Right	Paint / Scratch / Scuff	
3	Door / Back Right	Paint / Scratch / Scuff	
4	Fender / Front Right	Paint / Scratch / Scuff	
5	Tailgate	Bodywork / Dent / Dent	
6	Fender / Front Left	Bodywork / Dent / Dent	
7	Hood	Bodywork / Dent / Dent	
8	Steering Wheel / Front	Interior / Worn - out

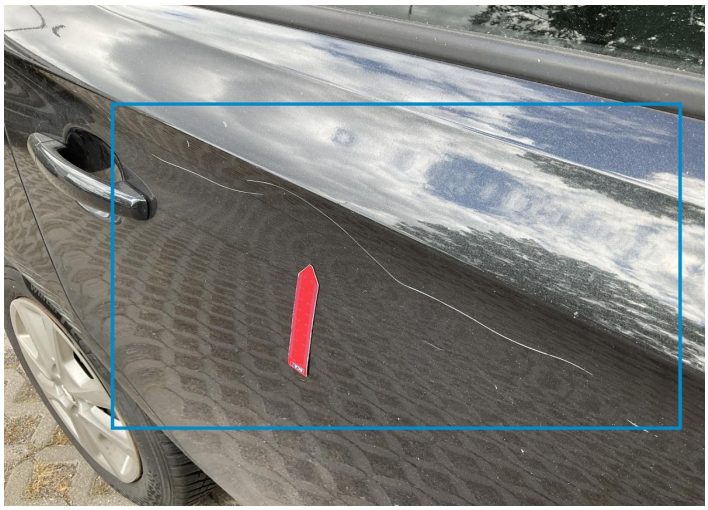
2. Side Panel / Back Right
Paint / Scratch / Scuff -

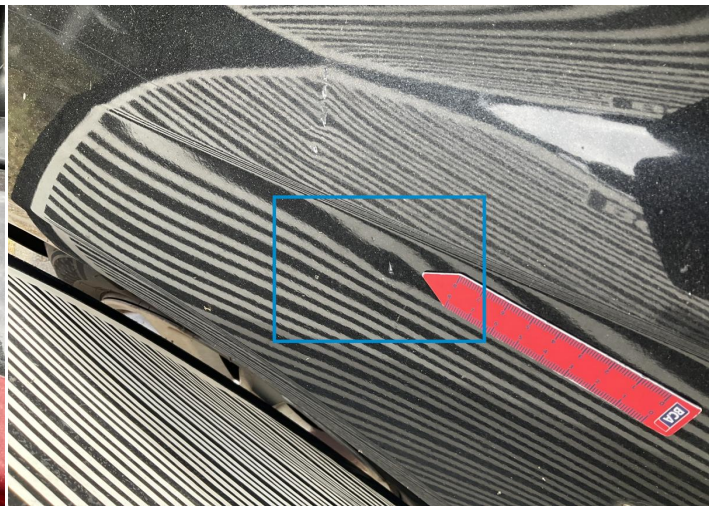
5. Tailgate
Bodywork / Dent / Dent -

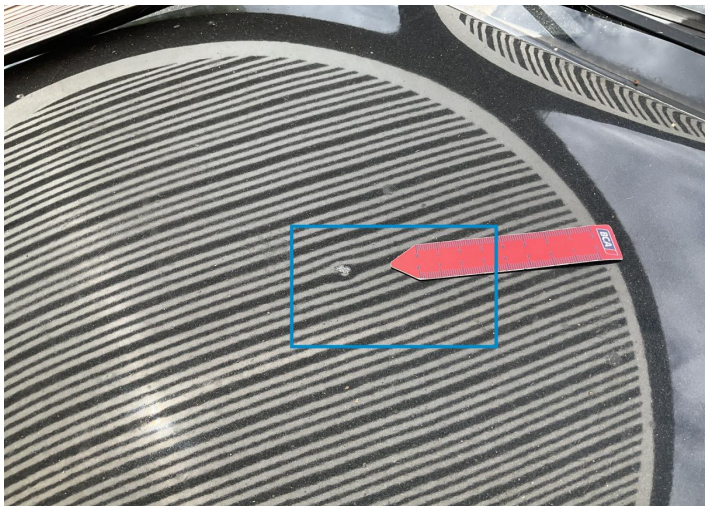
6. Fender / Front Left
Bodywork / Dent / Dent -
