OPEL Astra

Astra 1.3 CDTI DPF ecoFLEX Sports TourerStart/Stop

VIN NO W0LPD8EA5C8017786

Inspection Report Summary

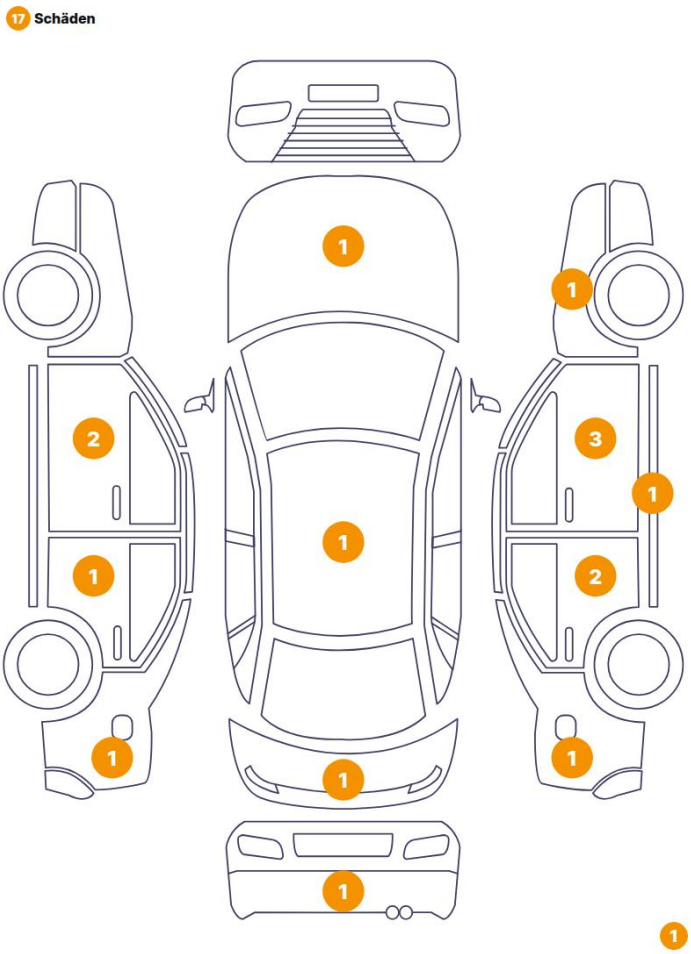
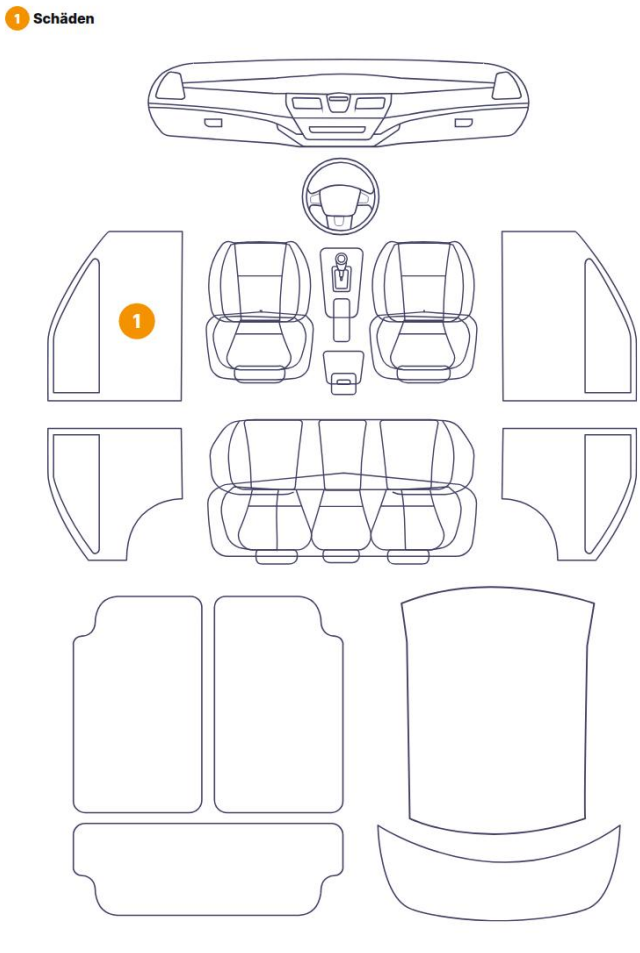
Cosmetic Damage

Component	Damage	Comments
1	Roof	Paint / Chipping	
2	Hood	Paint / Scratch / Scuff	
3	Door / Front Left	Bodywork / Dent / Dent	
4	Fender / Back Left	Bodywork / Dent / Dent	
5	Bumper / Back	Bodywork / Breakage	
6	Tailgate	Bodywork / Dent / Dent	
7	Fender / Back Right	Bodywork / Dent / Dent	
8	Door / Back Right	Bodywork / Dent / Dent	
9	Rocker Panel / Center Right	Bodywork / Dent / Dent	
10	Door / Front Right	Bodywork / Dent / Dent	
11	Door / Front Right	Bodywork / Dent / Dent	
12	Door / Back Right	Paint / Poor Previous Repair

13	Door / Front Right	Paint / Poor Previous Repair
14	Fender / Front Right	Bodywork / Dent / Dent
15	Door / Back Left	Paint / Poor Previous Repair
16	Door / Front Left	Paint / Poor Previous Repair
17	Panel Filling / Front Left	Interior / Worn - out
18	Other	Bodywork / Dent / Dent

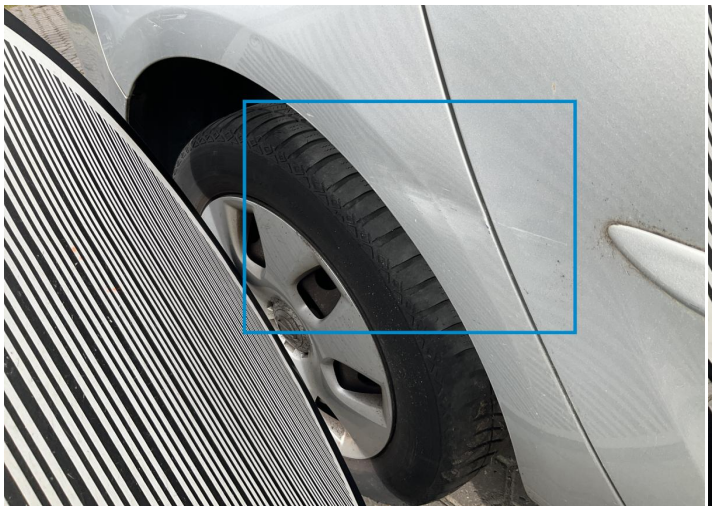
7. Fender / Back Right
Bodywork / Dent / Dent -

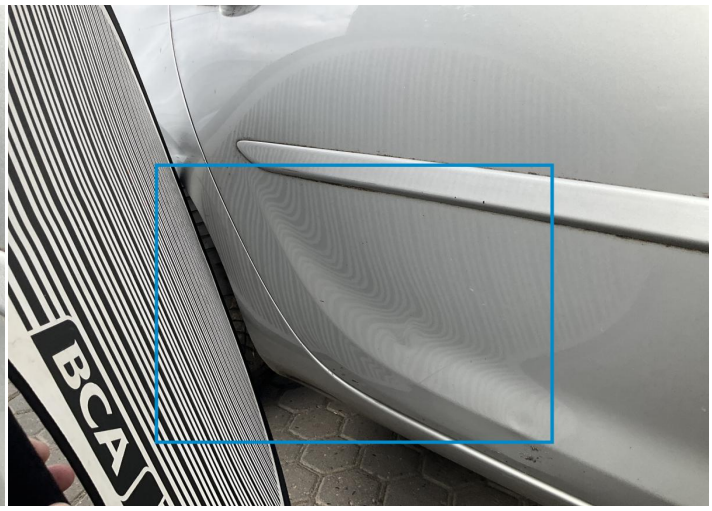
8. Door / Back Right
Bodywork / Dent / Dent -

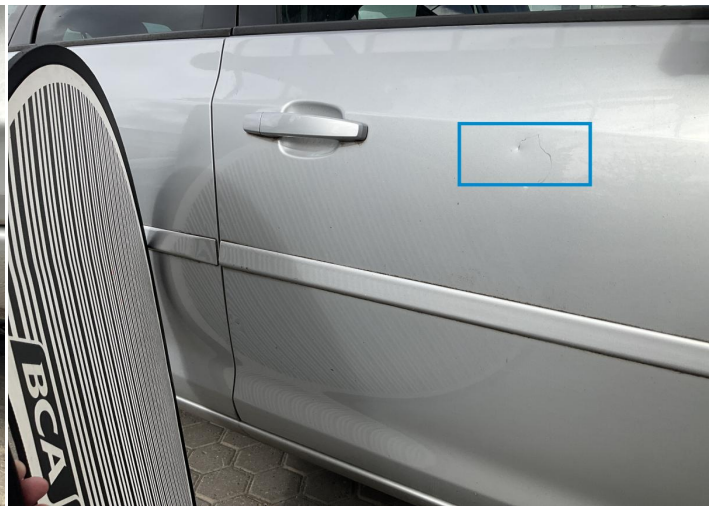
10. Door / Front Right
Bodywork / Dent / Dent -

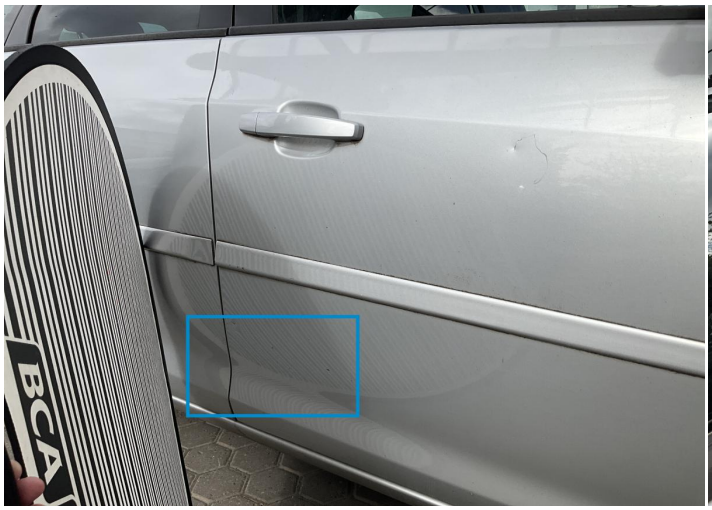
11. Door / Front Right
Bodywork / Dent / Dent -

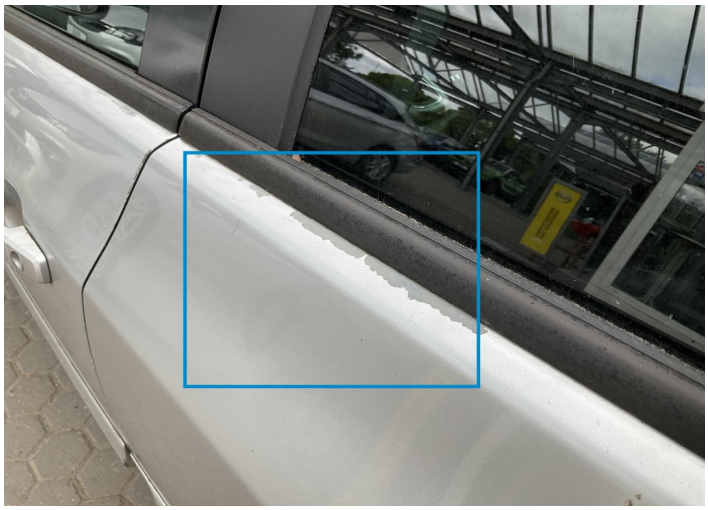
15. Door / Back Left
Paint / Poor Previous Repair -
