OPEL Astra
Astra 2.0 CDTI DPF Sports Tourer

VIN NO W0LPD8EN6D8020376

Inspection Report Summary

Customer	BCA Online	Report Number	P20250908120120
Inspection Date / Place	2025-09-08 / SULOJA Mönchengladbach	Cosmetic Grade	5

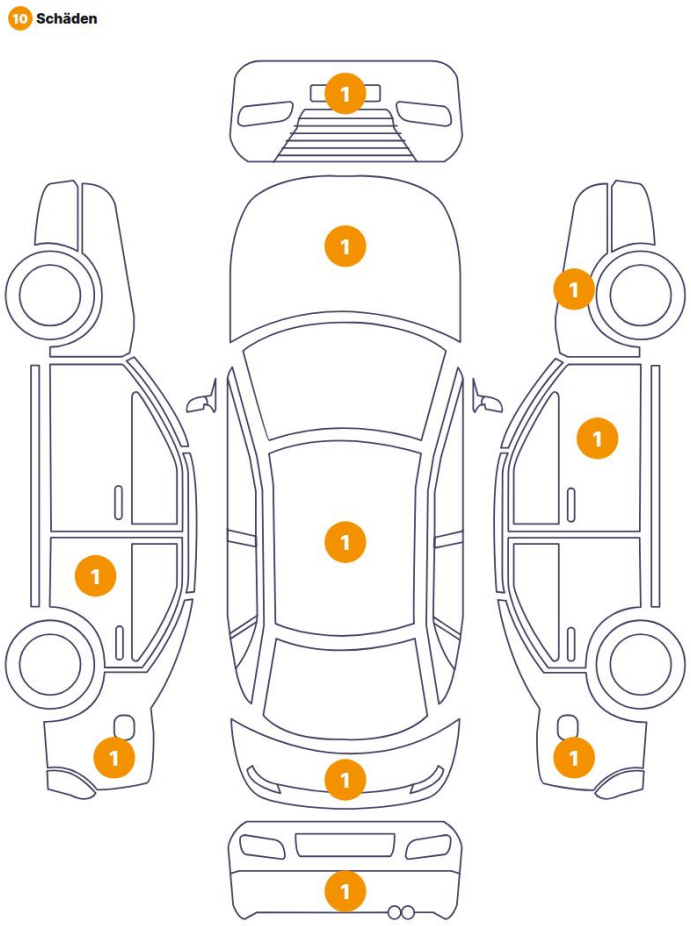
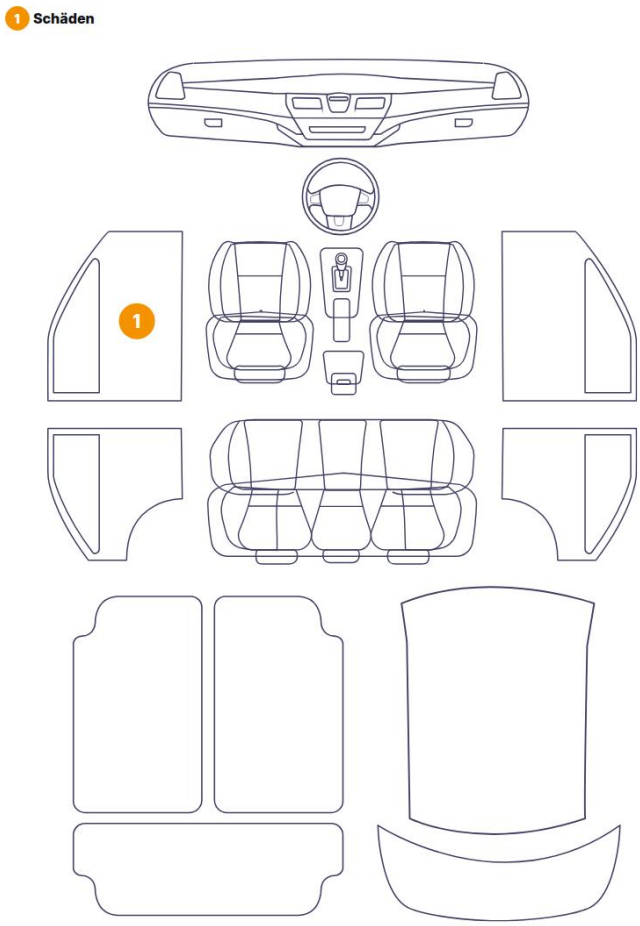
Cosmetic Damage

Component	Damage	Comments
1	Corner Bumper / Front Right	Bodywork / Breakage / Hole	
2	Hood	Bodywork / Dent / Dent	
3	Door / Back Left	Paint / Scratch / Scuff	
4	Side Panel / Back Left	Paint / Scratch / Scuff	
5	Tailgate	Bodywork / Dent / Dent	
6	Bumper / Back	Paint / Scratch / Scuff	
7	Roof	Bodywork / Dent / Dent	
8	Side Panel / Back Right	Bodywork / Breakage / Hole	
9	Door / Front Right	Paint / Scratch / Scuff	
10	Fender / Front Right	Bodywork / Dent / Dent	
11	Panel Filling / Front Left	Interior / Scratched

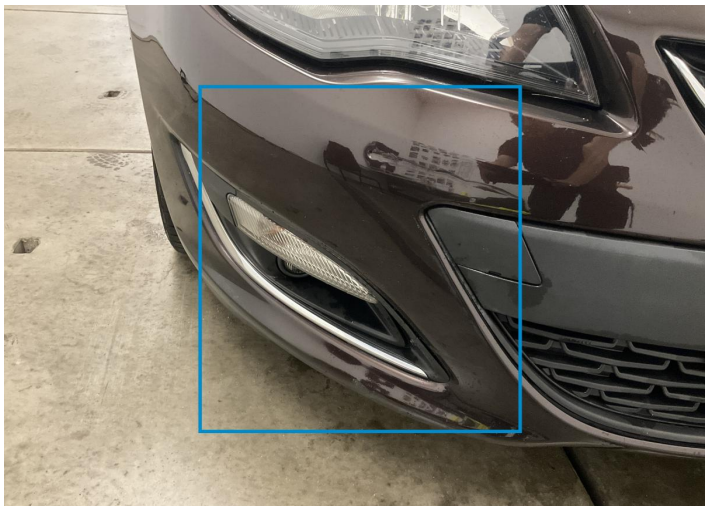
1. Corner Bumper / Front Right
Bodywork / Breakage / Hole -

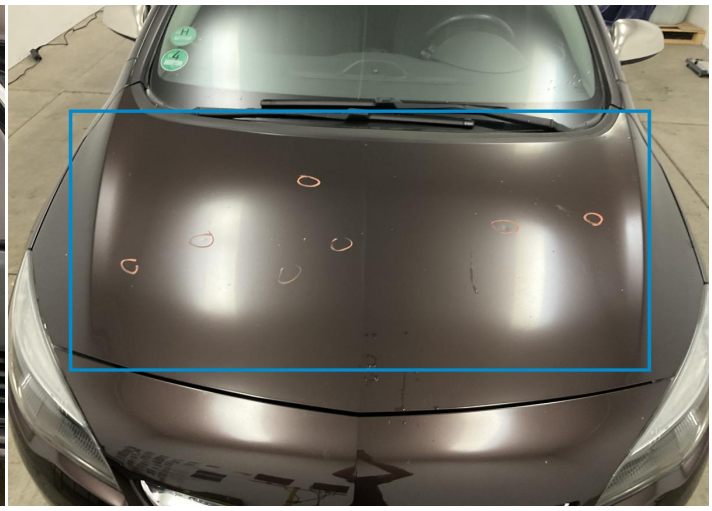
2. Hood
Bodywork / Dent / Dent -
