OPEL Corsa
Corsa 1.4 Turbo (ecoFLEX) Start/Stop

VIN NO W0V0XEP68J4261812

Inspection Report Summary

Customer	BCA Online	Report Number	P20250605132423
Inspection Date / Place	2025-06-05 / BCA Oberndorf	Cosmetic Grade	2

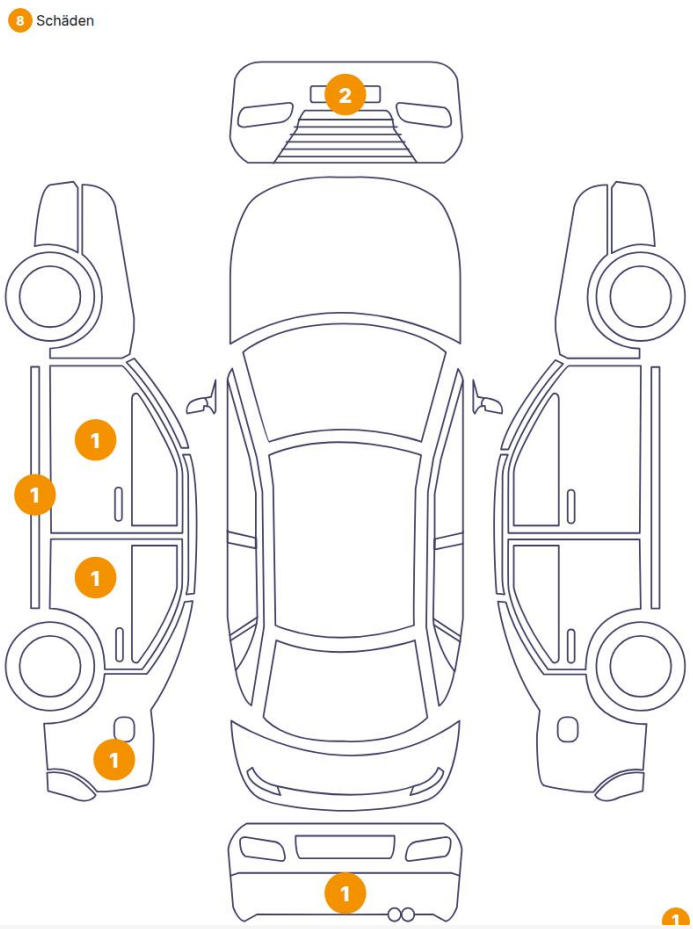
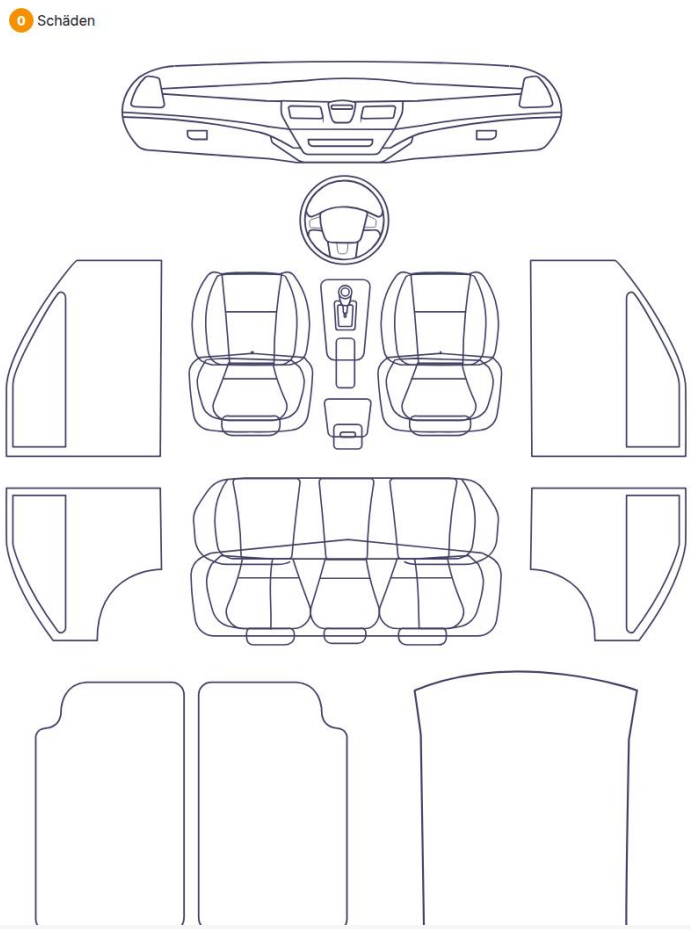
Cosmetic Damage

Component	Damage	Comments
1	Other	Anomalyon Element	
2	Blade/spoiler / Front	Bodywork / Breakage	
3	Bumper / Front	Paint / Scratch / Scuff	
4	Rocker Panel / Center Left	Bodywork / Dent / Dent	
5	Door / Back Left	Bodywork / Dent / Dent	
6	Door Edge / Back Left	Bodywork / Dent / Dent	
7	Pillar / Front Left	Bodywork / Dent / Dent	
8	Bumper / Back	Paint / Scratch / Line
