OPEL Corsa
Corsa 1.4 Turbo (ecoFLEX) Start/Stop

VIN NO W0V0XEP68J4261812

Inspection Report Summary

Customer	BCA Online	Report Number	P20250605132423
Inspection Date / Place	2025-06-05 / BCA Oberndorf	Cosmetic Grade	2

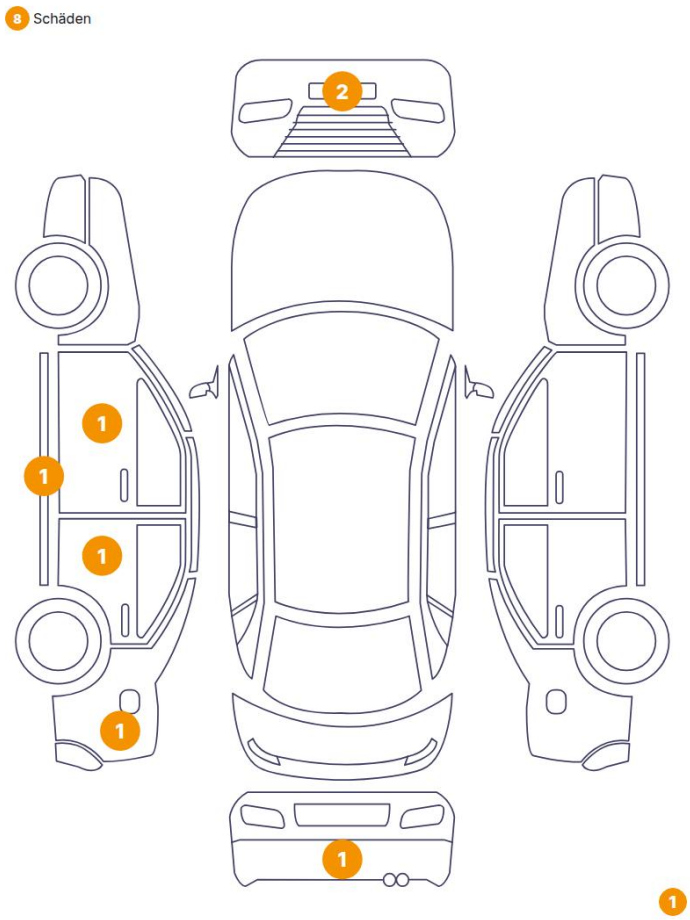
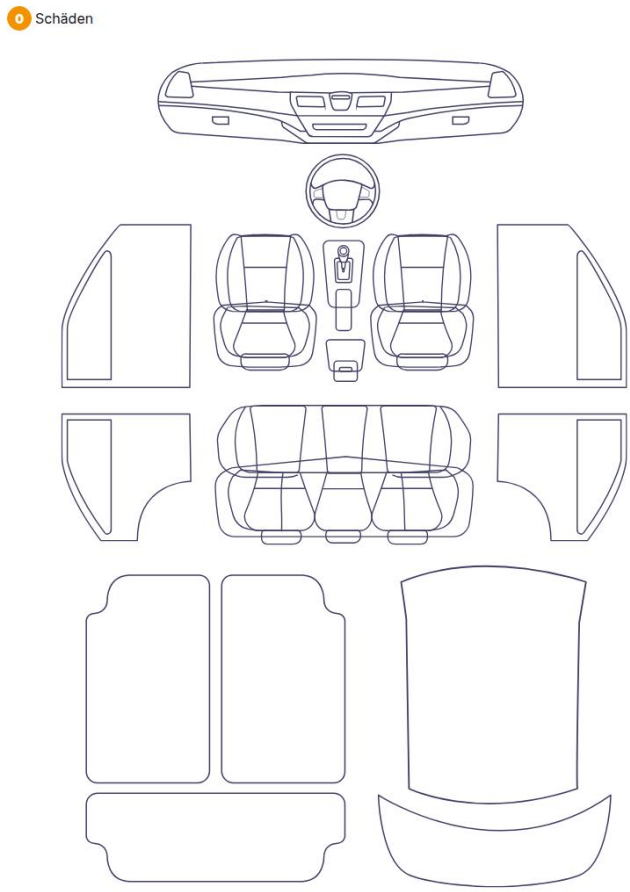
Cosmetic Damage

Component	Damage	Comments
1	Other	Anomalyon Element	
2	Blade/spoiler / Front	Bodywork / Breakage	
3	Bumper / Front	Paint / Scratch / Scuff	
4	Rocker Panel / Center Left	Bodywork / Dent / Dent	
5	Door / Back Left	Bodywork / Dent / Dent	
6	Door Edge / Back Left	Bodywork / Dent / Dent	
7	Pillar / Front Left	Bodywork / Dent / Dent	
8	Bumper / Back	Paint / Scratch / Line

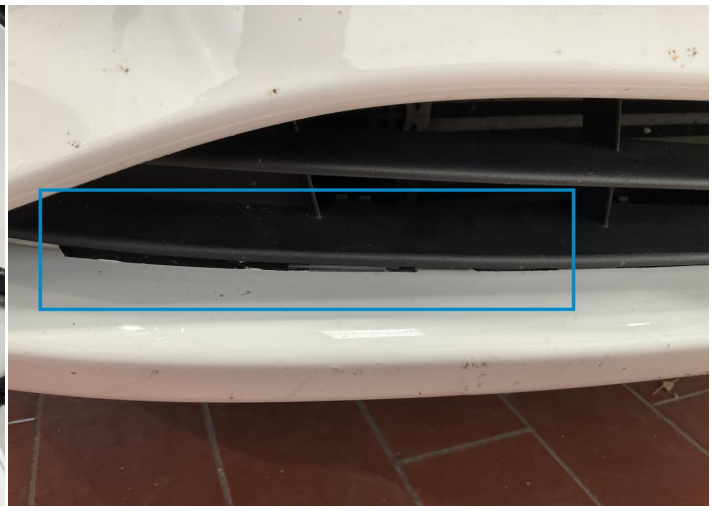
1.
Anomalyon Element -

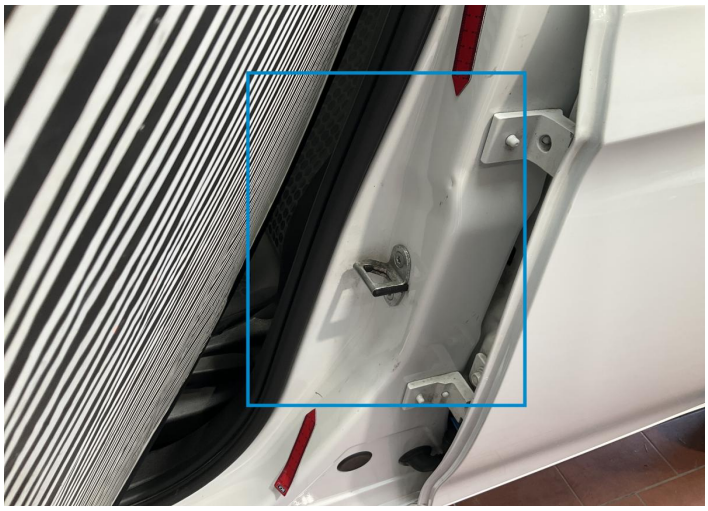
6. Door Edge / Back Left
Bodywork / Dent / Dent -
