MERCEDES-BENZ C-Klasse
C 220 d T 9G-TRONIC

VIN NO W1K2052141G077283

Inspection Report Summary

Customer	BCA Online	Report Number	P20250924110249
Inspection Date / Place	2025-09-24 / ARS Altmann AG Wolnzach	Cosmetic Grade	4

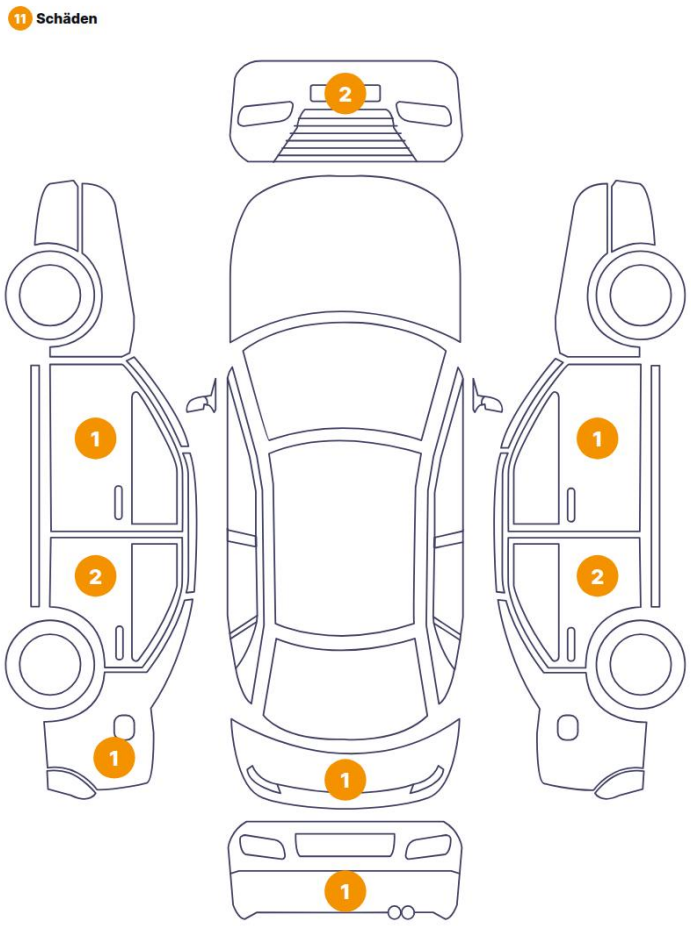
Cosmetic Damage

Component	Damage	Comments
1	Bumper / Front	Paint / Scratch / Scuff	
2	Door / Front Left	Paint / Scratch / Scuff	
3	Pillar / Back Left	Bodywork / Dent / Dent	
4	Door / Back Left	Paint / Scratch / Scuff	
5	Side Panel / Back Left	Paint / Scratch / Scuff	
6	Bumper / Back	Paint / Scratch / Scuff	
7	Tailgate	Paint / Scratch / Scuff	
8	Luggage Space Cover / Back	Interior / Scratched	
9	Door / Back Right	Paint / Scratch / Scuff	
10	Pillar / Back Right	Paint / Scratch / Scuff	
11	Door / Front Right	Paint / Scratch / Scuff	
12	Bumper / Front	Paint / Scratch / Scuff

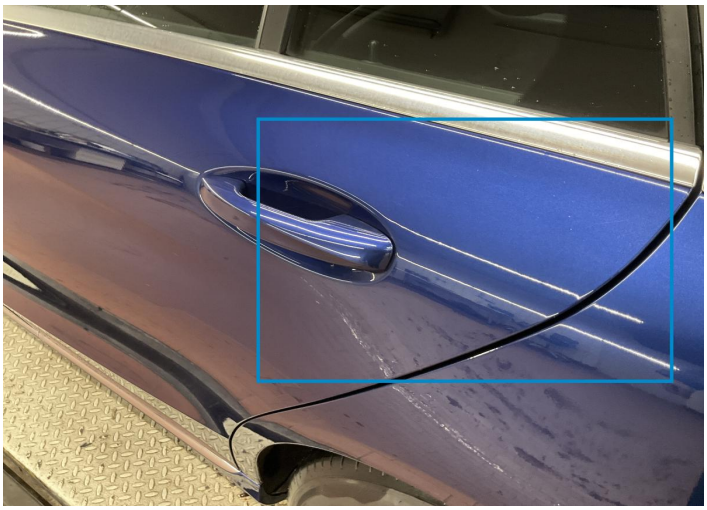
1. Bumper / Front
Paint / Scratch / Scuff -

2. Door / Front Left
Paint / Scratch / Scuff -

3. Pillar / Back Left
Bodywork / Dent / Dent -

4. Door / Back Left
Paint / Scratch / Scuff -

5. Side Panel / Back Left
Paint / Scratch / Scuff -

6. Bumper / Back
Paint / Scratch / Scuff -

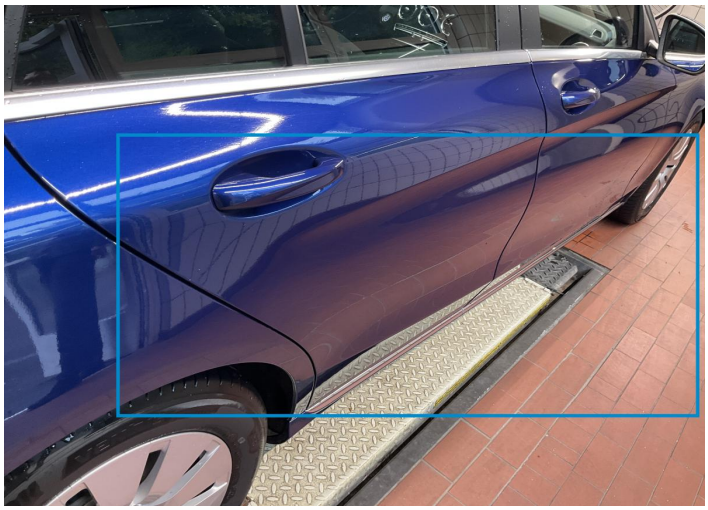
7. Tailgate
Paint / Scratch / Scuff -

8. Luggage Space Cover / Back
Interior / Scratched -

9. Door / Back Right
Paint / Scratch / Scuff -

10. Pillar / Back Right
Paint / Scratch / Scuff -

11. Door / Front Right
Paint / Scratch / Scuff -

12. Bumper / Front
Paint / Scratch / Scuff -
