MERCEDES-BENZ C-Klasse
AMG C 43 Coupe 4Matic AMG Speedshift TCT 9G

VIN NO W1K2053641G089941

Inspection Report Summary

|			
Customer	BCA Online	Report Number	P20250915141142
Inspection Date / Place	2025-09-15 / ARS Altmann AG Riedstadt	Cosmetic Grade	3

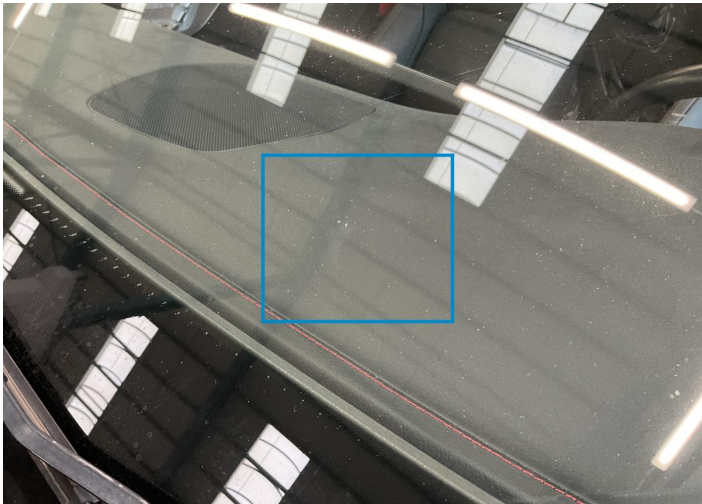
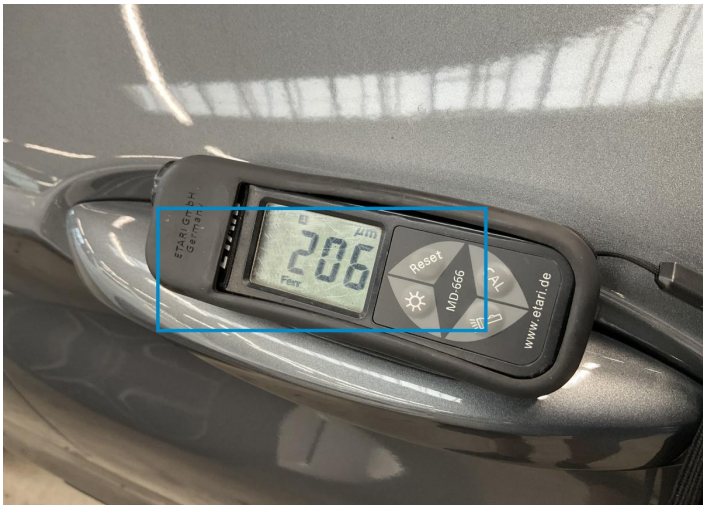
|	Component	Damage	Comments
1	Hood	Paint / Scratch / Scuff	
2	Bumper / Back	Paint / Scratch / Scuff	
3	Side Panel / Back Right	Paint / Scratch / Scuff	
4	Windshield / Front	Glass Break / Impact	
5	Door / Front Right	Paint / Poor Previous Repair	
6	Side Panel / Back Right	Paint / Poor Previous Repair

1. Hood
Paint / Scratch / Scuff -

2. Bumper / Back
Paint / Scratch / Scuff -

3. Side Panel / Back Right
Paint / Scratch / Scuff -

4. Windshield / Front
Glass Break / Impact -

5. Door / Front Right
Paint / Poor Previous Repair -

6. Side Panel / Back Right
Paint / Poor Previous Repair -
