MERCEDES-BENZ E-Klasse
E 300 de 4Matic T 9G-TRONIC

VIN NO W1KZH1BB5PB099262

Inspection Report Summary

Customer	BCA Online	Report Number	P20250829142515
Inspection Date / Place	2025-08-29 / BCA Neuss	Cosmetic Grade	1

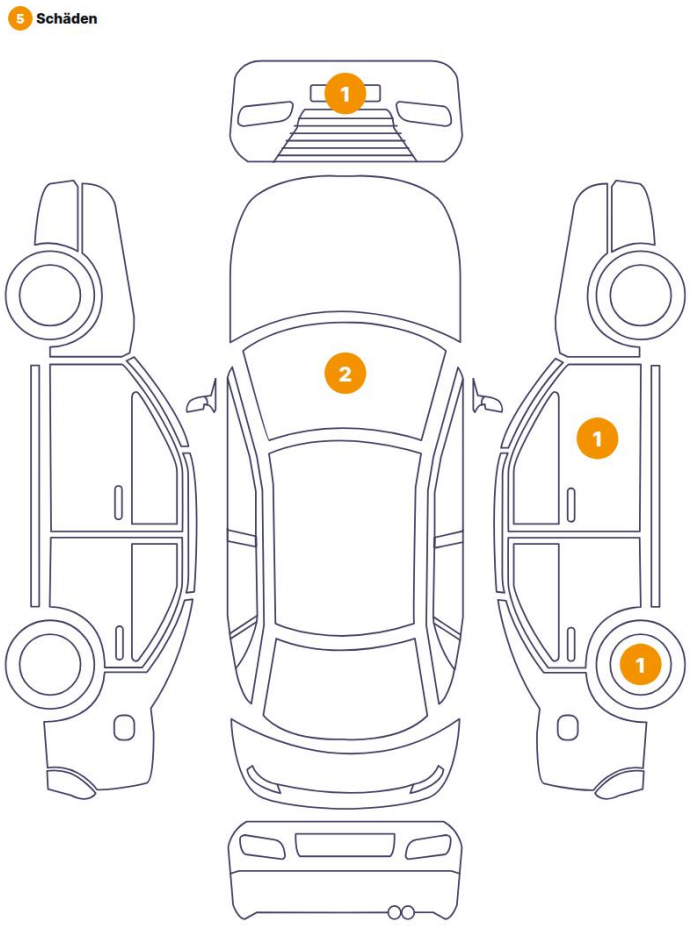
Cosmetic Damage

Component	Damage	Comments
1	Rim / Back Right	Out of Bodywork / Scratch	
2	Mirror Repeater / Right	Glass Break	
3	Windshield / Front	Paint / Chipping	
4	Windshield / Front	Paint / Chipping	
5	Bumper / Front	Paint / Chipping
