MERCEDES-BENZ G-Klasse
G AMG G 63 AMG Speedshift 9G-TRONIC

VIN NO W1N4632761X385913

Inspection Report Summary

Customer	BCA Online	Report Number	P20250815134546
Inspection Date / Place	2025-08-15 / ARS Altmann AG Riedstadt	Cosmetic Grade	3

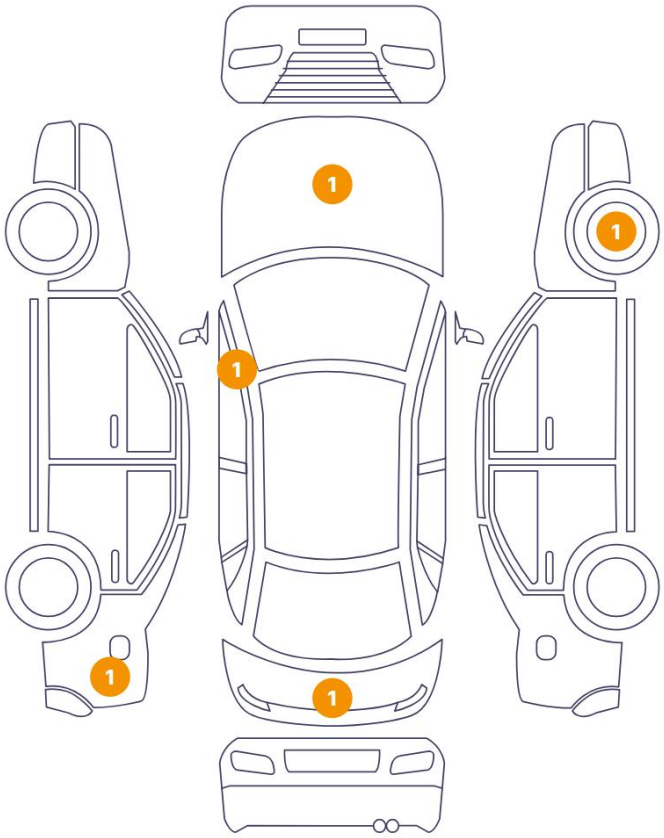
5 Schäden

Component	Damage	Comments
1	Hood	Paint / Stone Chip	
2	Rim / Front Right	Out of Bodywork / Scratch	
3	Wheel cover	Paint / Scratch / Scuff	
4	Side Panel / Back Left	Paint / Scratch / Scuff	
5	Deflector / Front Left	Paint / Stone Chip

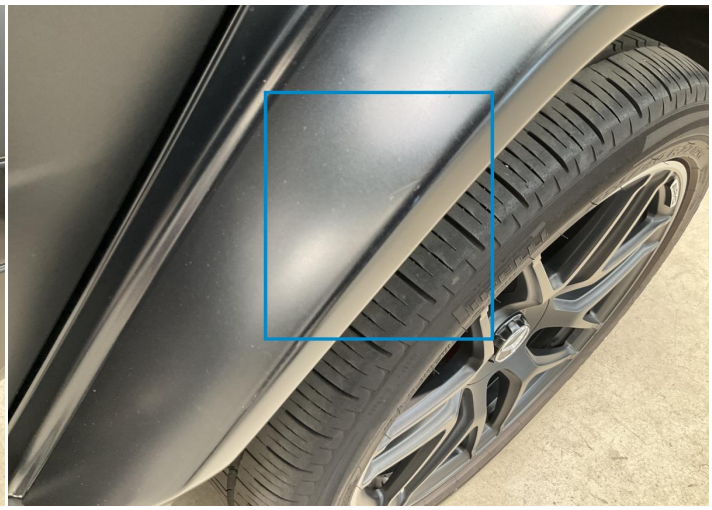
3. Wheel cover
Paint / Scratch / Scuff -
