AUDI A6

A6 Avant 2.8 FSI quattro

VIN NO WAUZZZ4F3BN014509

Inspection Report Summary

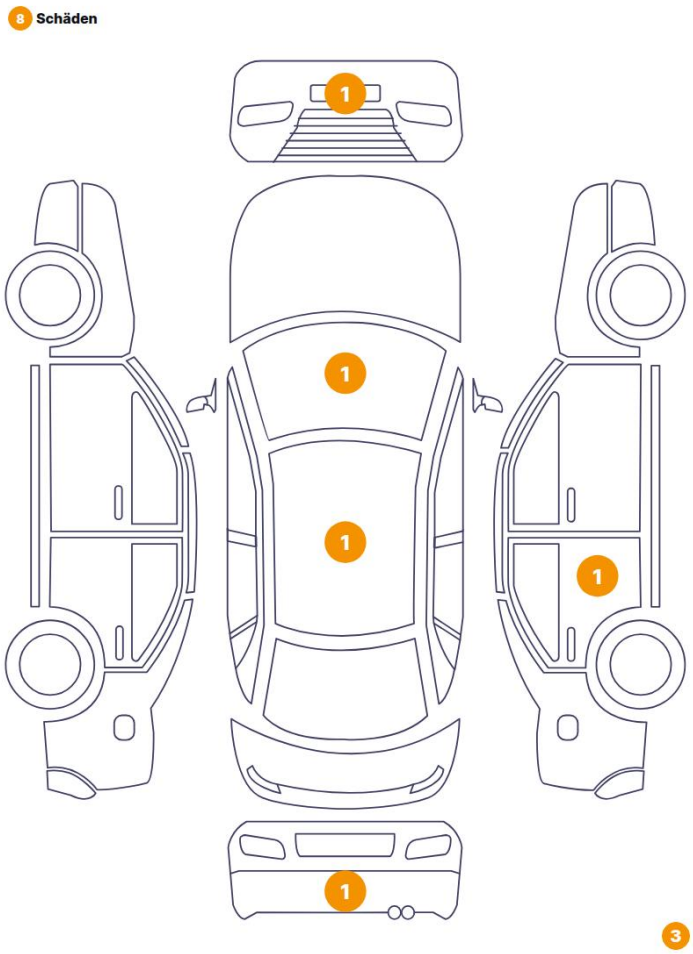
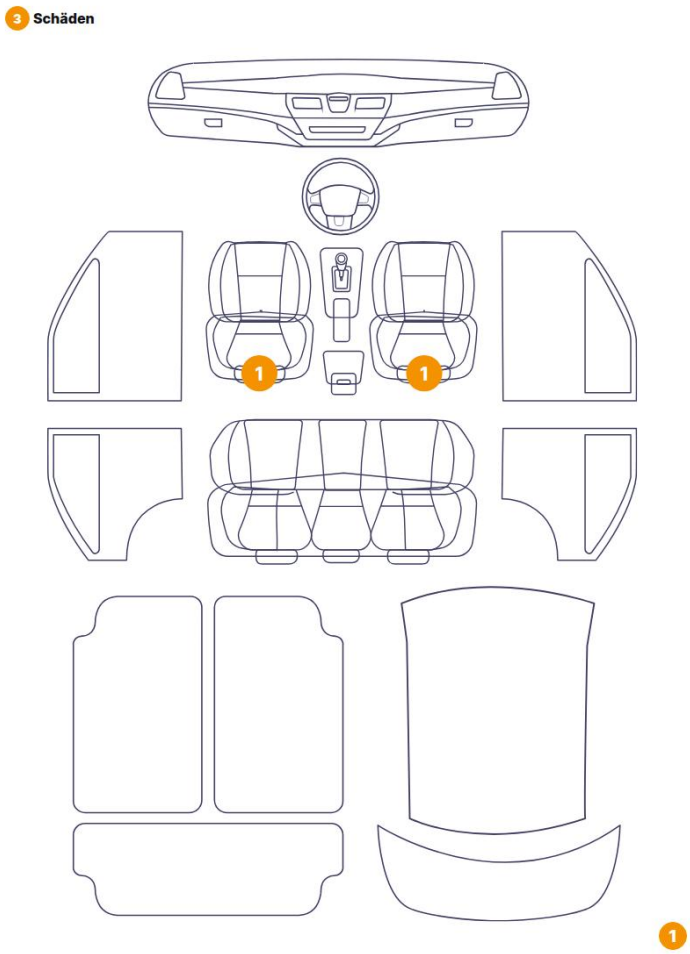
Cosmetic Damage

Component	Damage	Comments
1	Windshield / Front	Glass Break / Impact	
2	Other	Anomalyon Element	
3	Bumper / Front	Paint / Scratch / Scuff	
4	Other	Paint / Scratch / Scuff	
5	Seat / Front Left	Interior / Scratched	
6	Bumper / Back	Paint / Scratch / Line	
7	Other	Interior / Scratched	
8	Door / Back Right	Bodywork / Dent / Dent	
9	Seat / Front Right	Interior / Scratched	
10	Roof	Paint / Scratch / Line	
11	Other	Paint / Scratch / Scuff

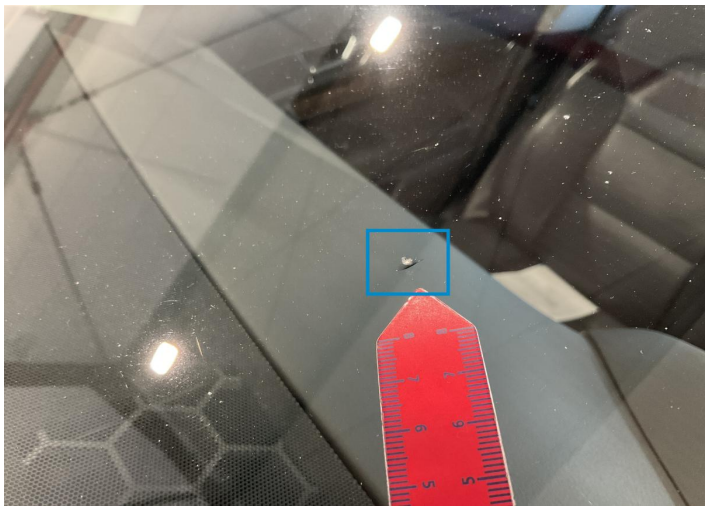
1. Windshield / Front
Glass Break / Impact -

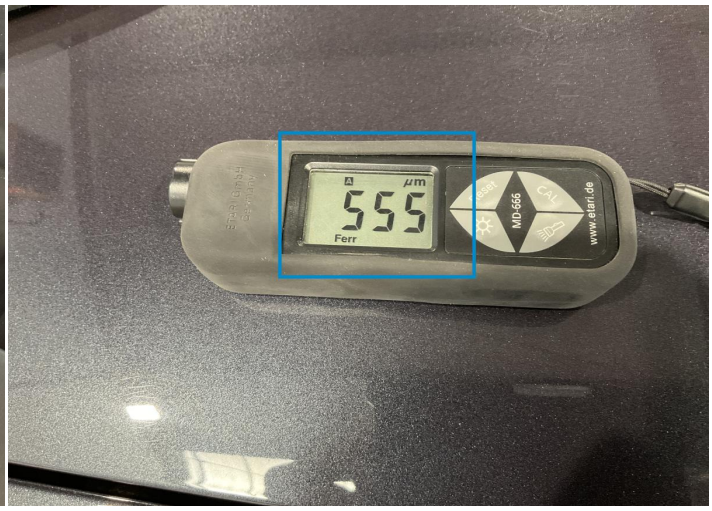
2.
Anomalyon Element -

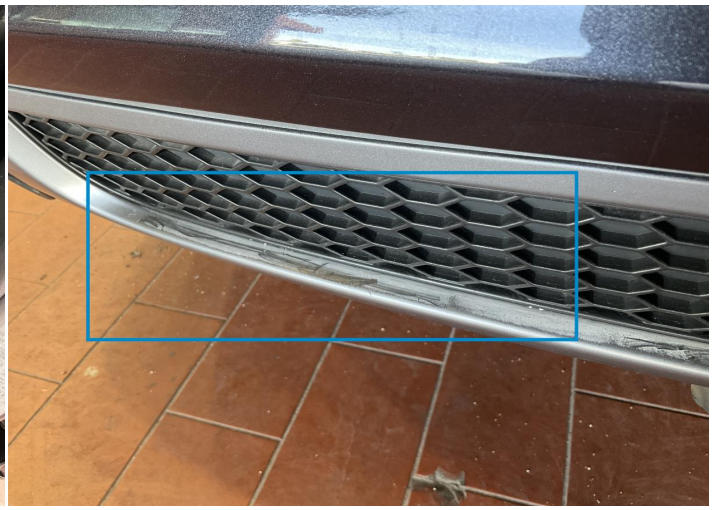
6. Bumper / Back
Paint / Scratch / Line -

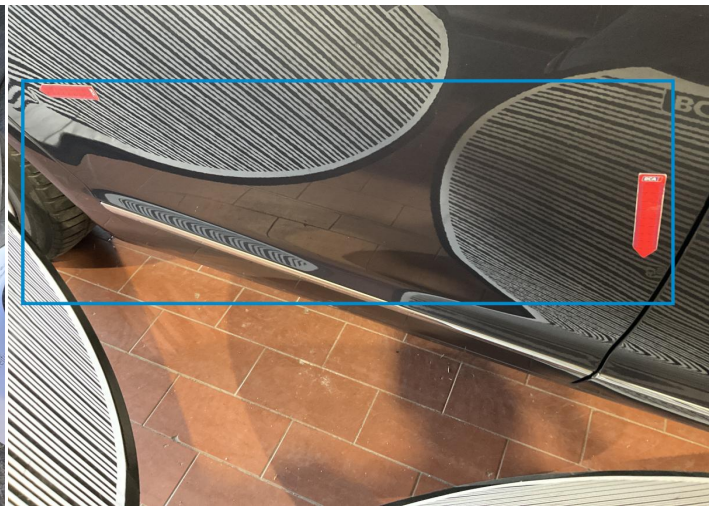
8. Door / Back Right
Bodywork / Dent / Dent -

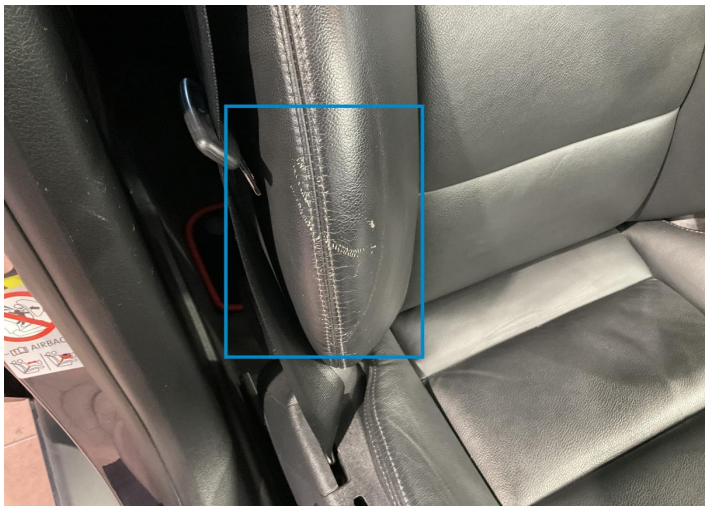
9. Seat / Front Right
Interior / Scratched -
