AUDI Q7

Q7 50 TDI quattro tiptronic

VIN NO WAUZZZ4M4PD031184

Inspection Report Summary

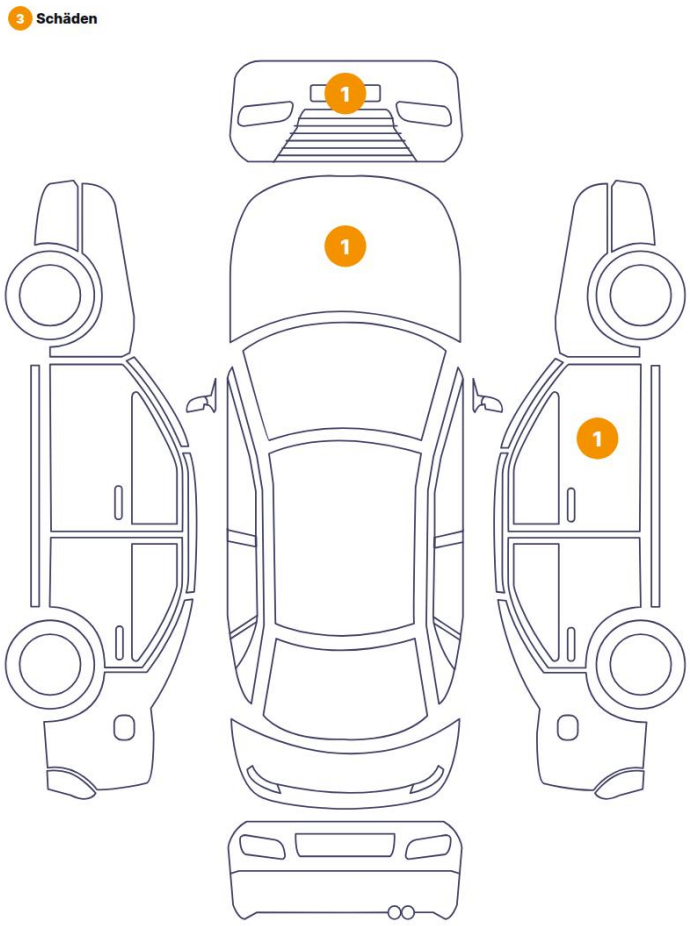
Component	Damage	Comments
1	Mirror Shell / Front Right	Paint / Scratch / Scuff	
2	Bumper / Front	Paint / Scratch / Scuff	
3	Hood	Paint / Scratch / Scuff

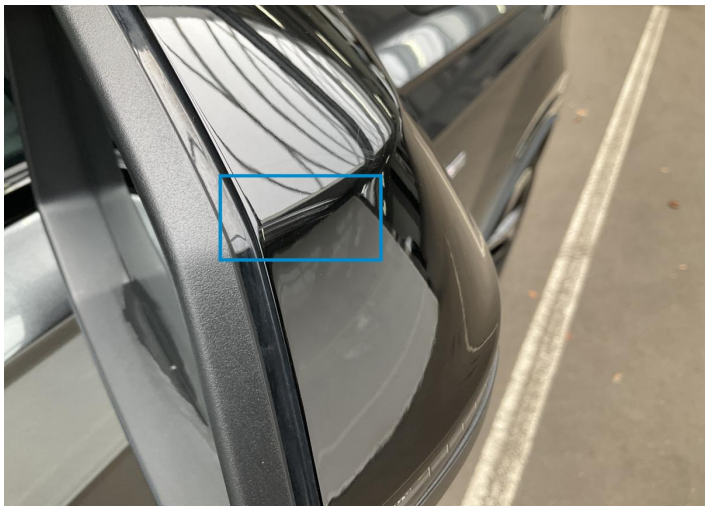
1. Mirror Shell / Front Right
Paint / Scratch / Scuff -

2. Bumper / Front
Paint / Scratch / Scuff -

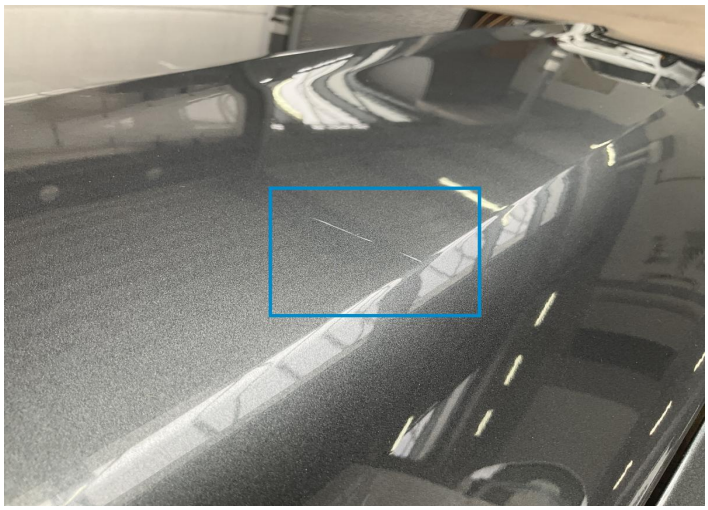
3. Hood
Paint / Scratch / Scuff -
