AUDI A3

A3 1.4 TFSI Sportback

VIN NO WAUZZZ8P3AA105966

Inspection Report Summary

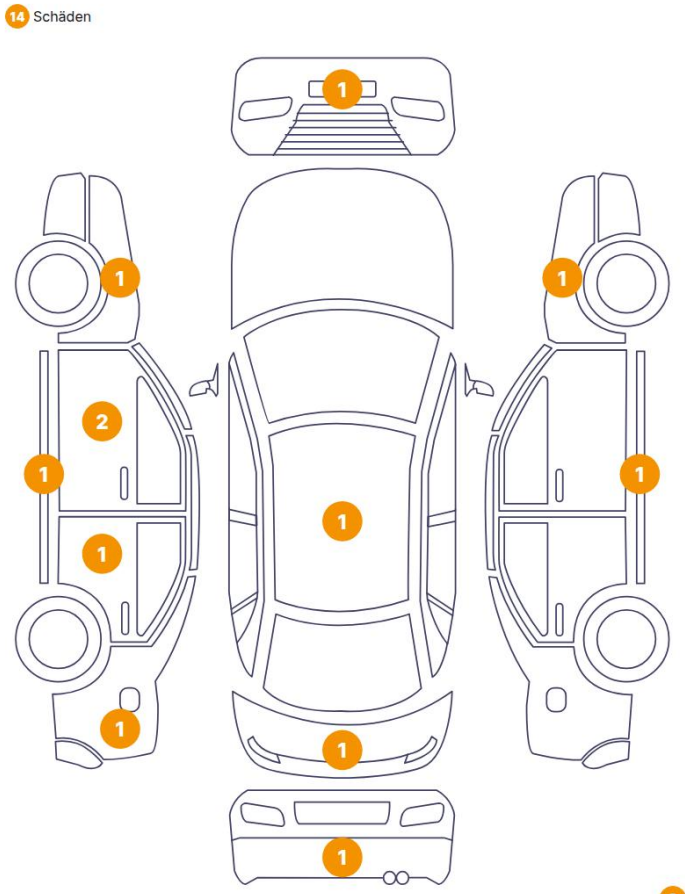
Cosmetic Damage

Component	Damage	Comments
1	Bumper / Front	Paint / Scratch / Scuff	
2	Roof	Paint / Stone Chip	
3	Fender / Front Left	Paint / Scratch / Line	
4	Rocker Panel / Center Left	Paint / Scratch / Line	
5	Door Side Molding / Front Left	Bodywork / Breakage / Crack	
6	Door / Front Left	Bodywork / Dent / Dent	
7	Door / Back Left	Bodywork / Dent / Dent	
8	Side Panel / Back Left	Bodywork / Dent / Dent	
9	Other	Paint / Scratch / Scuff	
10	Bumper / Back	Paint / Scratch / Line	
11	Tailgate	Paint / Scratch / Line	
12	Other	Paint / Scratch / Scuff	
13	Fender / Front Right	Paint / Scratch / Line

14	Rocker Panel / Center Right	Paint / Scratch / Line

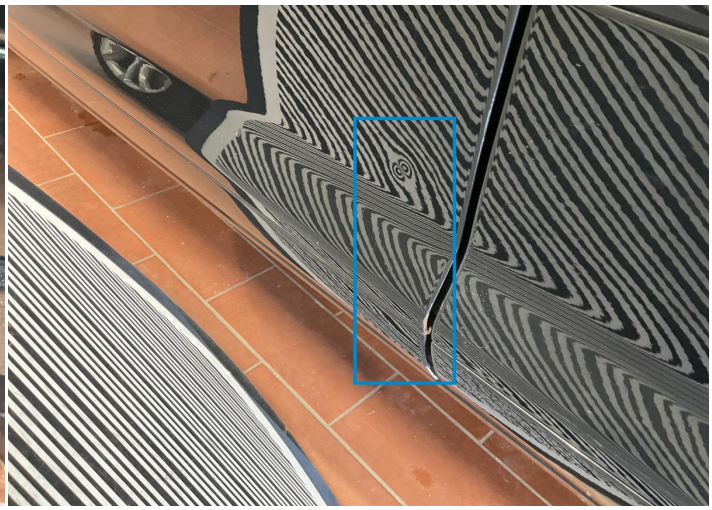
1. Bumper / Front
Paint / Scratch / Scuff -

2. Roof
Paint / Stone Chip -

3. Fender / Front Left
Paint / Scratch / Line -

4. Rocker Panel / Center Left
Paint / Scratch / Line -

5. Door Side Molding / Front Left
Bodywork / Breakage / Crack -

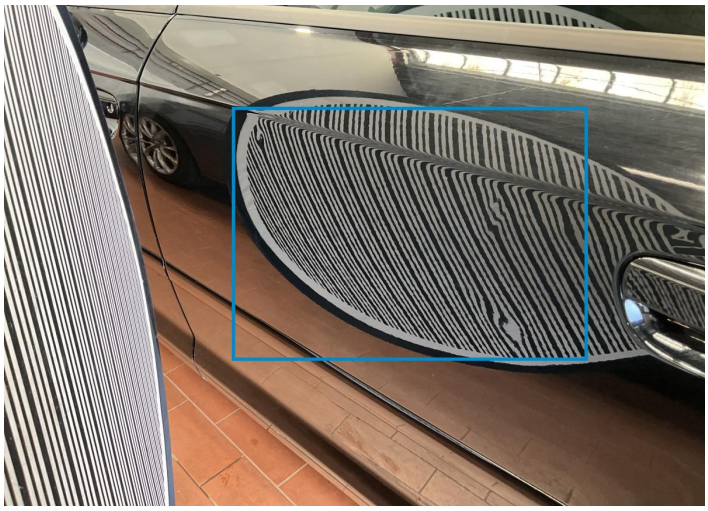
6. Door / Front Left
Bodywork / Dent / Dent -

7. Door / Back Left
Bodywork / Dent / Dent -

8. Side Panel / Back Left
Bodywork / Dent / Dent -

9.
Paint / Scratch / Scuff -

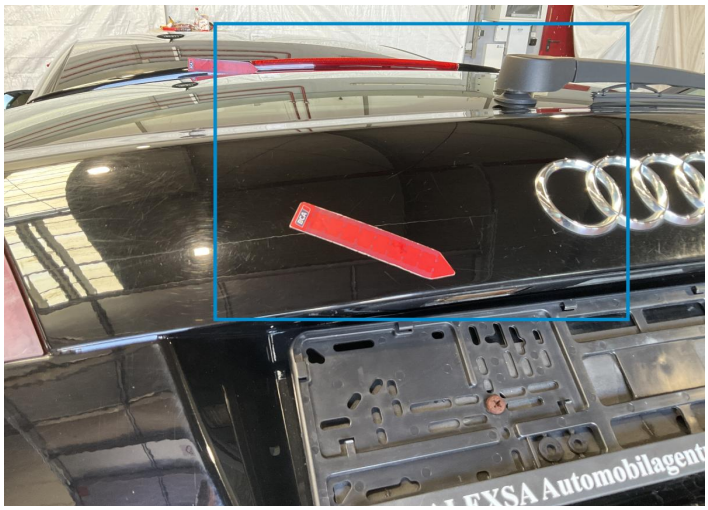
10. Bumper / Back
Paint / Scratch / Line -

11. Tailgate
Paint / Scratch / Line -

12.
Paint / Scratch / Scuff -
