AUDI A6

A6 Avant 40 TDI quattro S tronic

VIN NO WAUZZZF24NN060963

Inspection Report Summary

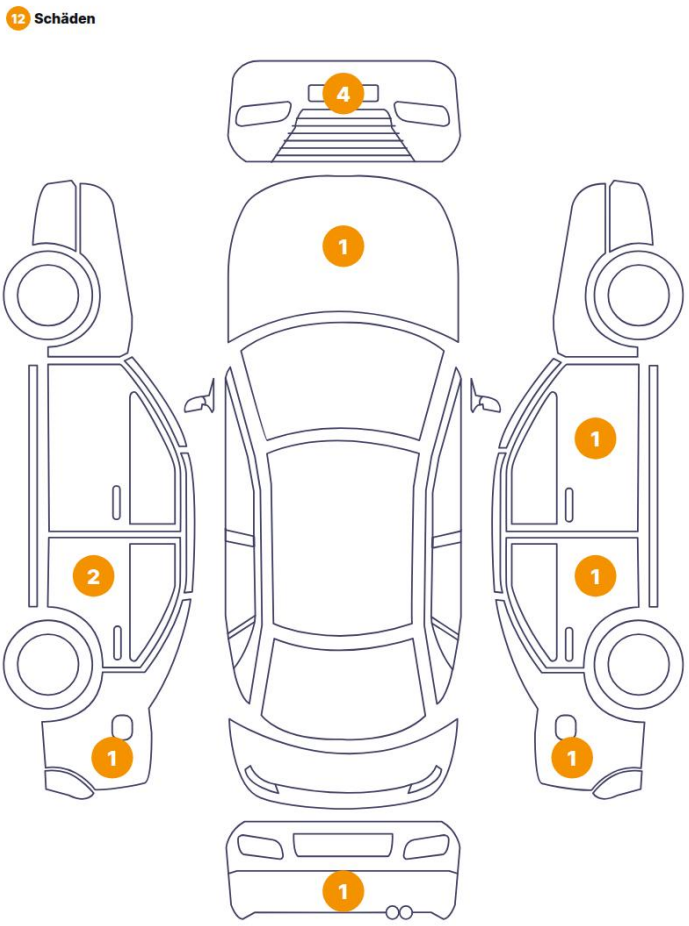
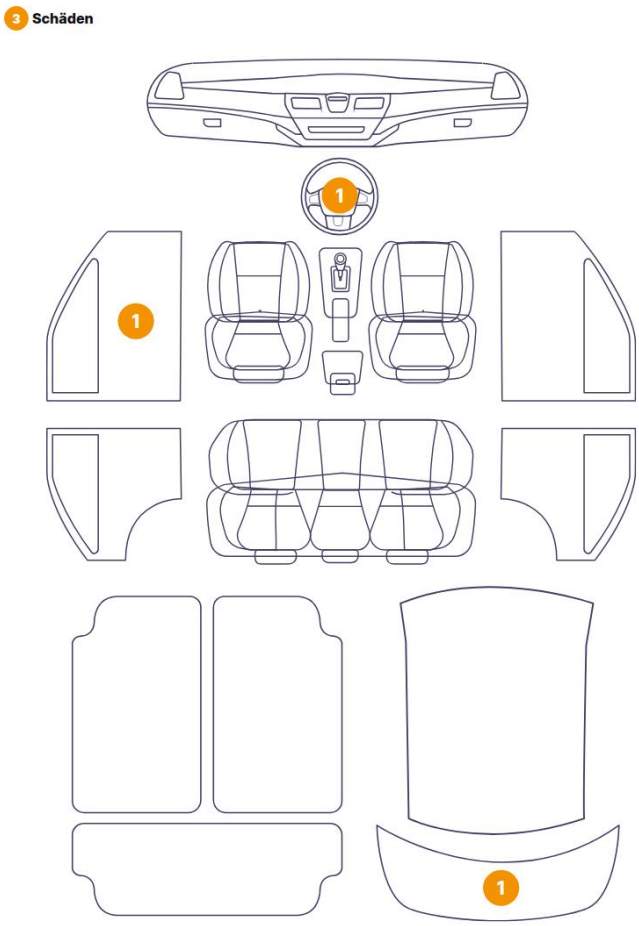
Cosmetic Damage

Component	Damage	Comments
1	Hood	Paint / Stone Chip	
2	Bumper / Front	Paint / Scratch / Scuff	
3	Bumper / Front	Paint / Scratch / Scuff	
4	Bumper / Front	Paint / Scratch / Scuff	
5	Panel Filling / Front Left	Interior / Scratched	
6	Door / Back Left	Paint / Scratch / Scuff	
7	Pillar / Back Left	Paint / Scratch / Scuff	
8	Side Panel / Back Left	Bodywork / Dent / Dent	
9	Bumper / Back	Paint / Scratch / Scuff	
10	Tailgate Upholstery / Back	Interior / Scratched	
11	Side Panel / Back Right	Paint / Scratch / Scuff	
12	Pillar / Back Right	Bodywork / Dent / Dent

13	Door / Front Right	Paint / Scratch / Scuff
14	Steering Wheel / Front	Interior / Scratched
15	Bumper / Front	Bodywork / Breakage / Crack

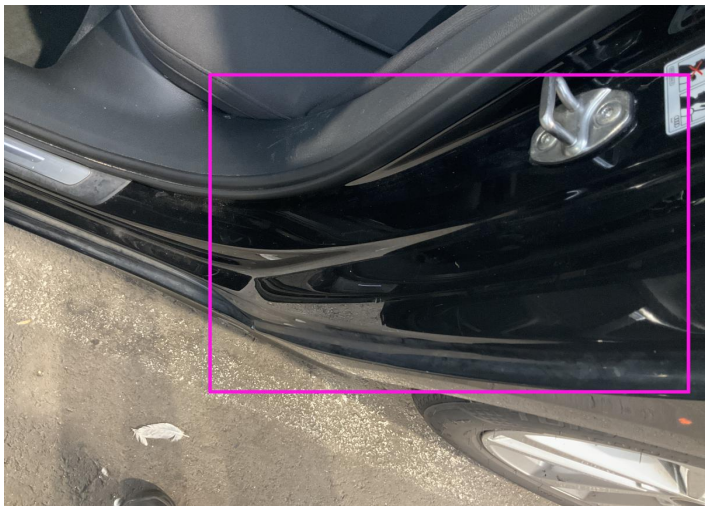
5. Panel Filling / Front Left
Interior / Scratched -

6. Door / Back Left
Paint / Scratch / Scuff -
