AUDI A4

A4 Avant 40 TDI quattro S tronic

VIN NO WAUZZZF47NA047987

Inspection Report Summary

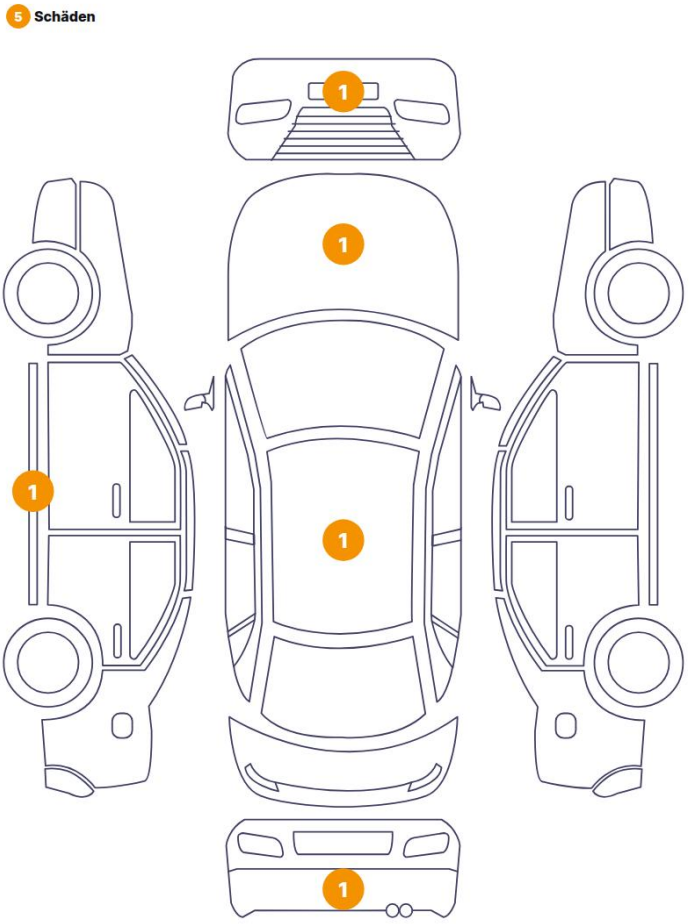
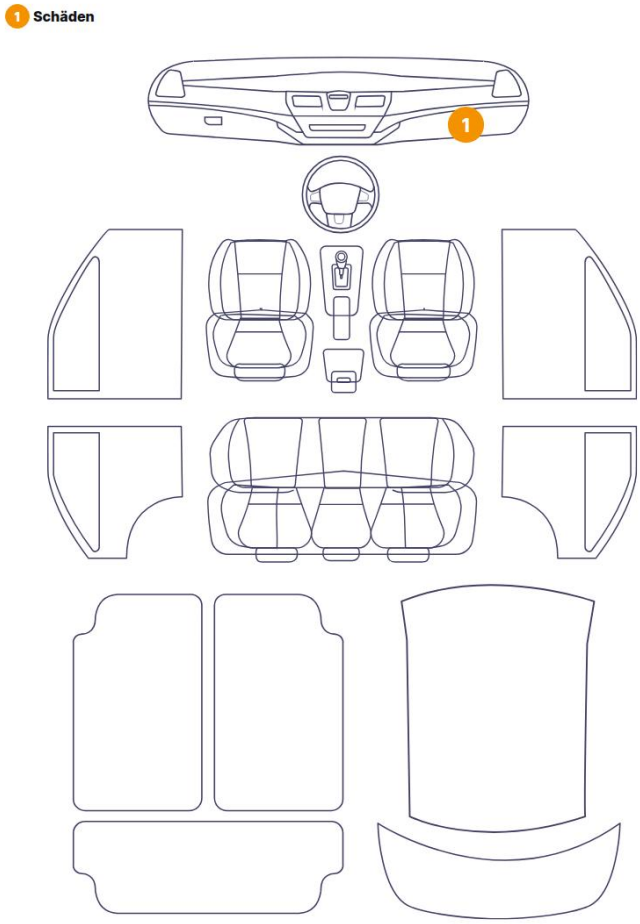
Cosmetic Damage

Component	Damage	Comments
1	Rocker Panel / Center Left	Bodywork / Breakage	
2	Bumper / Back	Paint / Scratch / Scuff	
3	Roof	Paint / Scratch / Scuff	
4	Bumper / Front	Paint / Scratch / Scuff	
5	Hood	Paint / Scratch / Scuff	
6	Center Console	Interior / Scratched

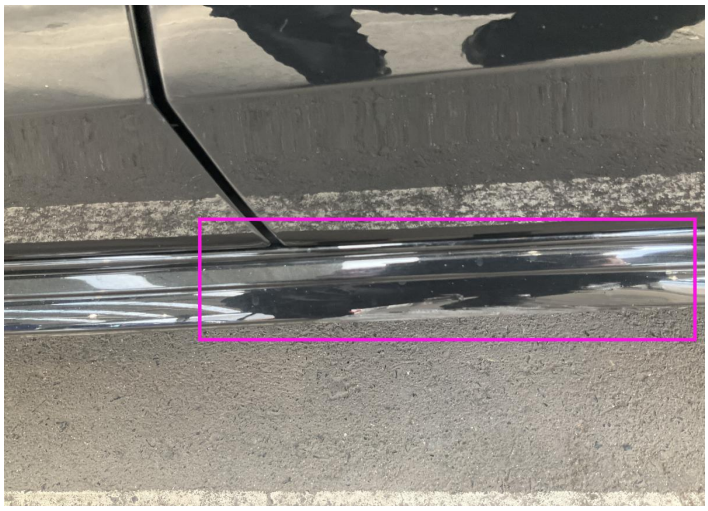
1. Rocker Panel / Center Left
Bodywork / Breakage -

2. Bumper / Back
Paint / Scratch / Scuff -

3. Roof
Paint / Scratch / Scuff -

4. Bumper / Front
Paint / Scratch / Scuff -

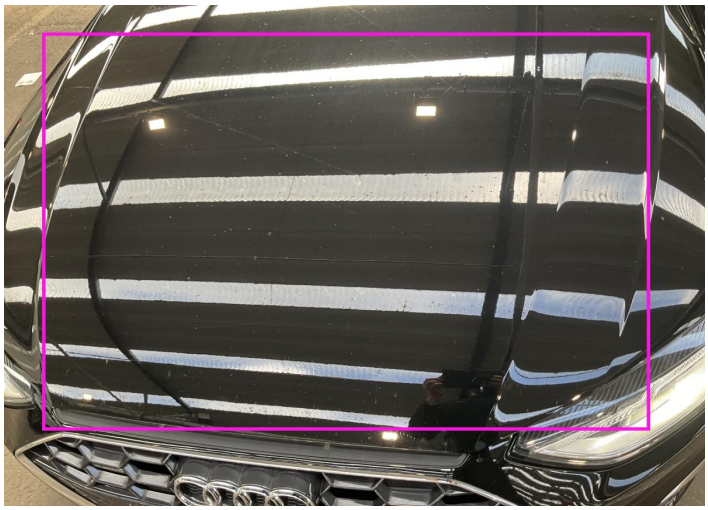
5. Hood
Paint / Scratch / Scuff -
