AUDI A3

A3 45 TFSIe Sportback S tronic

Inspection Report Summary

Customer	BCA Online	Report Number	P20250808091124
Inspection Date / Place	2025-08-08 / BCA Heidenheim	Cosmetic Grade	3

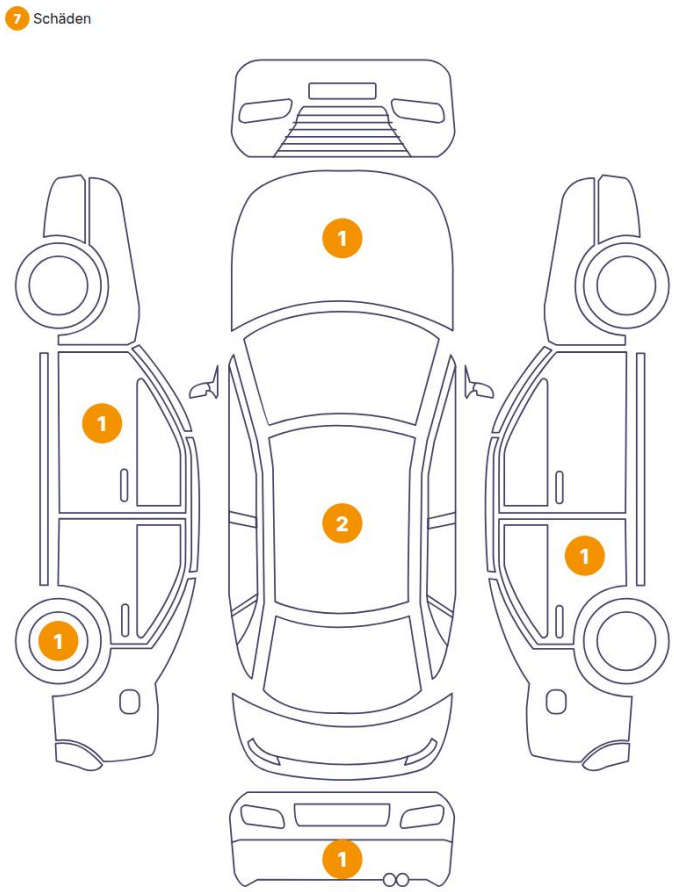
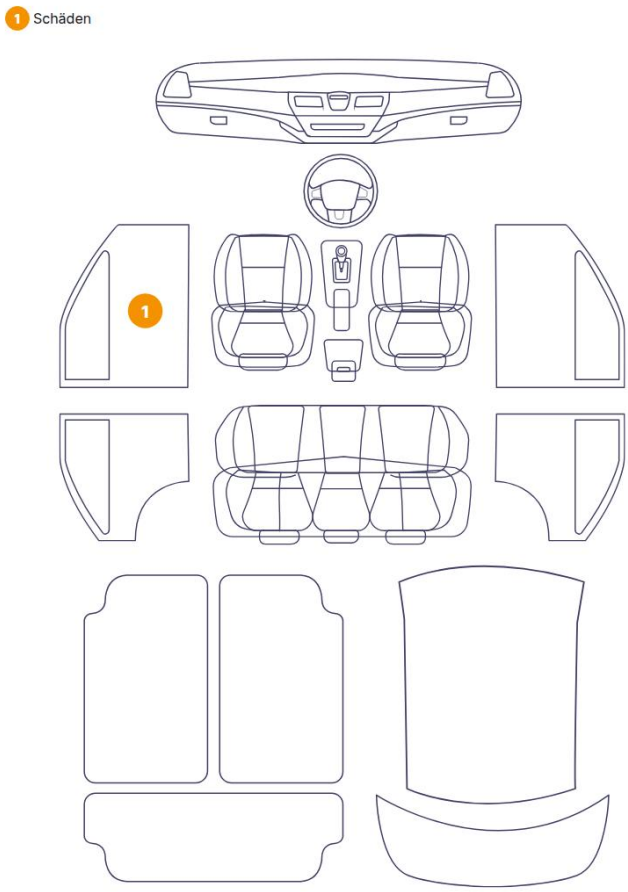
Cosmetic Damage

Component	Damage	Comments
1	Panel Filling / Front Left	Interior / Scraped	
2	Roof	Paint / Scratch / Scuff	
3	Roof	Paint / Scratch / Scuff	
4	Rim / Back Left	Out of Bodywork / Scratch	
5	Hood	Paint / Stone Chip	
6	Door / Back Right	Paint / Scratch / Line	
7	Bumper / Back	Paint / Scratch / Scuff	
8	Door Joint / Front Left Top	Bodywork / Assembly

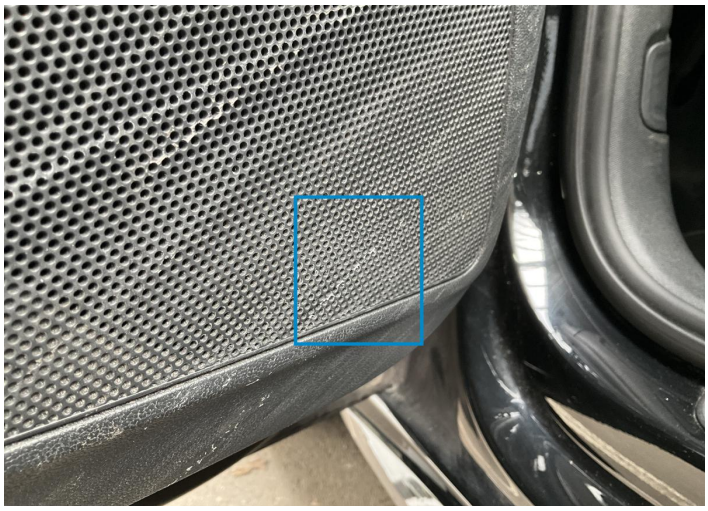
1. Panel Filling / Front Left
Interior / Scraped -

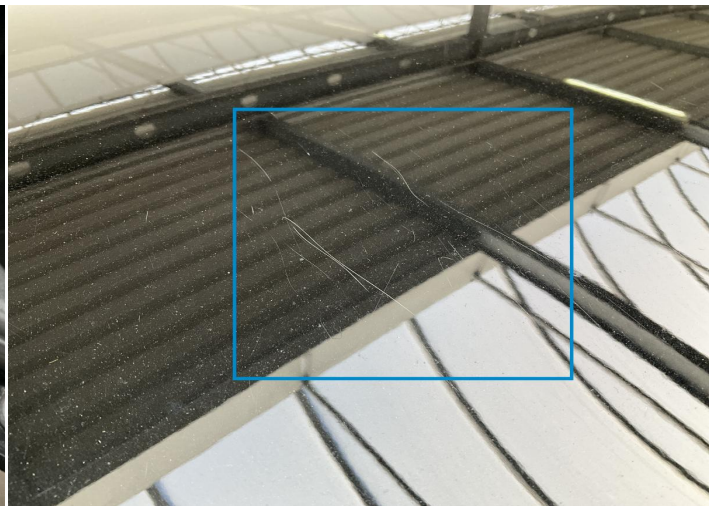
2. Roof
Paint / Scratch / Scuff -

3. Roof
Paint / Scratch / Scuff -

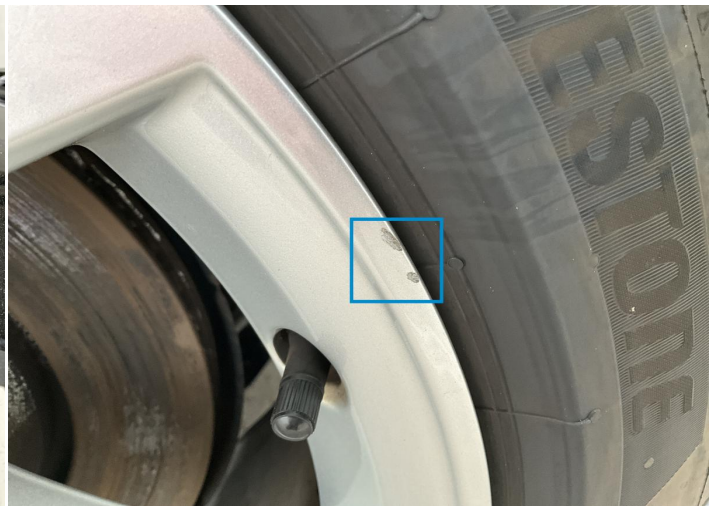
4. Rim / Back Left
Out of Bodywork / Scratch -

5. Hood
Paint / Stone Chip -

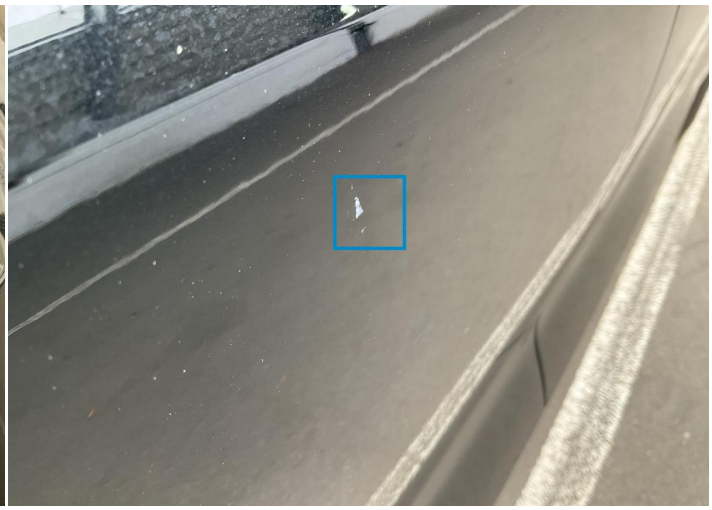
6. Door / Back Right
Paint / Scratch / Line -

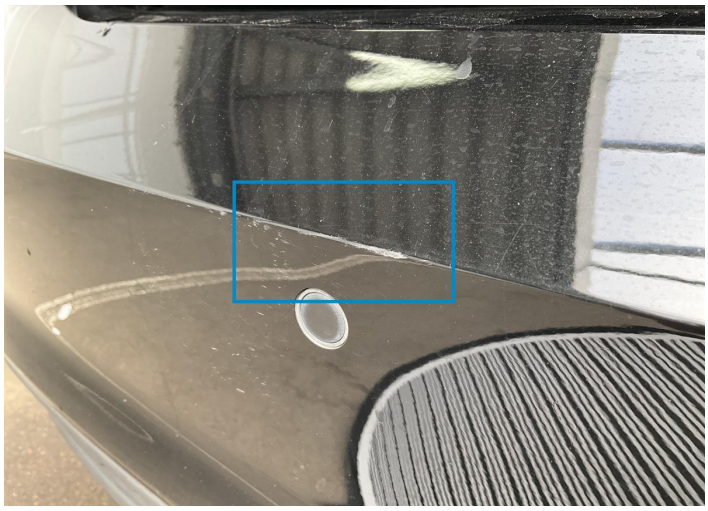
7. Bumper / Back
Paint / Scratch / Scuff -

8. Door Joint / Front Left Top
Bodywork / Assembly -
